Progressive Rehabilitation Report

Concrete Cap

Fatima (Texmont, New Texmont) Mine Site Vent Raise Cap

April 8, 2013 Rev. 1

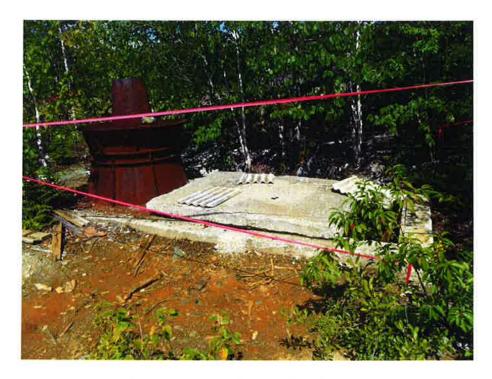
One specific concern to date, remedied as of September 13, 2012, has been the vent raise opening located at the north part of the Fatima (Texmont, New Texmont) Mine Site. At the time of the inspection site visit, the Fatima (Texmont, New Texmont) Mine Site was not secured and it was noted that a geocache (public GPS treasure hunt) site was located at the vent raise opening location. The vent raise was covered with a fractured concrete slab which could be moved. As such, the opening to surface had not been protected from access and presented a risk to public safety.

1. View of original shaft looking north.

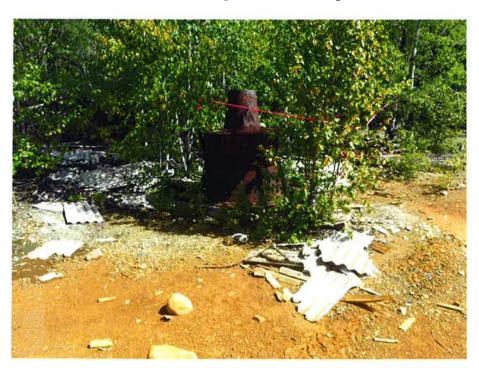
2. View of original shaft looking east.

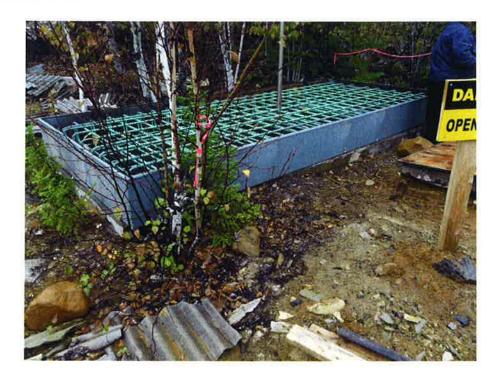
3. View of formwork and rebar prior to pour.

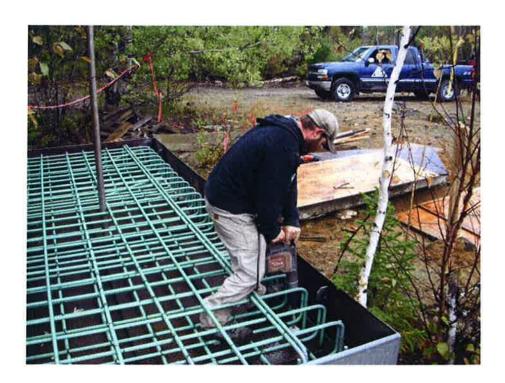
4. Cap dowel installation being completed.

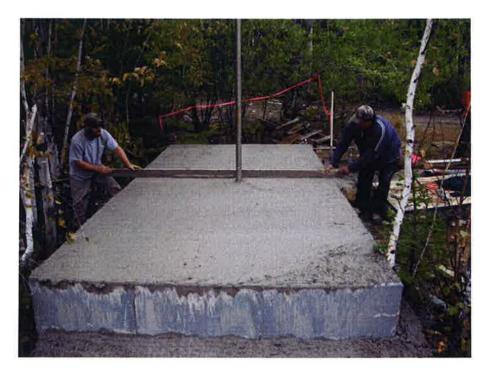
5. Concrete pour and surface finishing is completed.

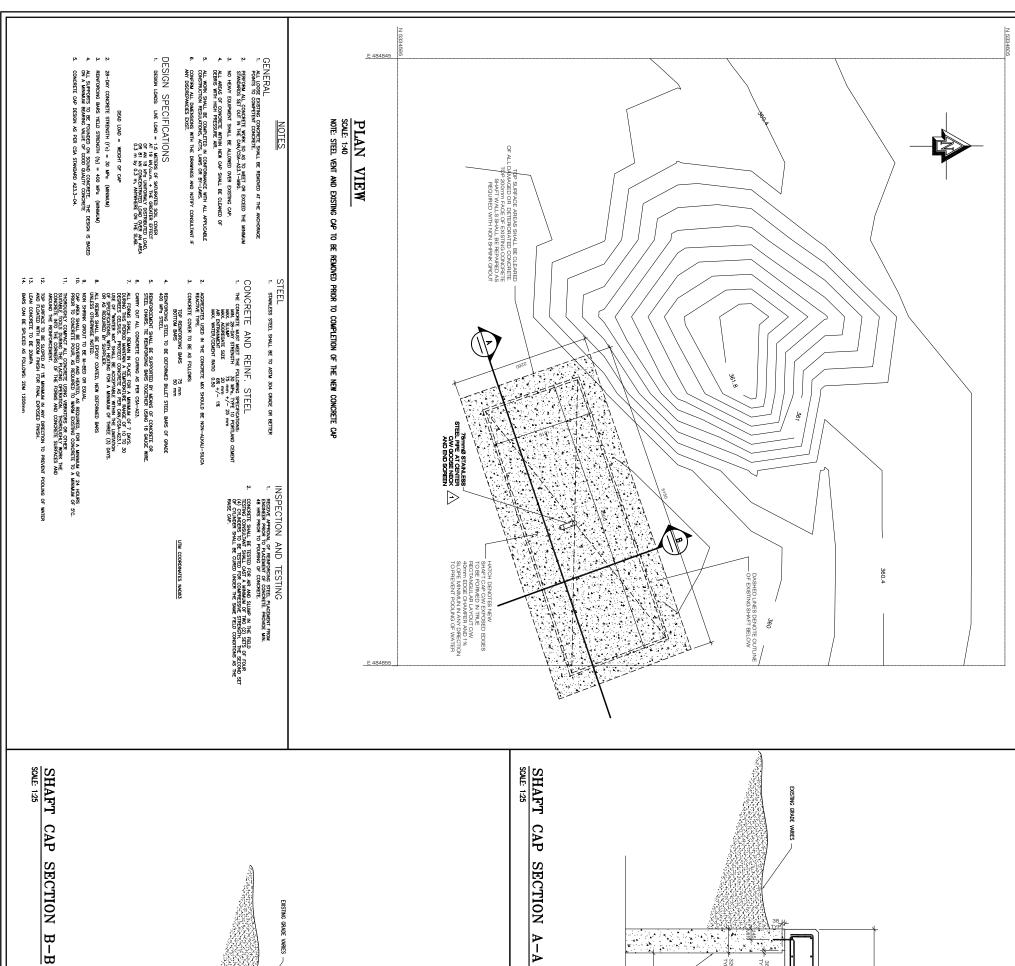
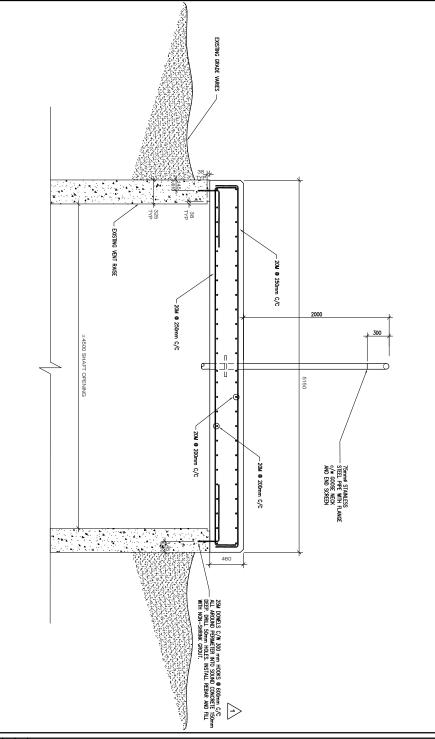
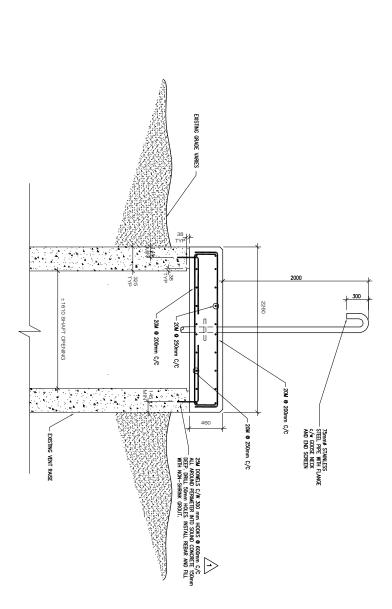
TM01 R1

A new reinforced concrete cap, constructed as prescribed by the Mining Act as outlined in Schedule 1, Part1, Section 3 of the Mine Rehabilitation Code of Ontario, was constructed above the existing concrete vent raise collar and tied into the perimeter of the collar. A copy of the as built drawing of the cap, complete with a 76 mm (3") diameter monitoring pipe is enclosed in Appendix B. Construction of the cap was completed on September 13, 2012.
