#### PRELIMINARY PROPERTY EXAMINATION

PROSPECTING REPORT ON THE TELLURIDE LAKE PROPERTY

**BEEMER TOWNSHIP**, PORCUPINE MINING DIVISION

CLAIM # 4267626

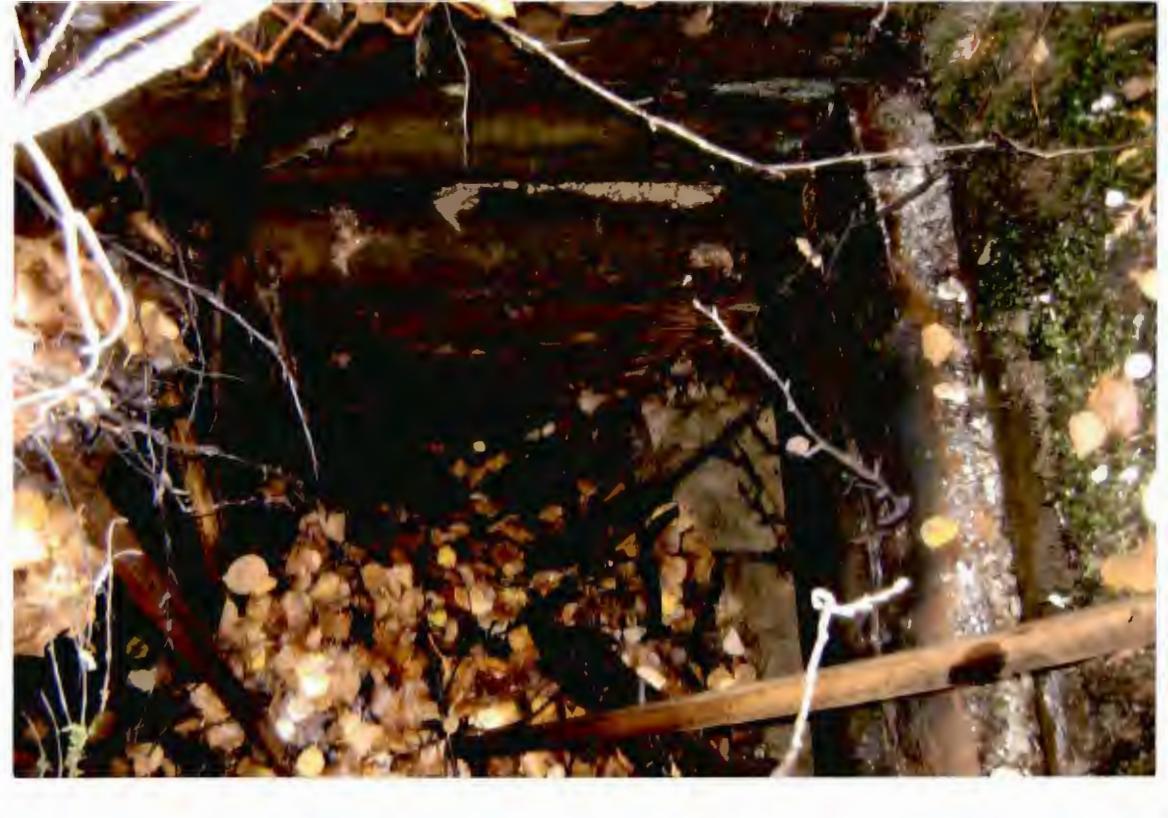
## Shaft

A shaft was put down on the north side of the out crop, reportedly 25 feet by Svlanite Gold Mines, in the 1930s (A.M.I.S# 00113) The shaft is approx 2m x 2m, and is partially caved in due to rotting timbers. Water level is about 3m below surface, the east, west and north faces of the shaft are surrounded by a muck pile, presumably material excavated from the shaft, no attempt was made to sample inside the shaft as it to dangerous at this time and will need rehabilitation before it can be examined. A orange plastic construction fence was pulled out of the shaft and re-erected by hanging on surrounding small trees, an open hole sighn was also picked up and posted in a tree in the best visible location should someone walk up to the shaft.

It is concluded that the showing has favourable possibility for gold mineralization. It is recommended to do open cutting and stripping of the entire outcrop as it is partially covered with moss and smaller trees and that systematic blasting or channel sampling and assays be done along the outcrops entirety, also the shaft should be pumped and ground supported and then examined.

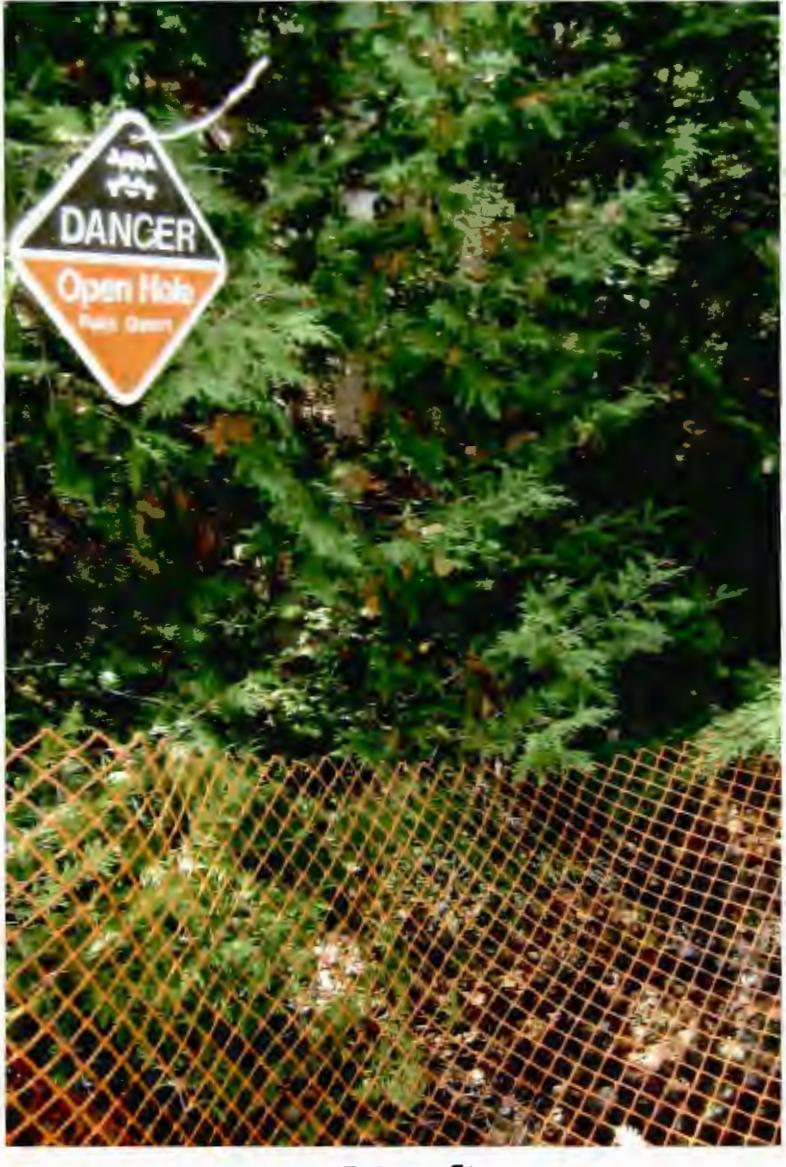
## Shaft hung fence up, post sign

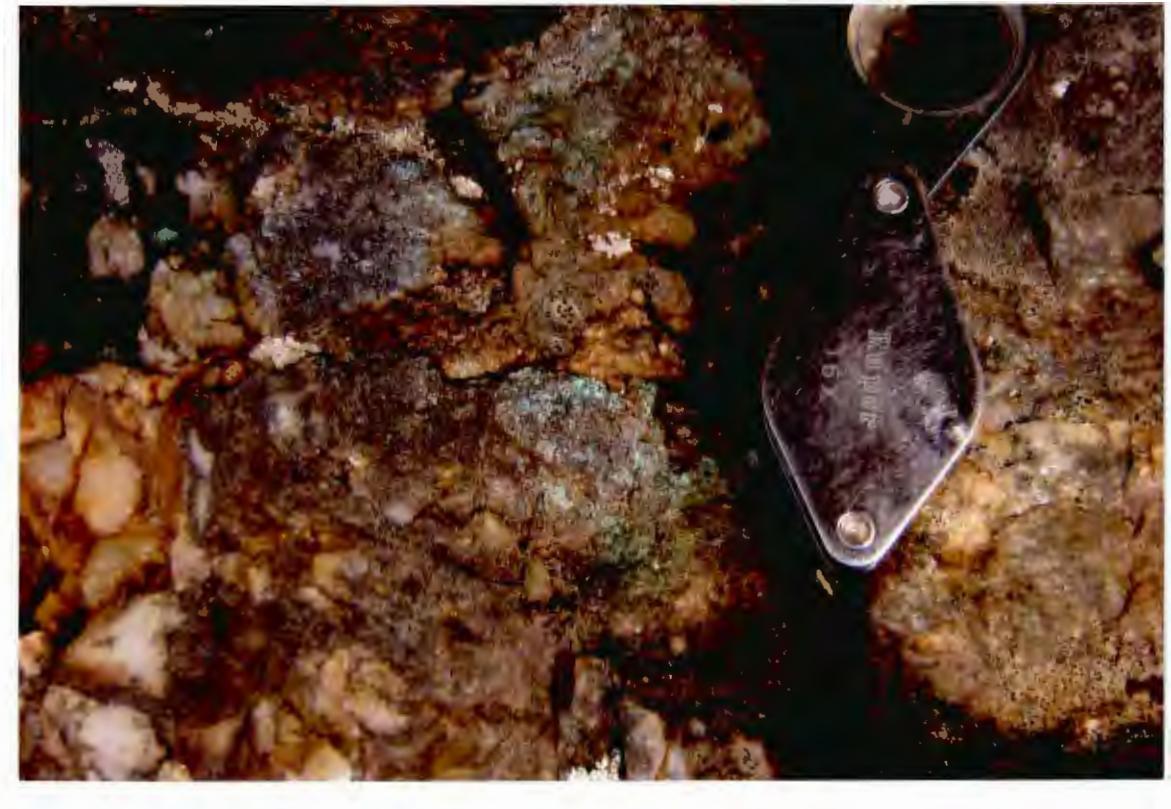
There is a trench approx 5m south of the shaft, refered to in this report as trench#1. It is approx 1.5m x 2m and was more of a slash of the south face of the outcrop than a true trench, however, The trench shows the contact of the quartz and the mica schist, quarts and schist very rusy coloured where the contact is made, malachite bloom was also noted. A total of three samples were taken from trench#1,sample#05916 schist, sample#05917 quartz and sample#05918 of qtz/schist contact.

# Trench #1 Malachite (copper bloom)
