APPENDIX H

SELECT INFRASTRUCTURE CORRIDOR PHOTOGRAPHS

PROJECT PHOTOGRAPHS
 PROPOSED INFRASTRUCTURE CORRIDOR
 NORTHWEST ONTARIO, CANADA

CANADA CHROME/FEASIBILITY STUDY/CANADA

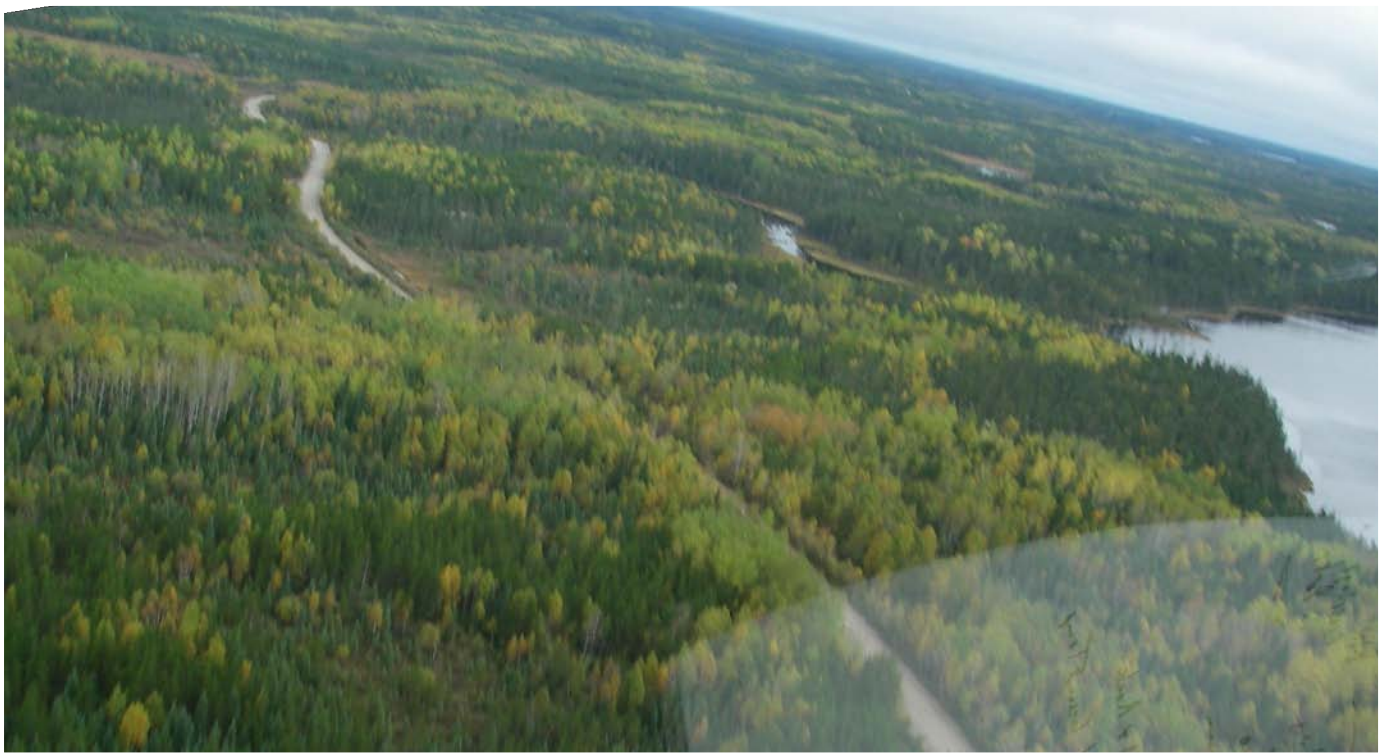
VIEW LOOKING NORTHWARD AT STATION 23+000 SHOWING ADJACENT ACCESS ROAD AND TYPICAL SPRUCE-BIRCH FOREST OVER SHALLOW BEDROCK.

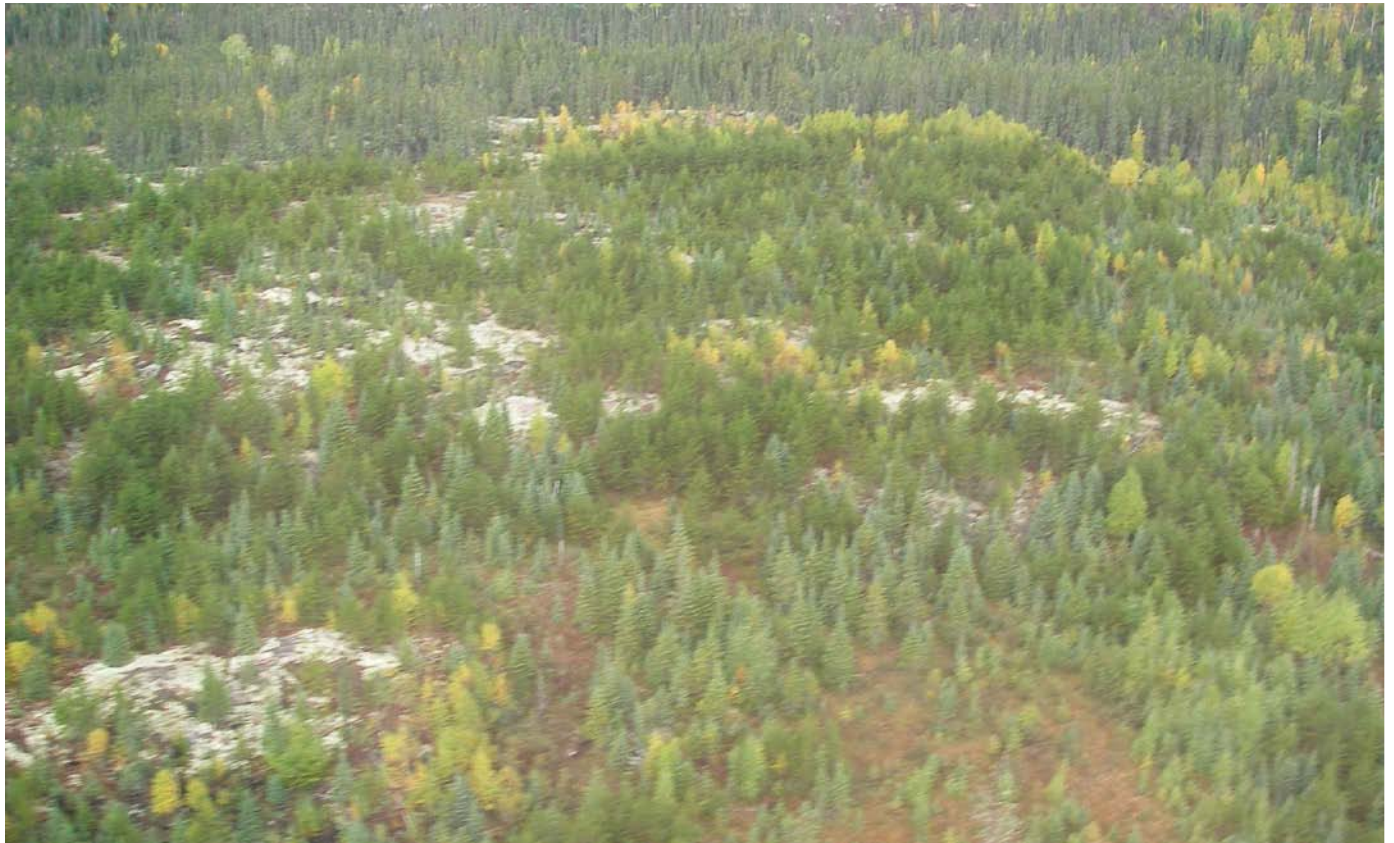
VIEW OF TERRAIN WITH SHALLOW AND EXPOSED BEDROCK NEAR STATION 45+000.

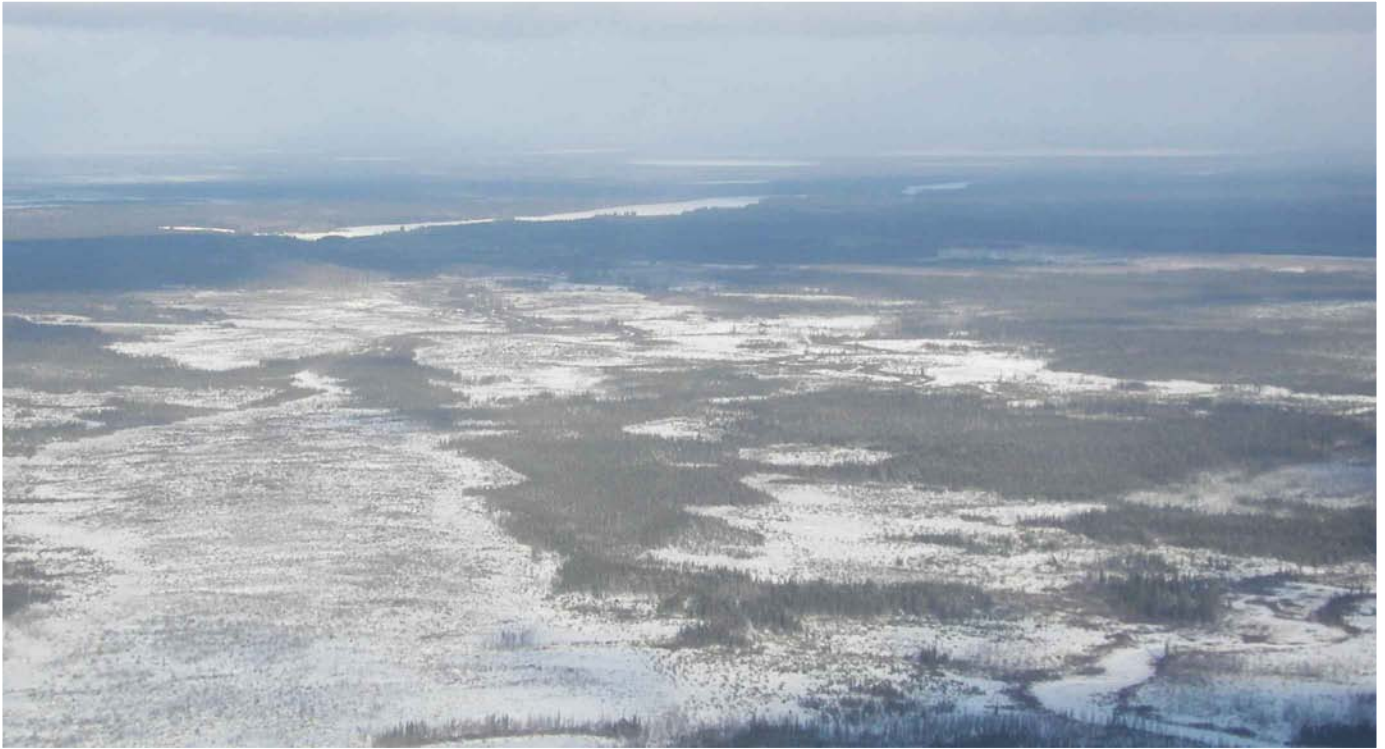
TYPICAL MID ALIGNMENT SURFACE CONDITIONS WITH SCATTERED TREES AND ORGANIC DEPOSITS.

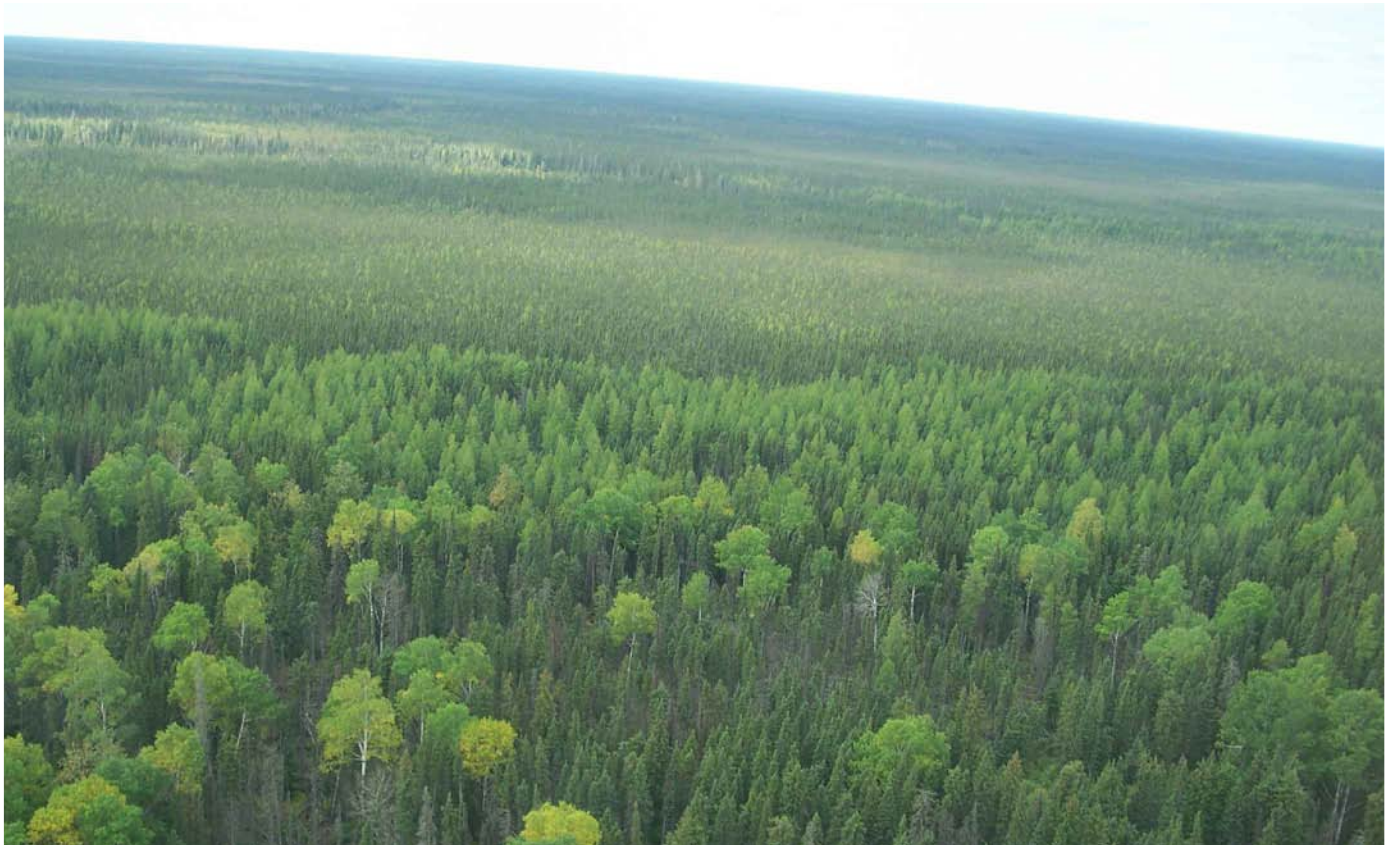
TYPICAL TOPOGRAPHY ENCOUNTERED ALONG SOUTHERN SEGMENT OF CORRIDOR.

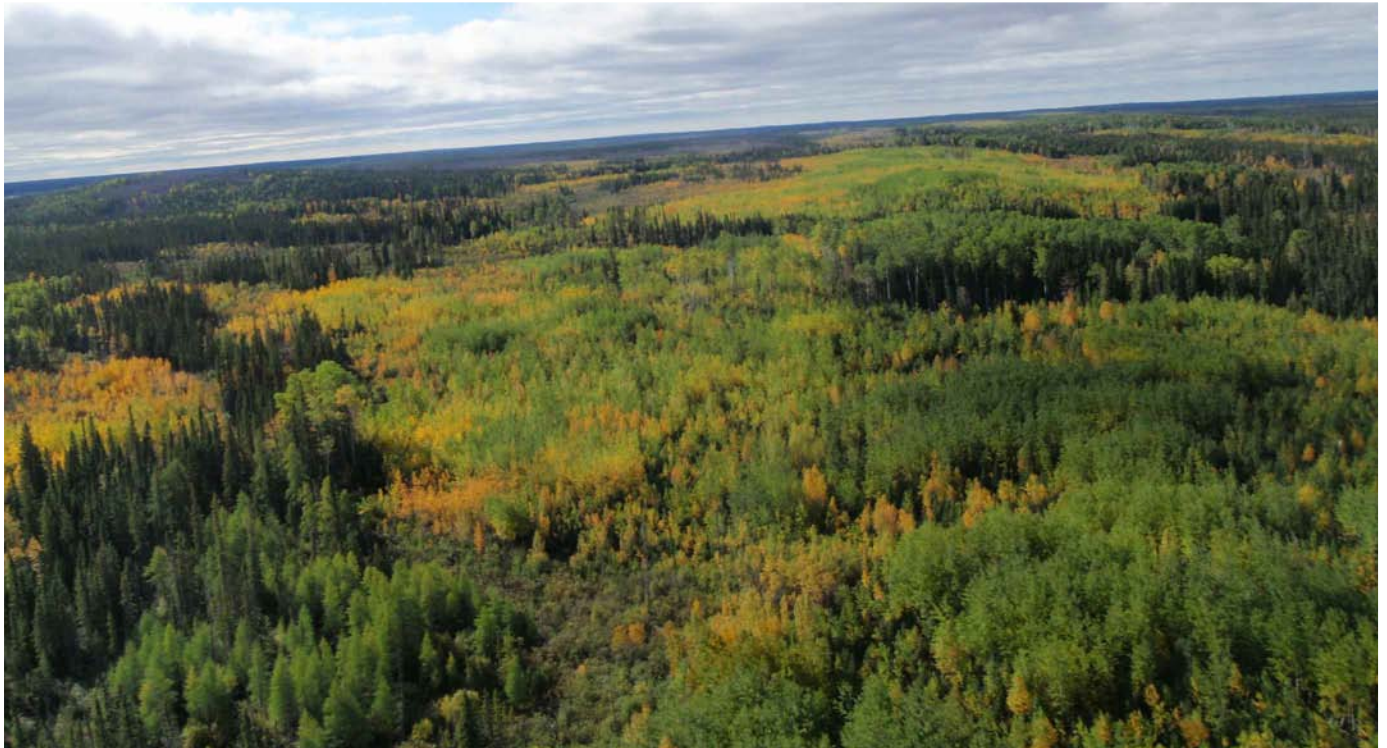
VIEW LOOKING NORTH ALONG AN ESKER.

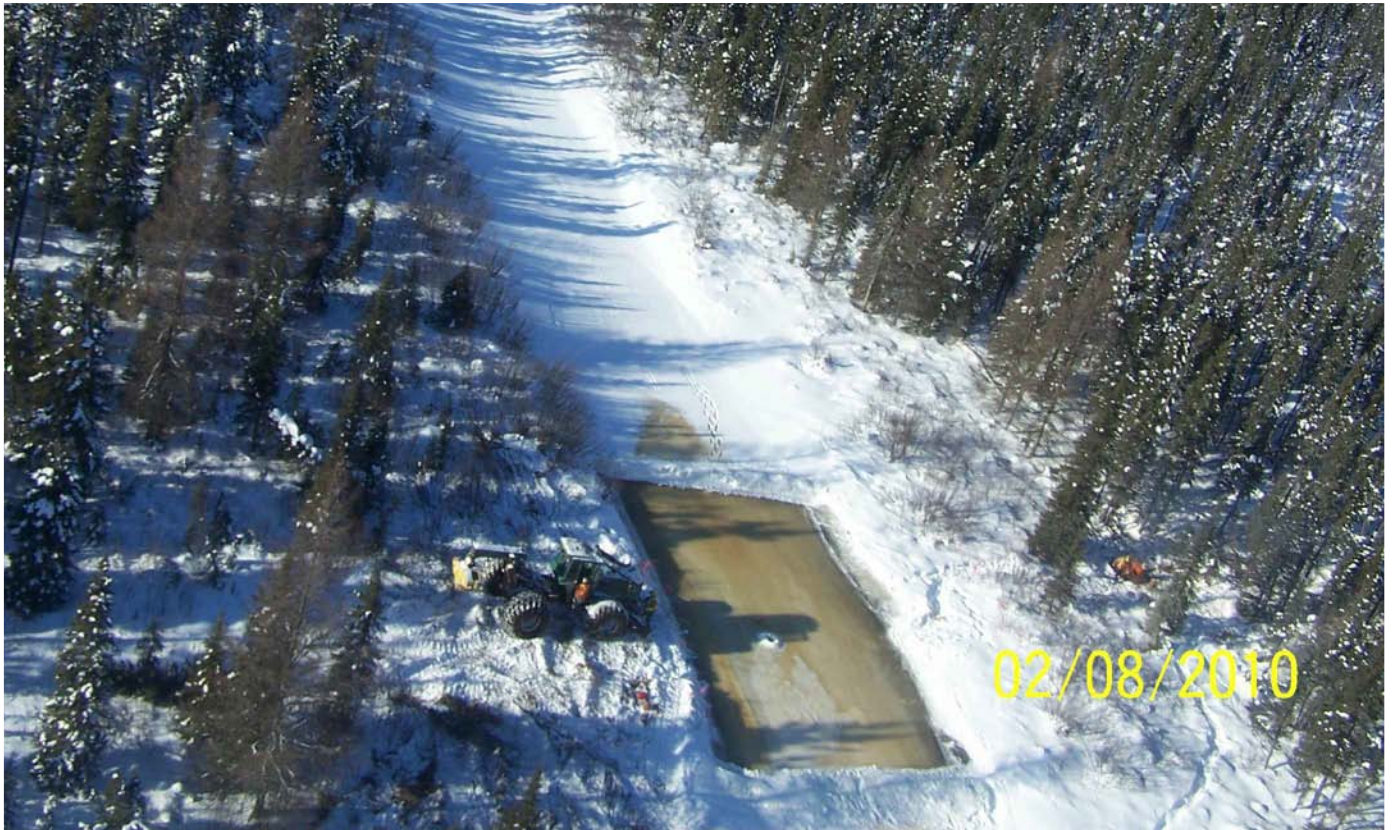
ICE PAD CONSTRUCTION AT SMALL RIVER CROSSING ALONG SOUTHERN SEGMENT OF CORRIDOR.

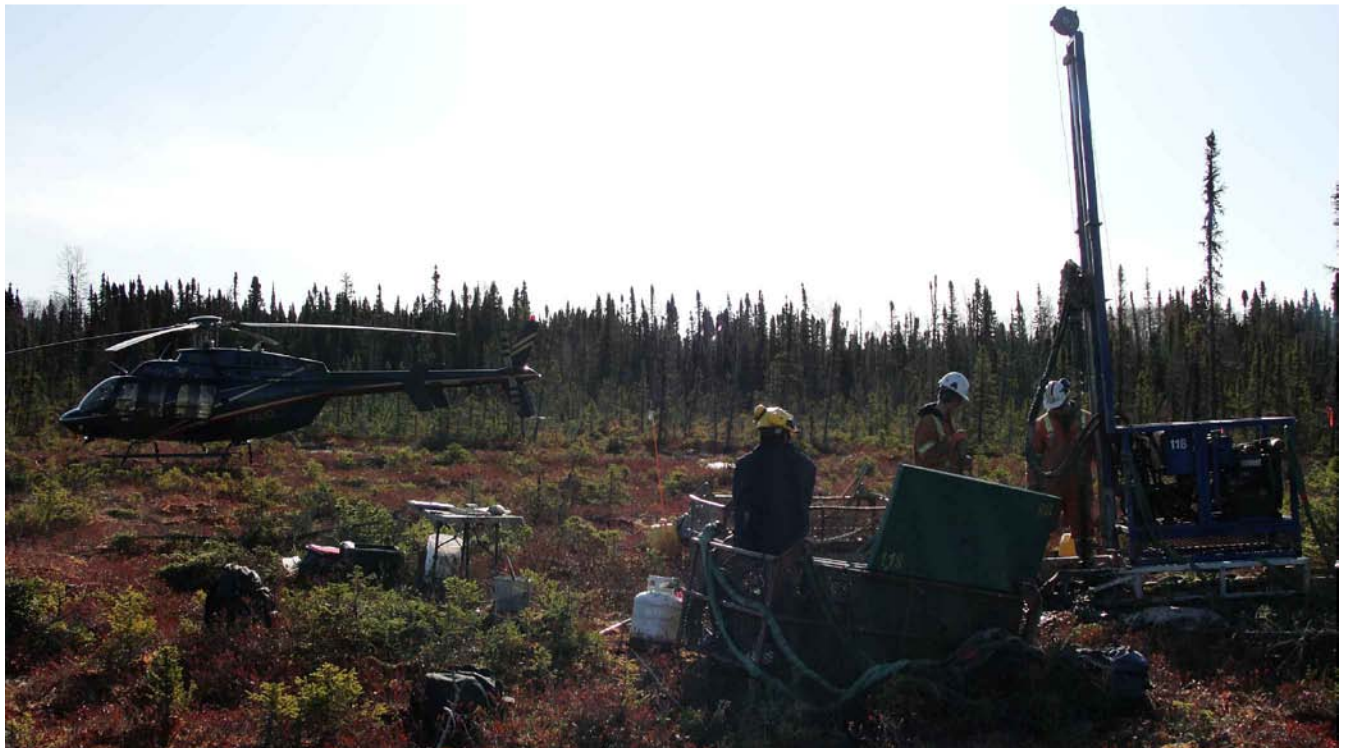
TYPICAL DRILLING SETUP IN LOWLAND TERRAIN, CENTRAL SEGMENT OF CORRIDOR.

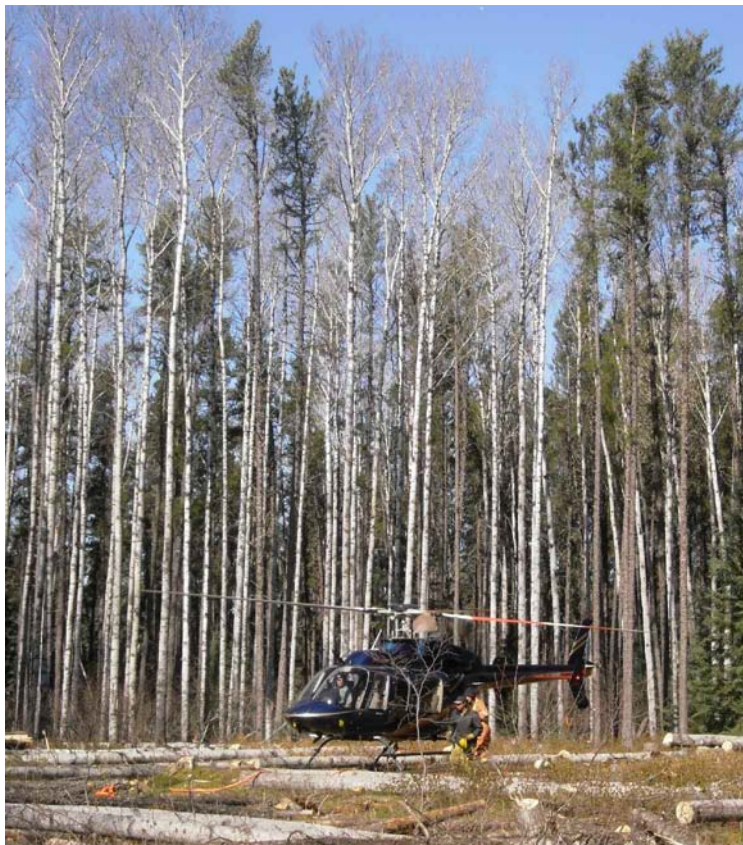
TYPICAL SURFACE CONDITIONS ON AN ESKER IN DENSE POPLAR TREES, STATION 305+702.

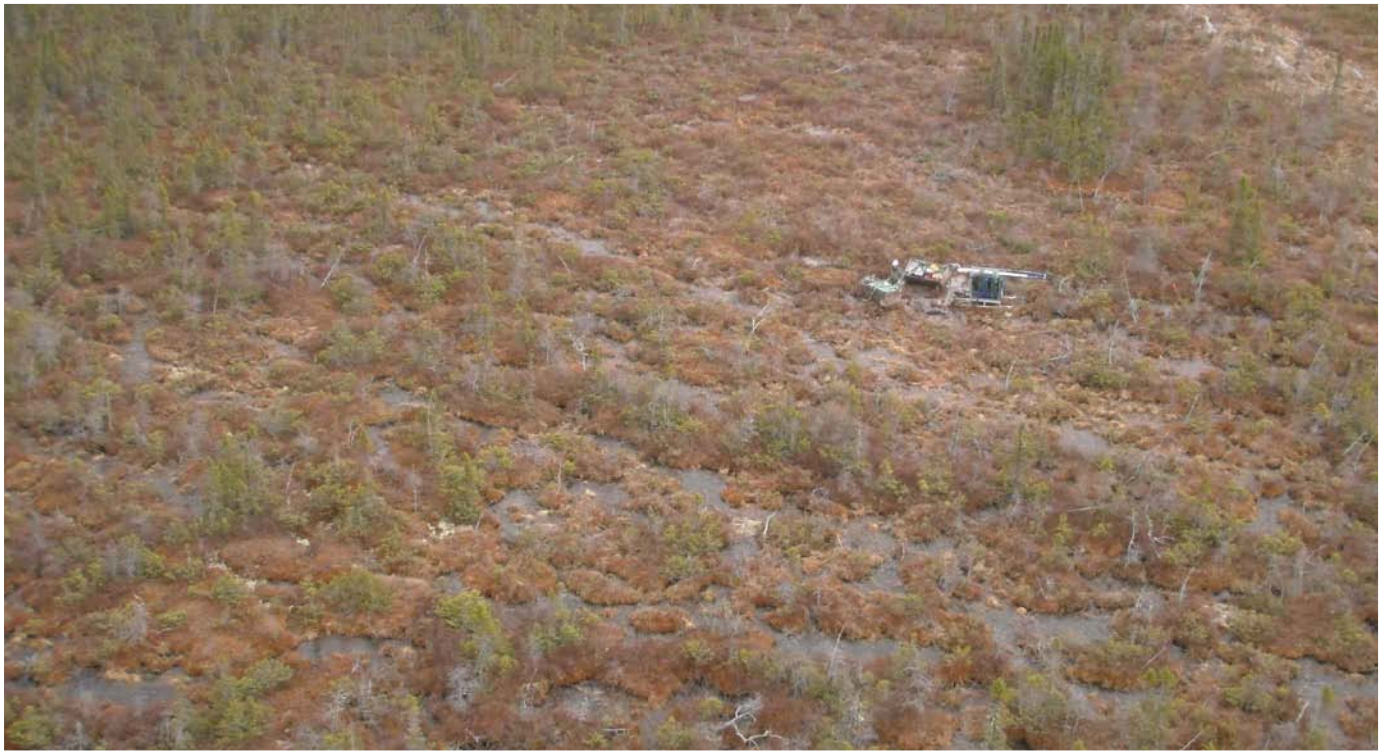
TYPICAL LOWLAND TERRAIN, PHOTO AT STATION 281+753 .

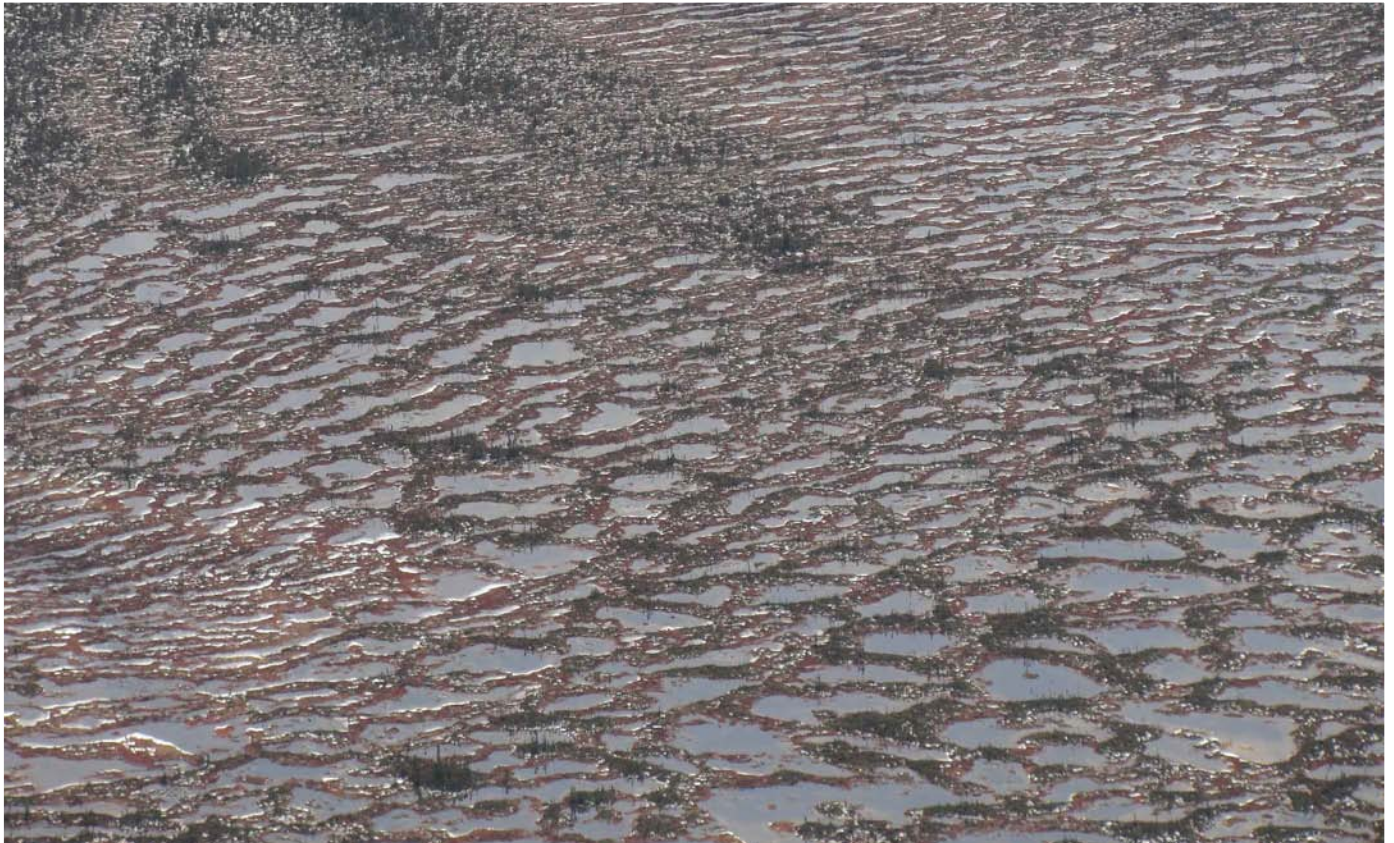
TYPICAL SATURATED LOWLAND TERRAIN WITH DEEP ORGANIC COVER OVERLYING LAKE DEPOSITS, NORTHERN SEGMENT OF CORRIDOR.

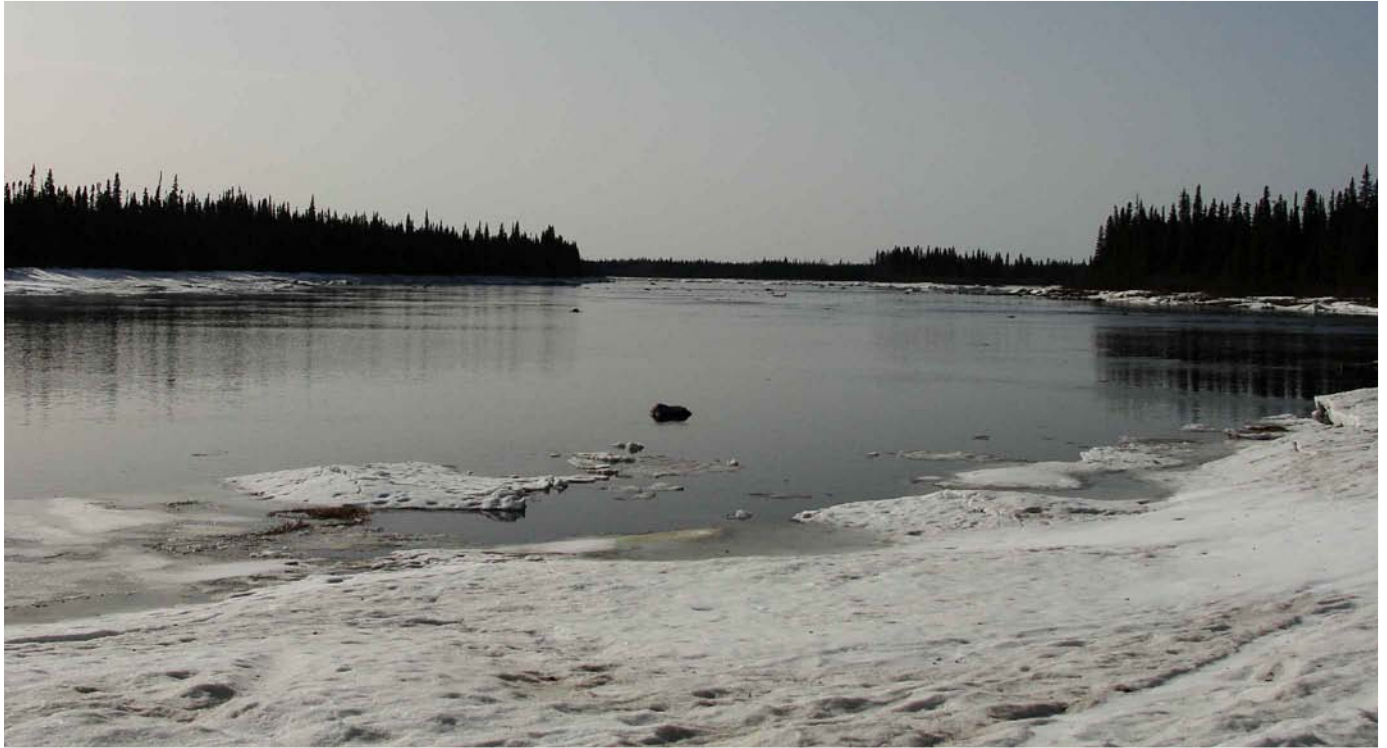
VIEW OF PROPOSED ATTAWAPISKAT RIVER BRIDGE CROSSING, STATION 247+500.

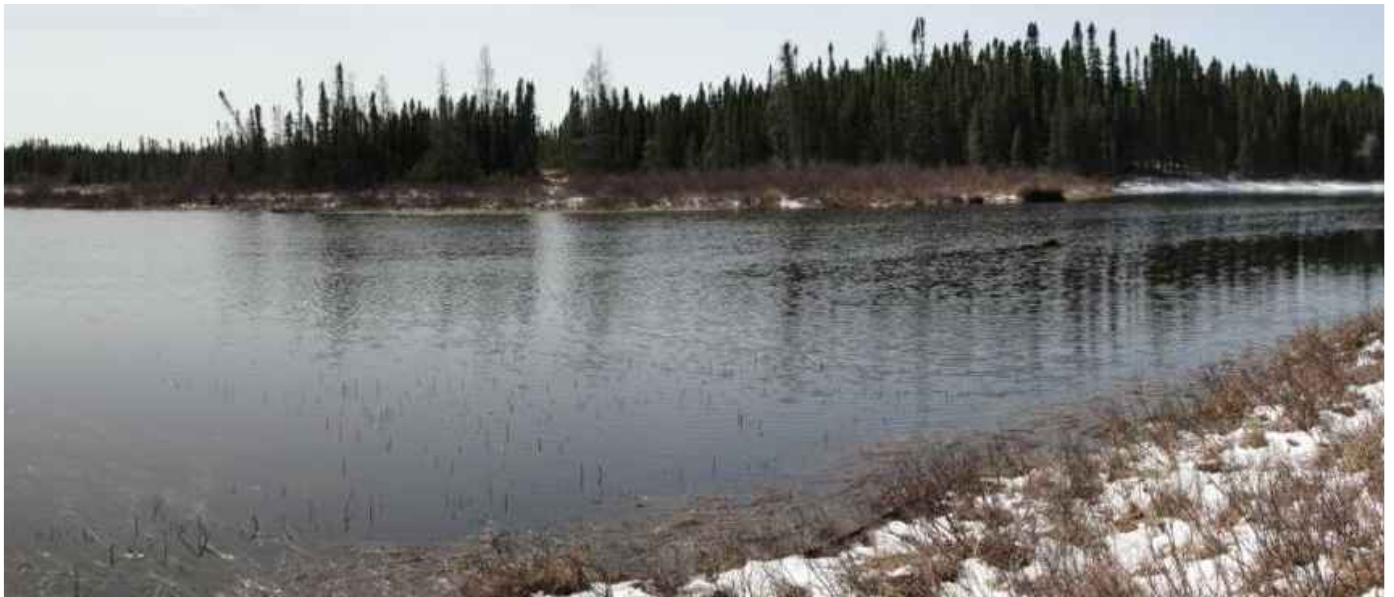
VIEW OF PROPOSED TRIBUTARY TO MUKETEI RIVER BRIDGE CROSSING, STATION 311+210.

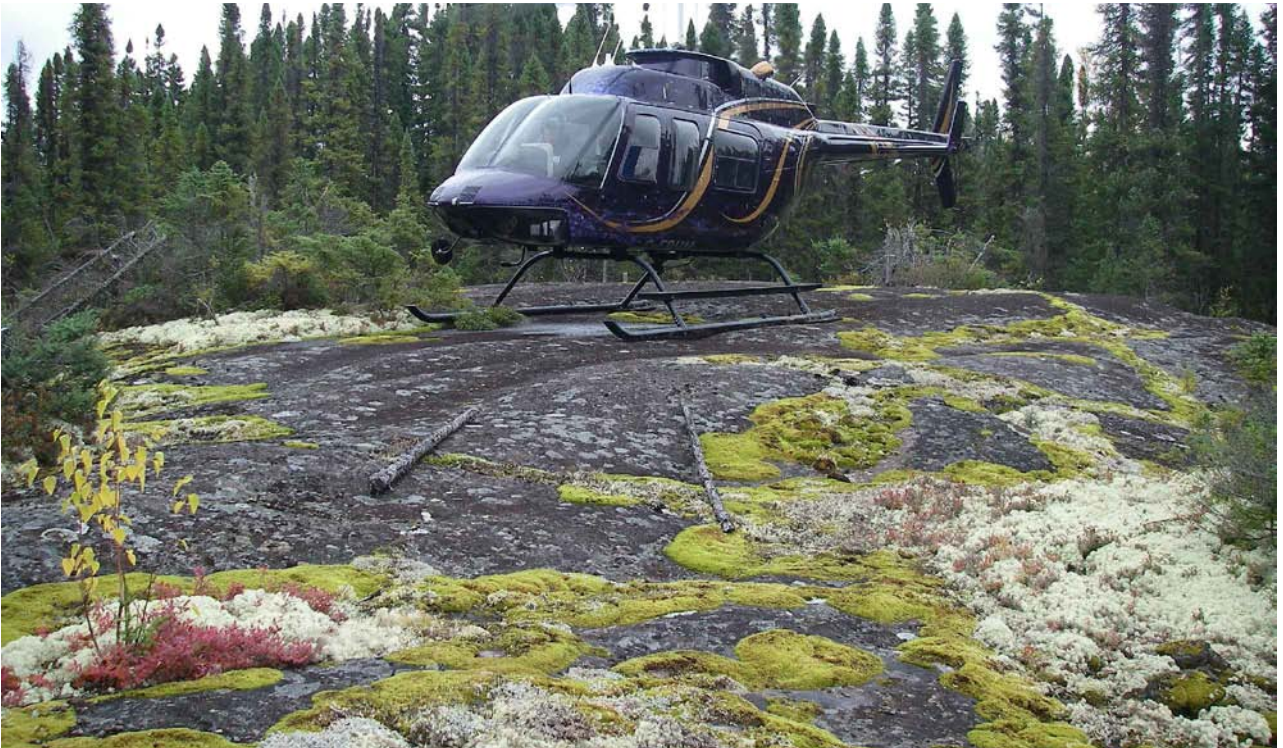
EXPOSED BEDROCK NEAR THE NORTH END OF FISH TRAP LAKE, EAST OF STATION 279+000.

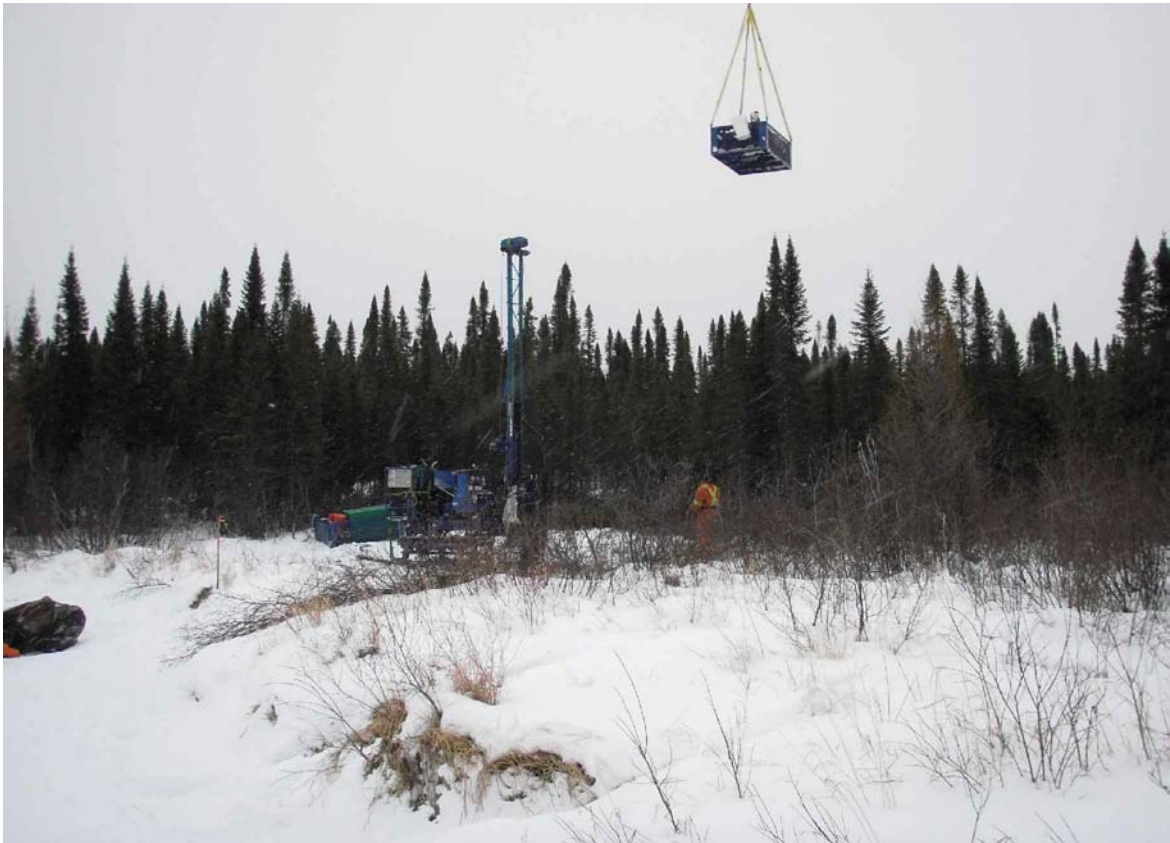
DRILLING OPERATIONS ON ICE-MARIGINAL DEPOSIT AT M-2010-5212, STATION 178+573.
