REPORT ON R. M. CLARKE'S

LATOUR LAKE

MINING PROPERTY

LATOUR LAKE PROPERTY

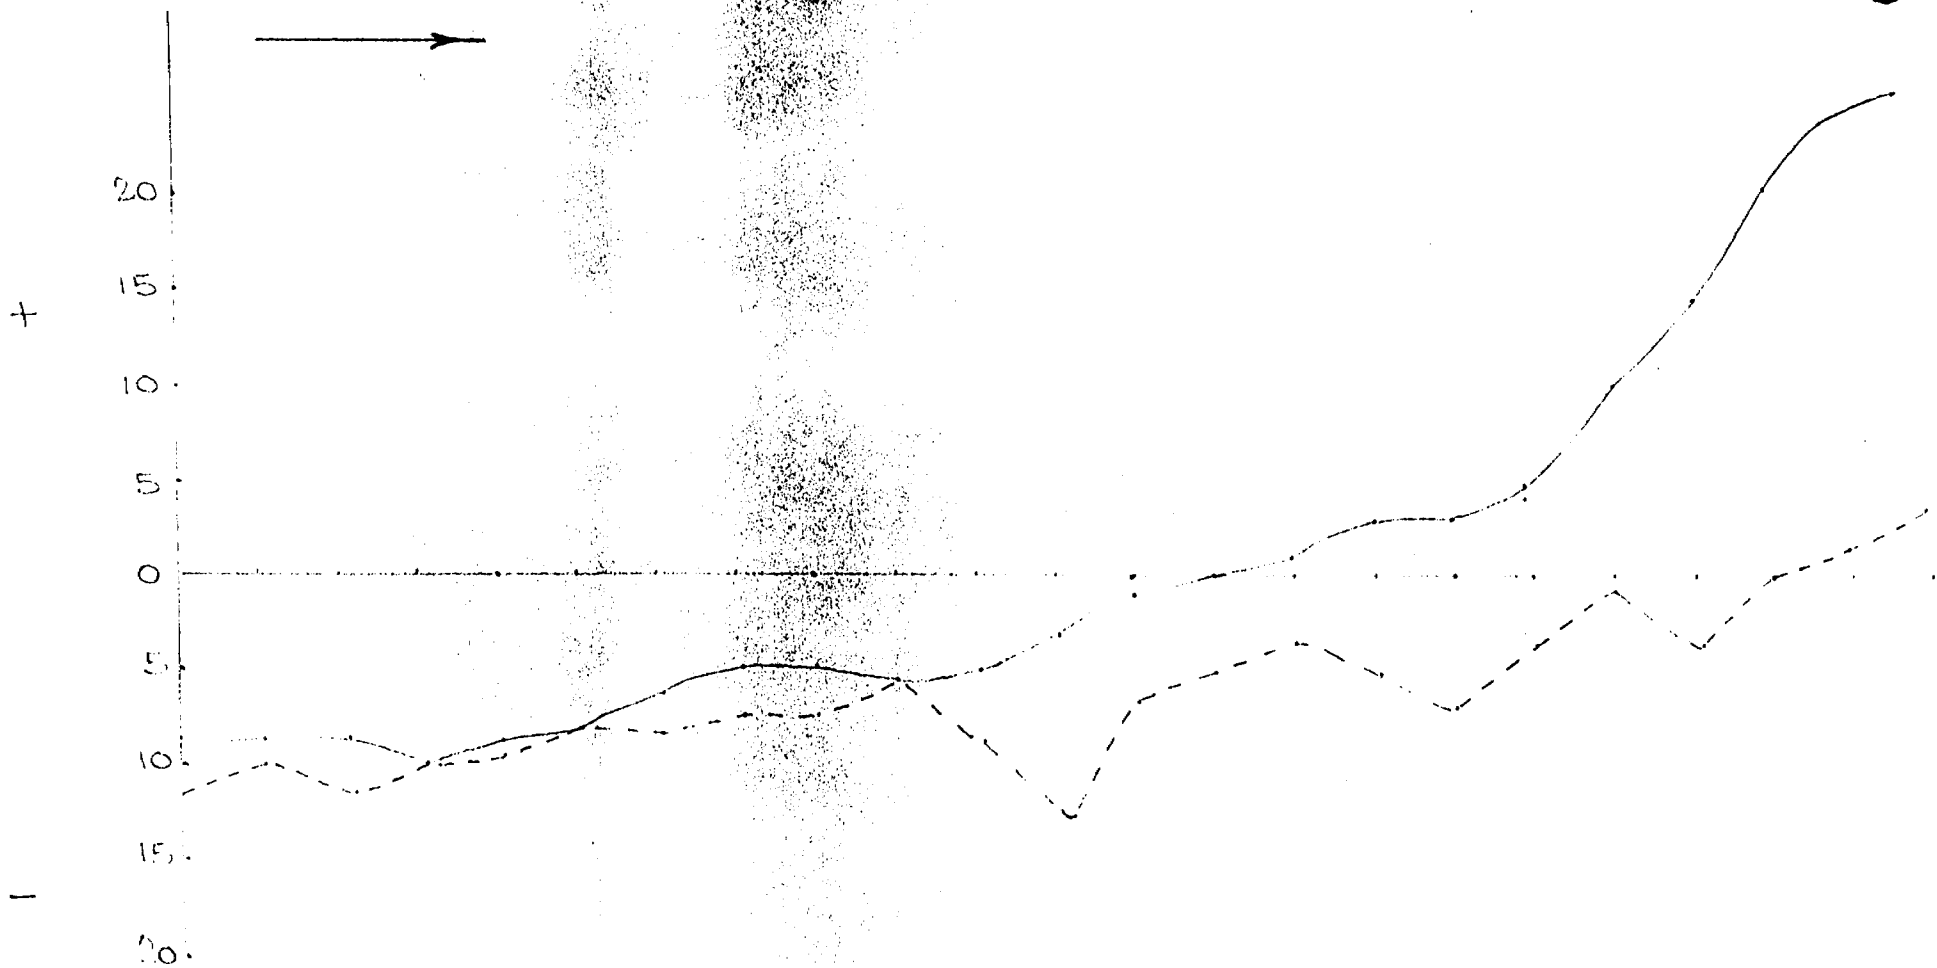
LINE # 2

EM-16 SURVEY : TRAVERSE SOUTH → NORTH STATION CUTLER MAIN.

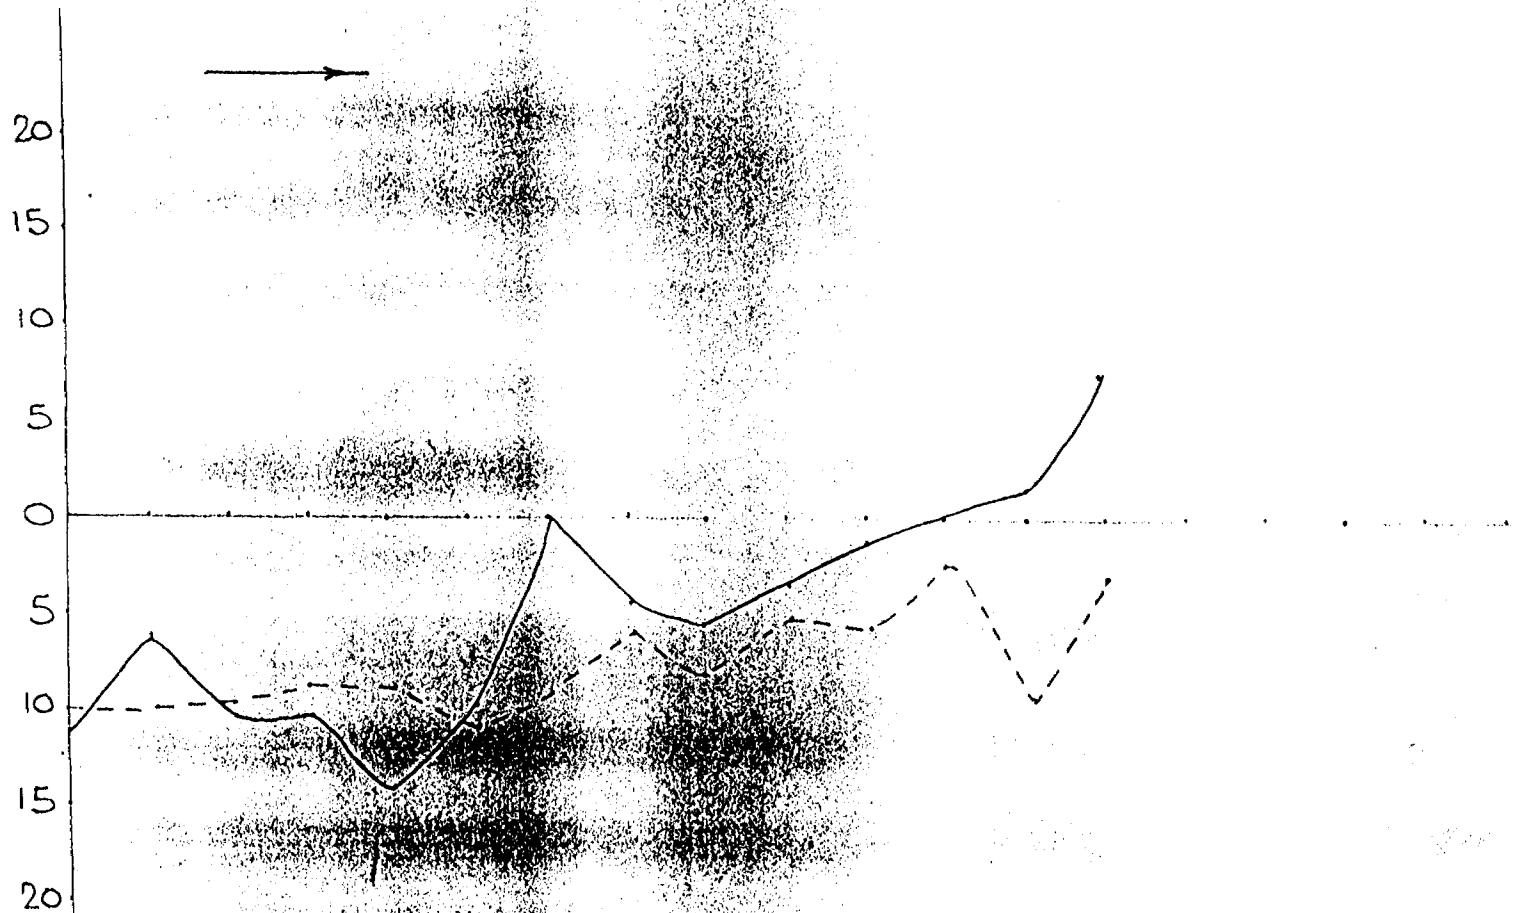
LINE # 3

EMIG SURVEY : TRAVERSE SOUTH → NORTH : STATION CUTLER MAINE

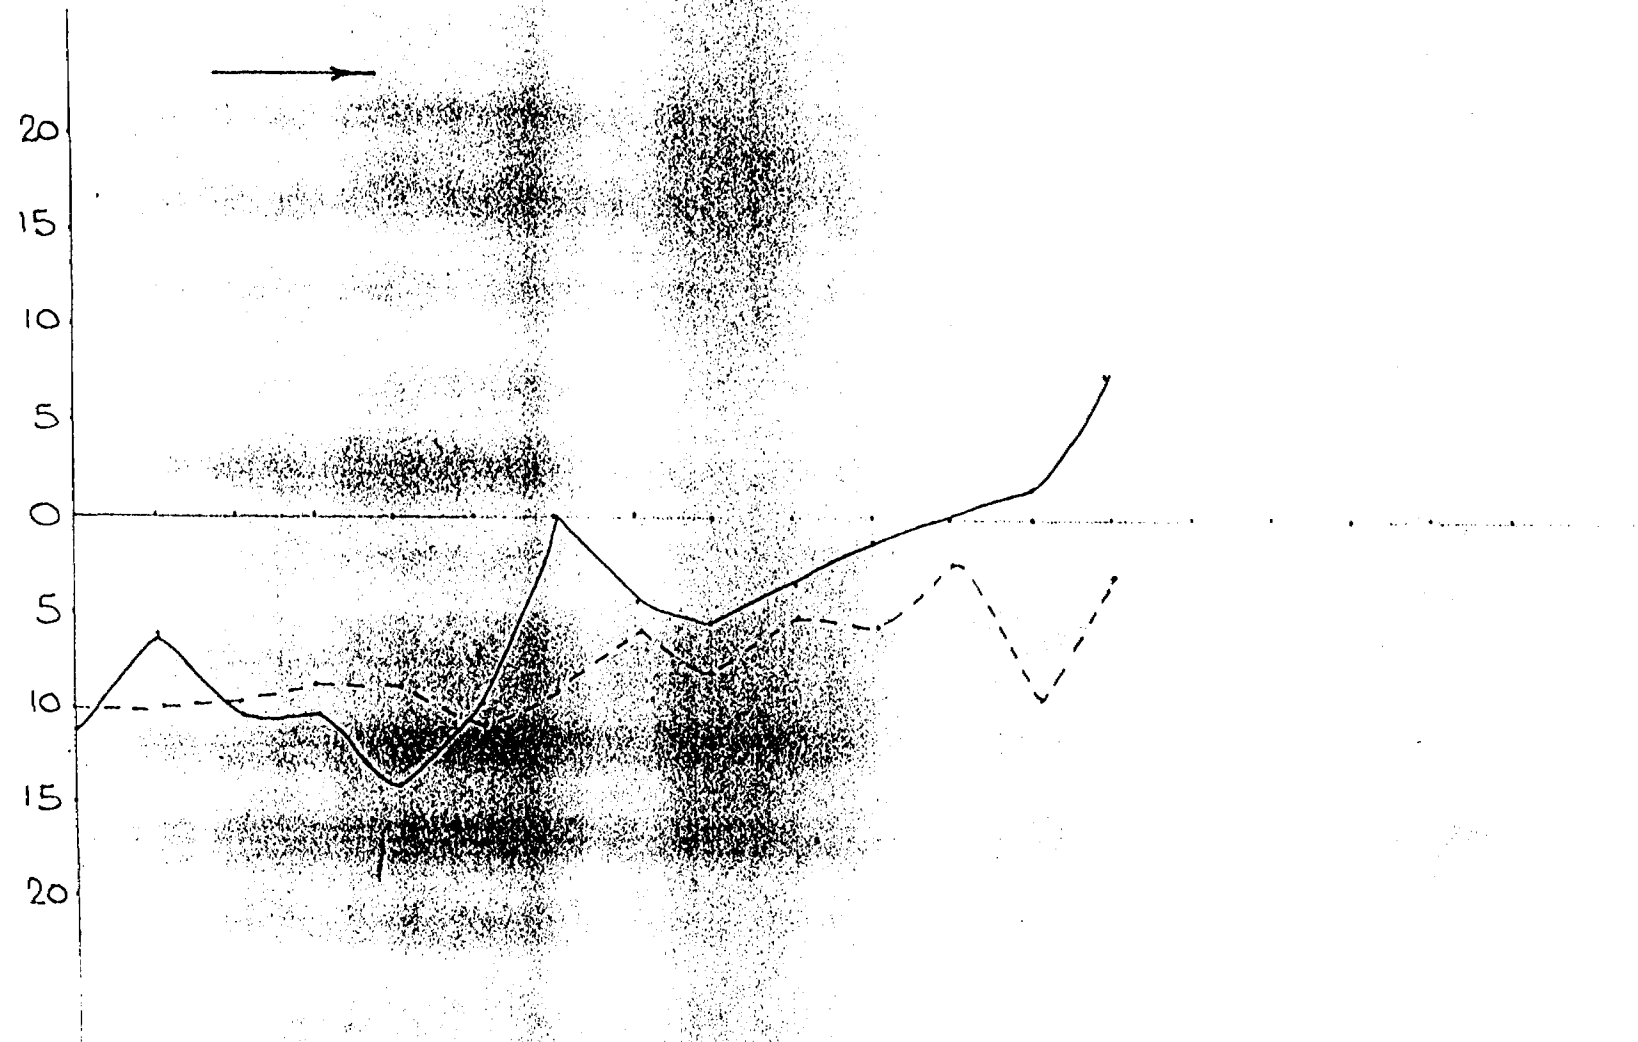
LINE # 3

EM 16 SURVEY : TRAVERSE SOUTH → NORTH : STATION CUTLER MAINE

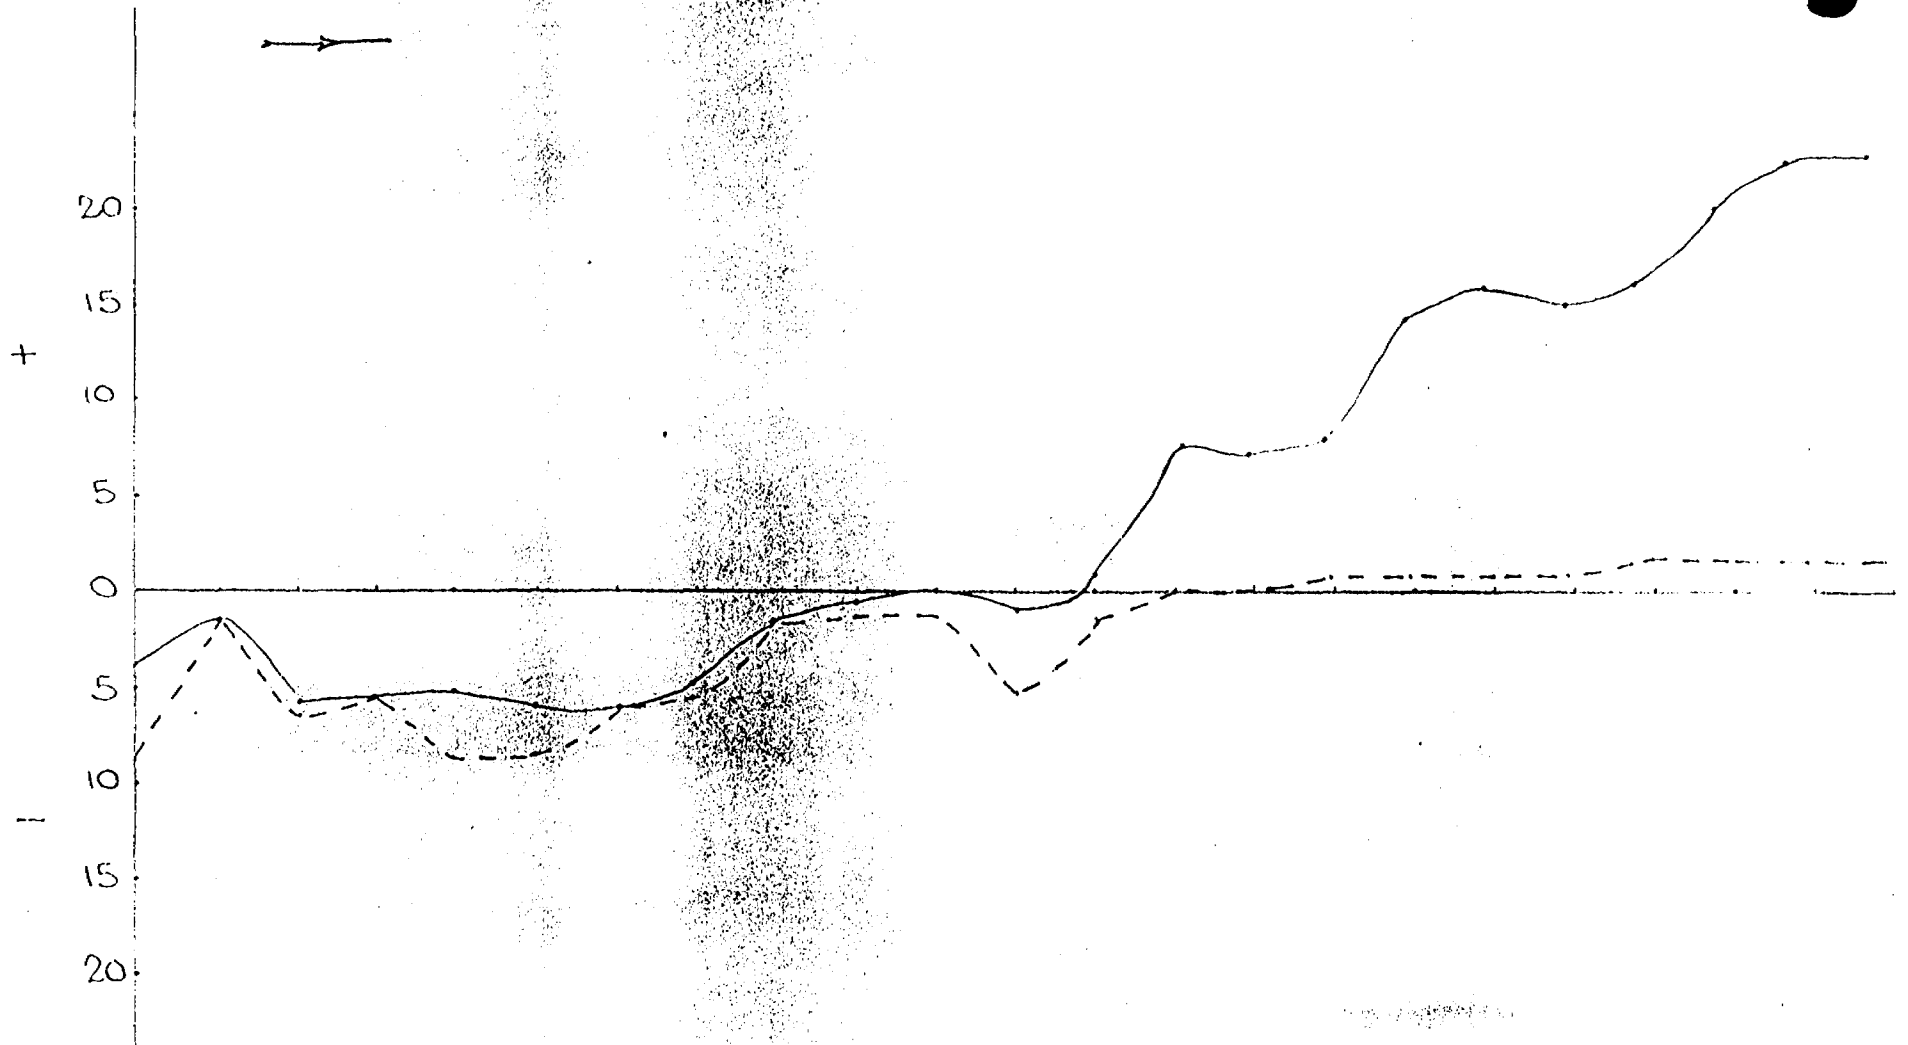
LINE # 1

EM-16 SURVEY: L-1 TRAVERSE, SOUTH → NORTH: STATION CLIFERT
