Assessment Work Report

**Claim Number – TB4250542,
incl. TB1216712 and TB4245680
Onion Lake (G-747)**

**Prepared
by
Mars Joseph**

October 25, 2013

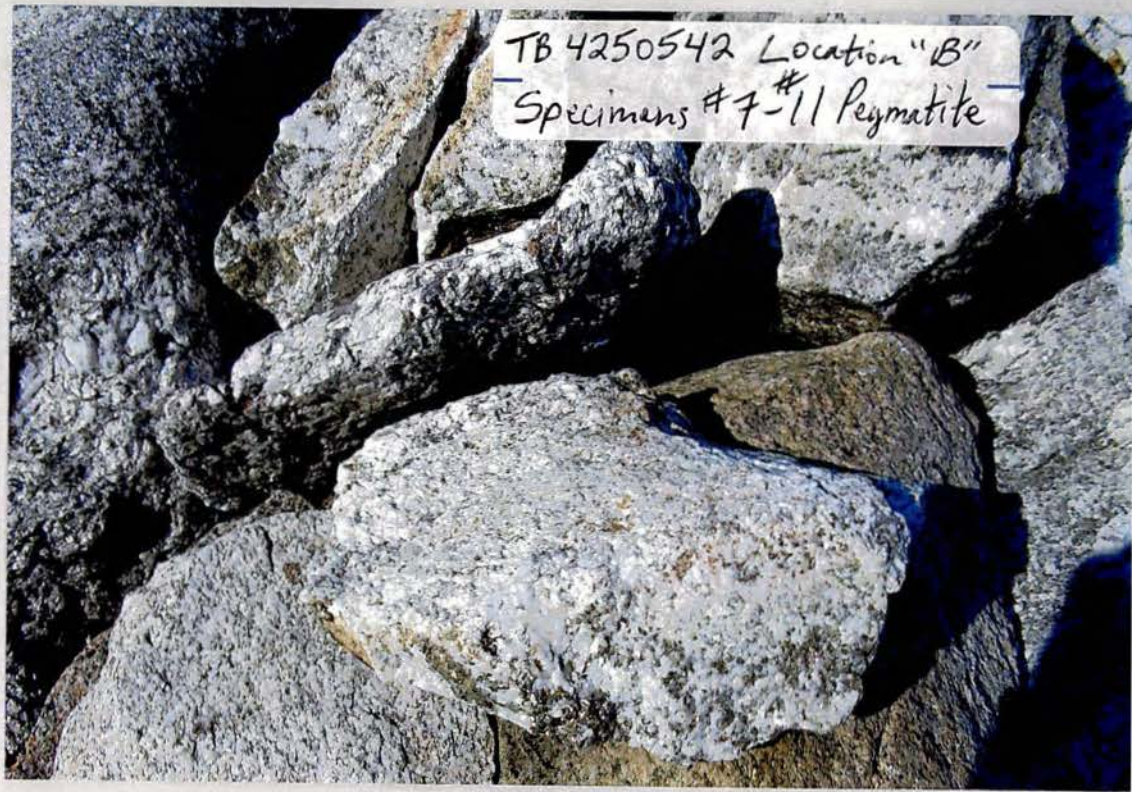
TB 4250542 Location "B"
Specimens #7-11 [#]11 Pegmatite

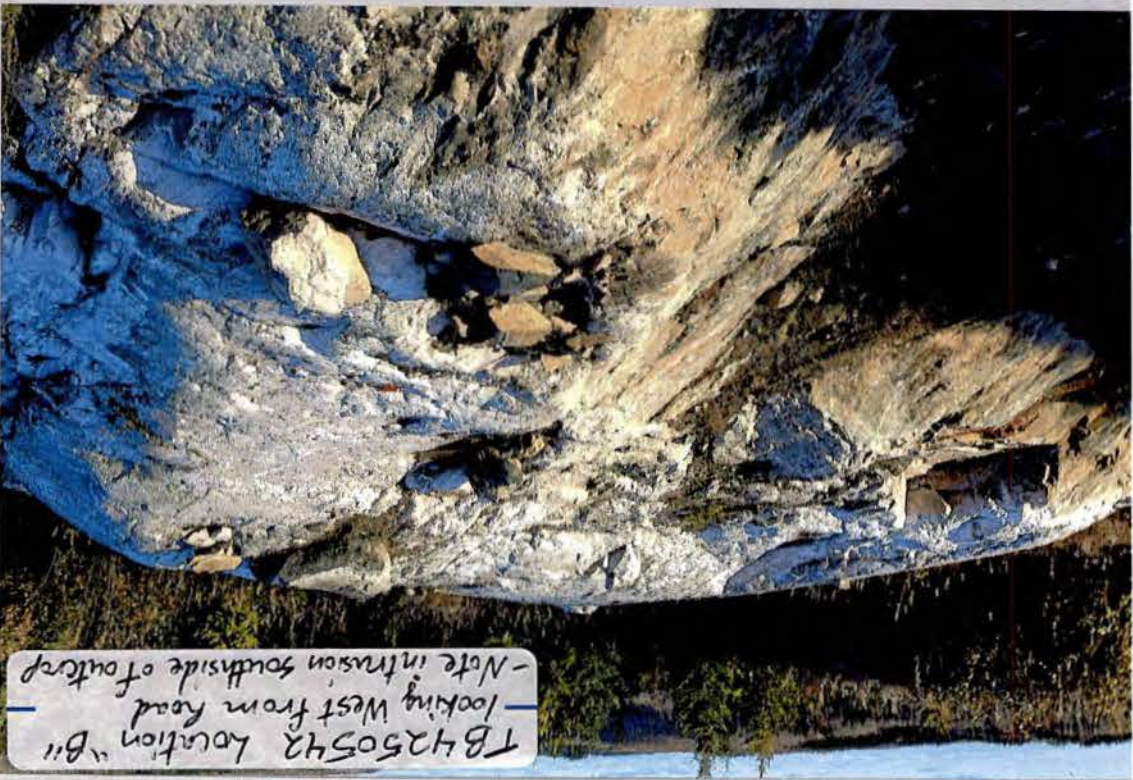
TB 4250542 location "B"
- looking West from road
- Note intrusion southside of outcrop

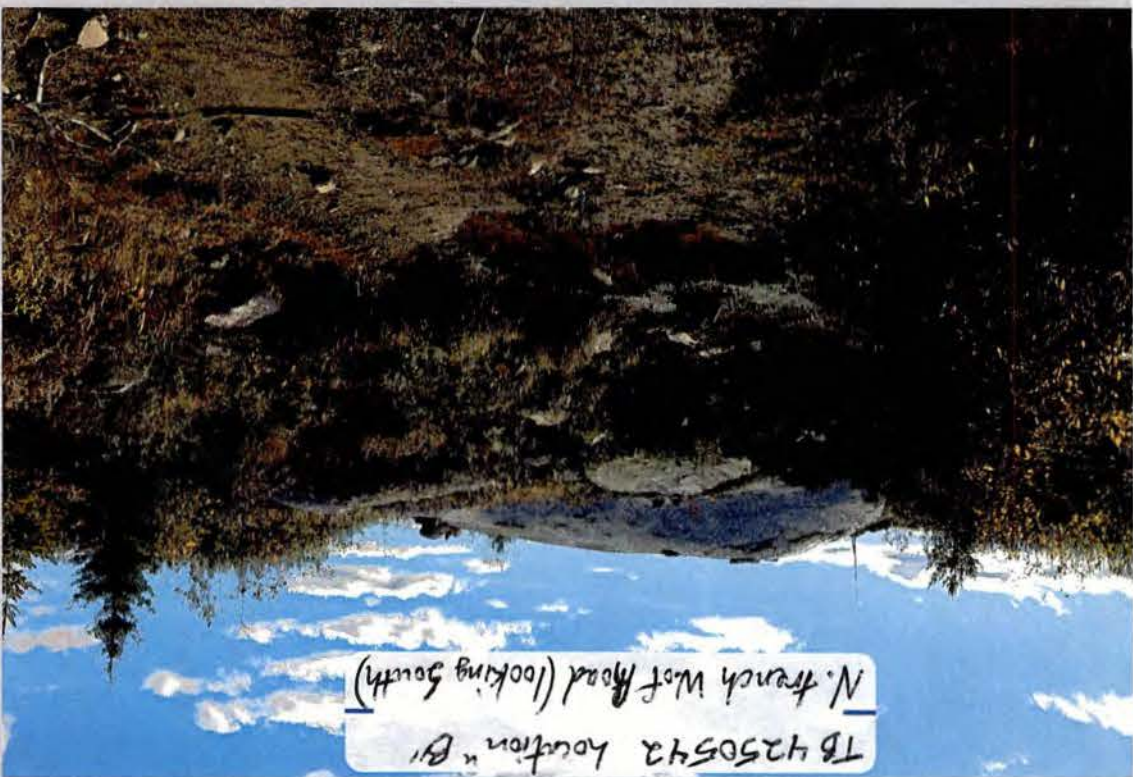
TB 4250542 location "B"
N. trench W. of Road (looking South)

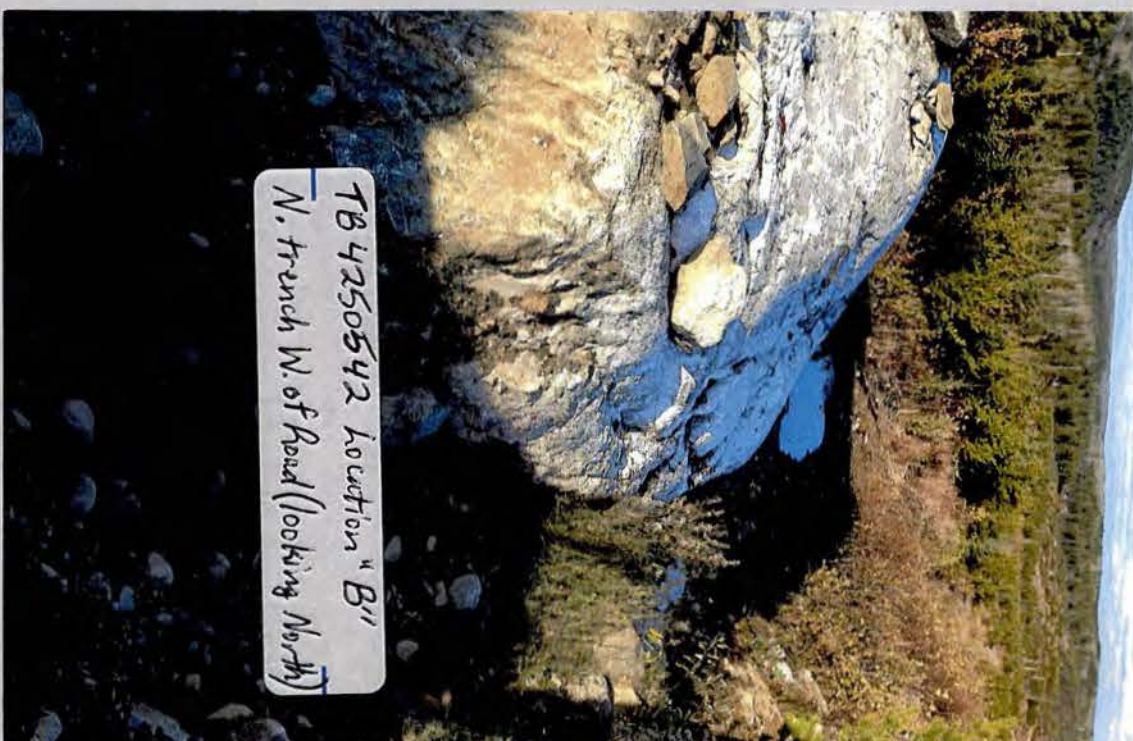
TB 4250542 location "B"
N. trench W. of Road (looking North)

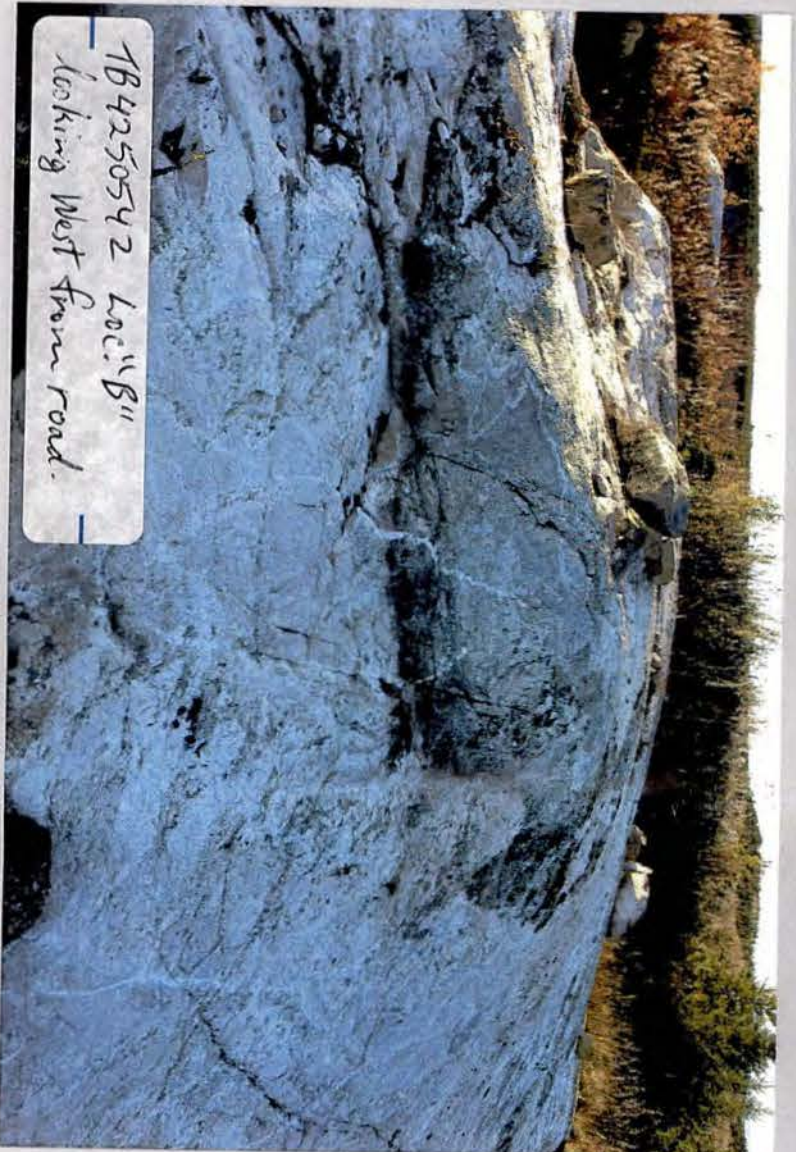
TB 4250542 loc "B"
- looking West from road

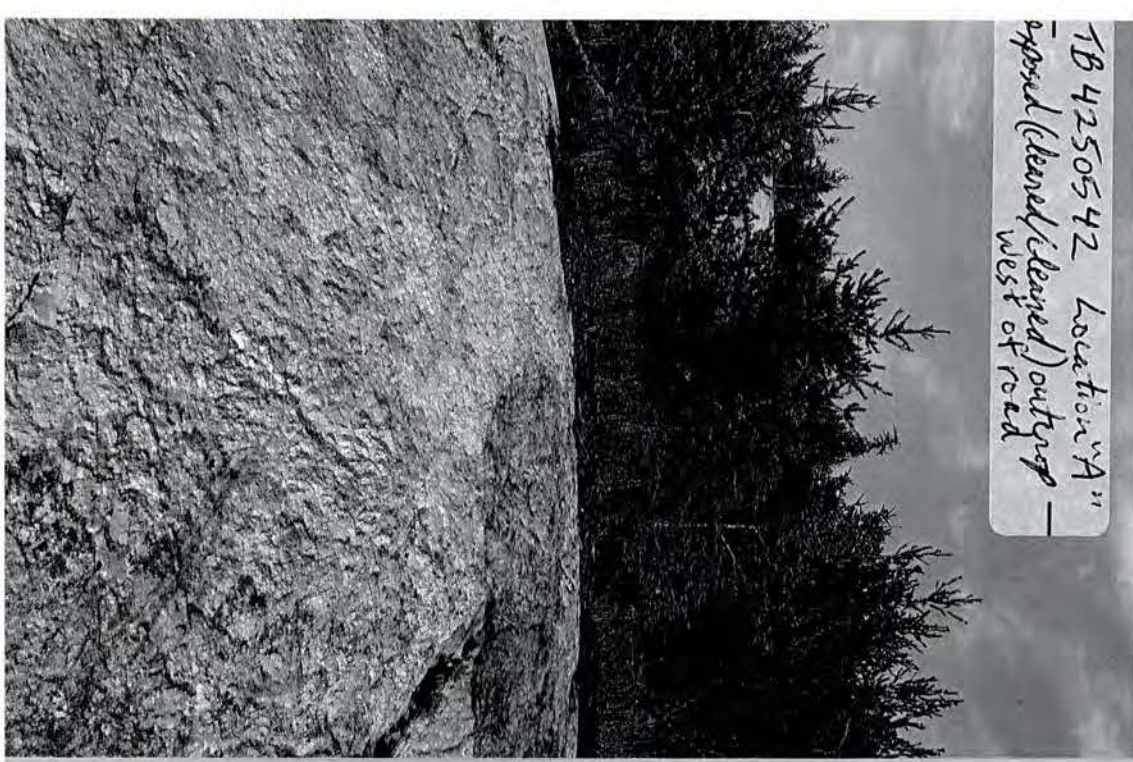
TB 4250542 Location "A"
exposed (cleaned/cleared) outcrop
west of road

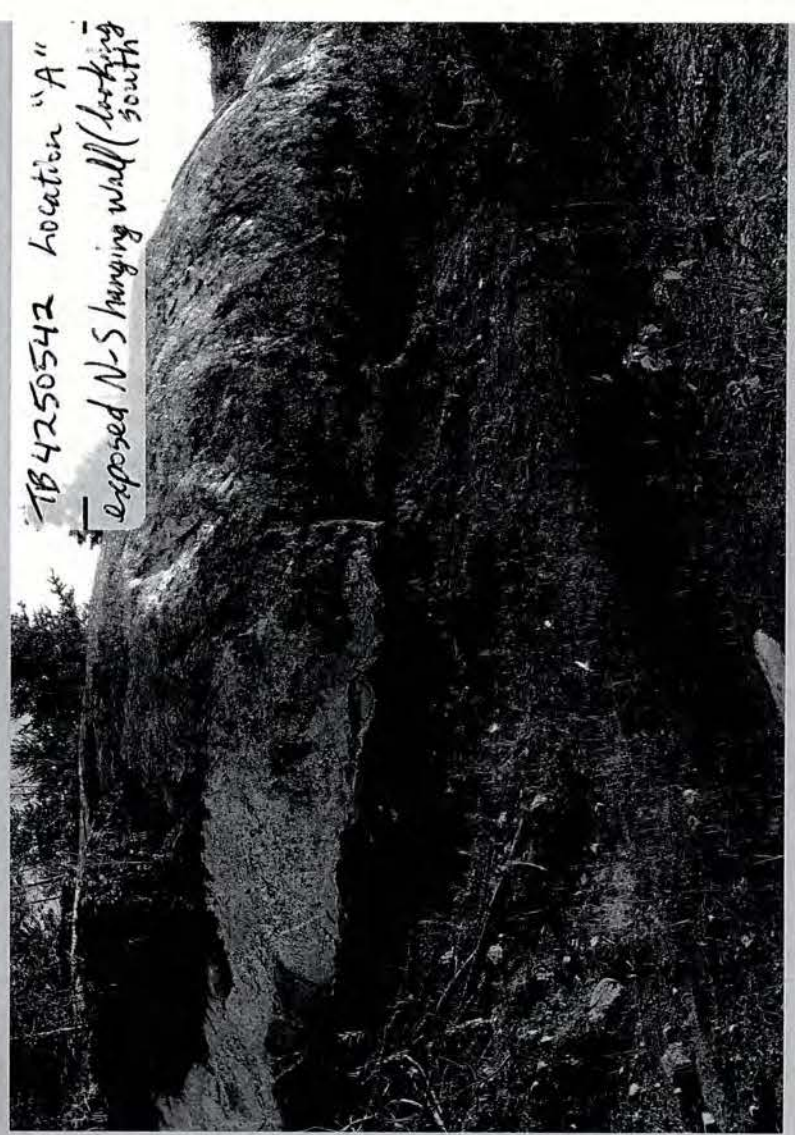
TB 4250542 Location "A"
exposed N-S hanging wall (looking south)

- Perimeter trenching north-south along tote road and east exposing approximately +30 metres of pegmatite outcrop hanging wall horizon, and +3 metres high, with vertical dip (180 degree azimuth) continuous and open at depth.
- Observed the gradual extension of pegmatite outcrop with shallow overburden (<3m) slopes northward at approximately 10 degrees for 100 metres and continues under tote road and northward toward Location "B" (see Overview Map)
- Shallow, sandy overburden noted to the south of outcrop beyond 50 metres. Overburden depth increases >2 m becoming gravel extending 100 m to Hwy.
- Observed large (+100 m x 200 m) flat area of peat moss, grass and stunted trees east of outcrop...target as most likely a float area associated with dike traps.
- Finished with manually cleaning and power-washing as much of the exposed rock surface as is possible.
- See photos attached.

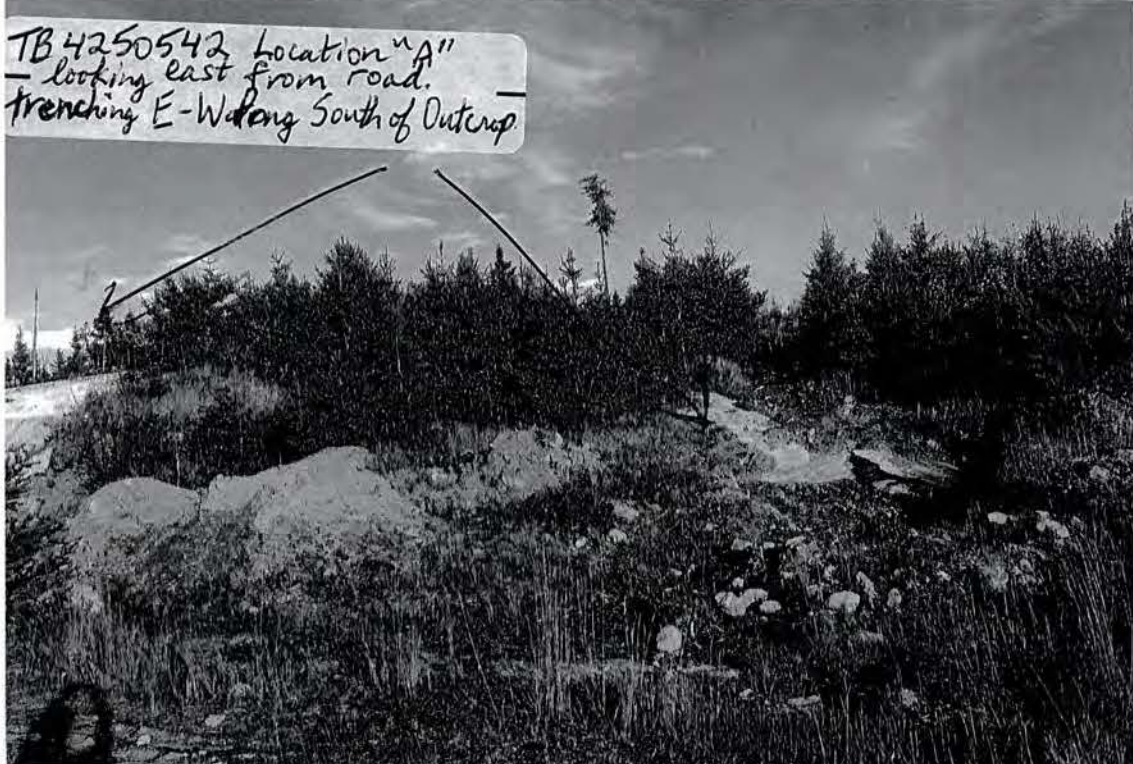
TB 4250542 Location "A"
looking east from road.
trenching E-W along South of Outcrop

- Perimeter trenching and stripping along southerly slope from tote road east-west (approx. 2 m x 30 m x +/- 2 metres deep) where outcrop and gneiss sill

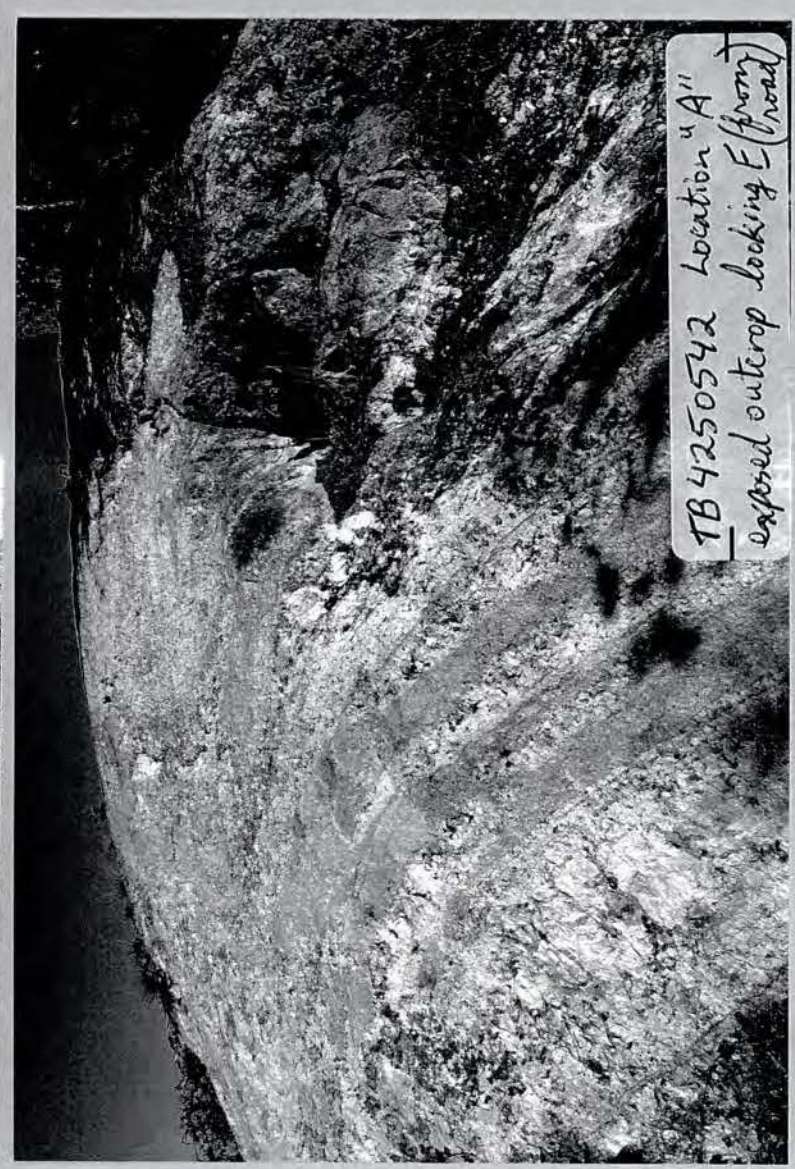
TB 4250542 Location "A"
exposed outcrop looking E (from road)

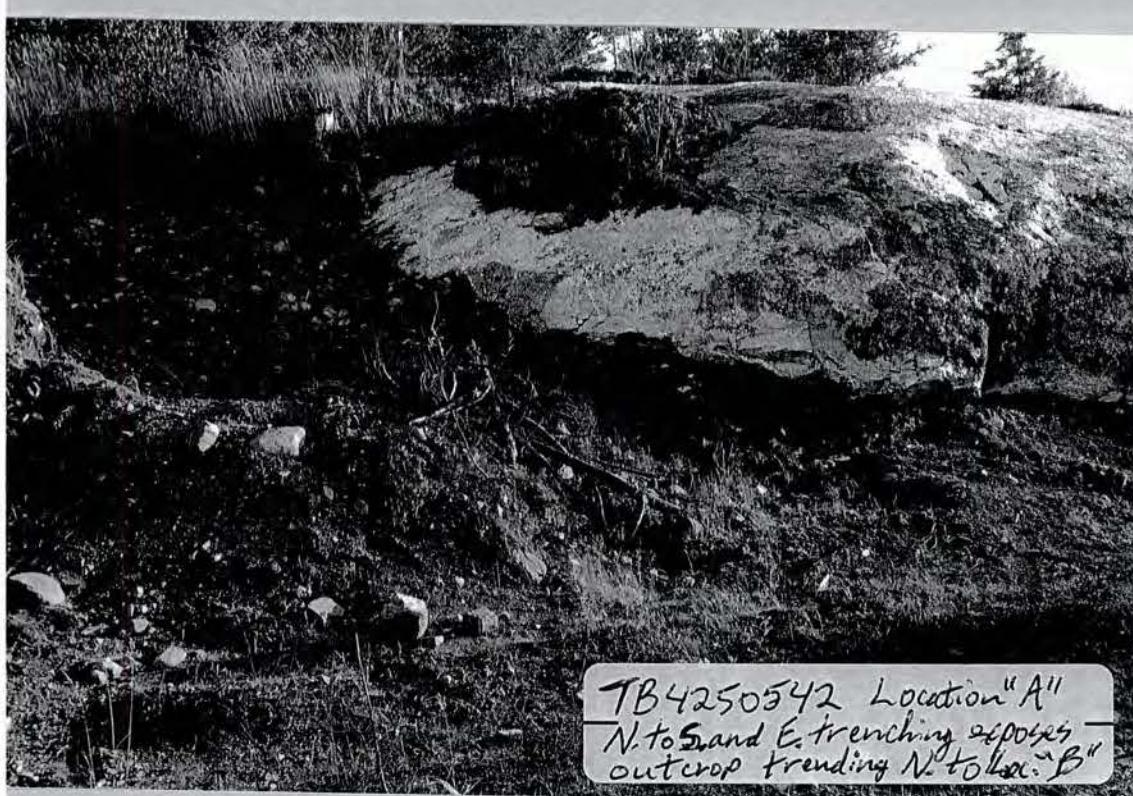
TB 4250542 Location "A"
N to S and E trenching exposes
outcrop trending N to loc. "B"

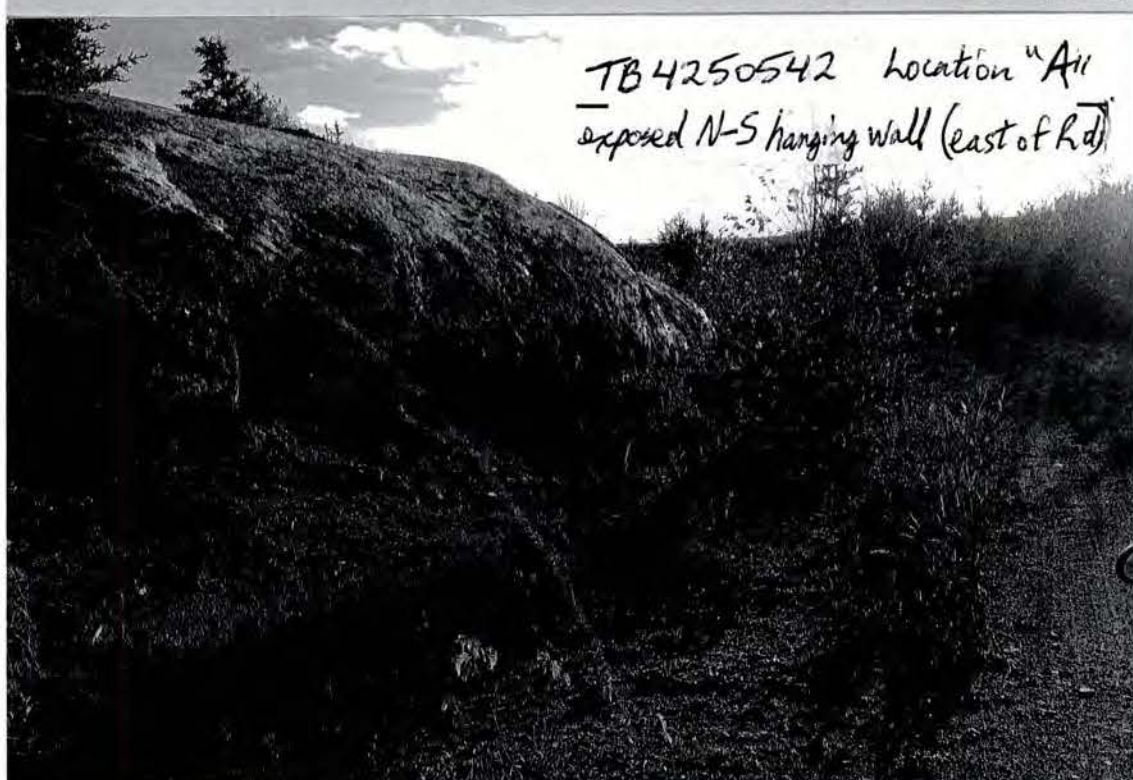
TB 4250542 Location "A"
exposed N-S hanging wall (east of Rd)

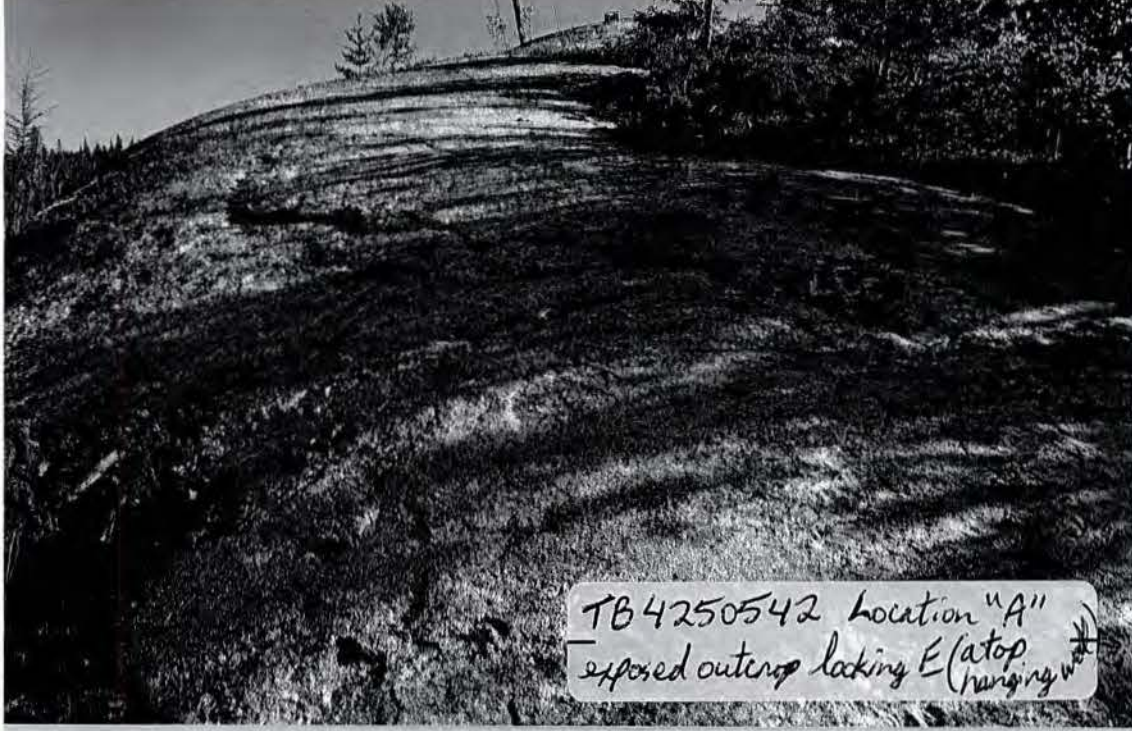
TB 4250542 Location "A"
exposed outcrop looking E (atop hanging wall)

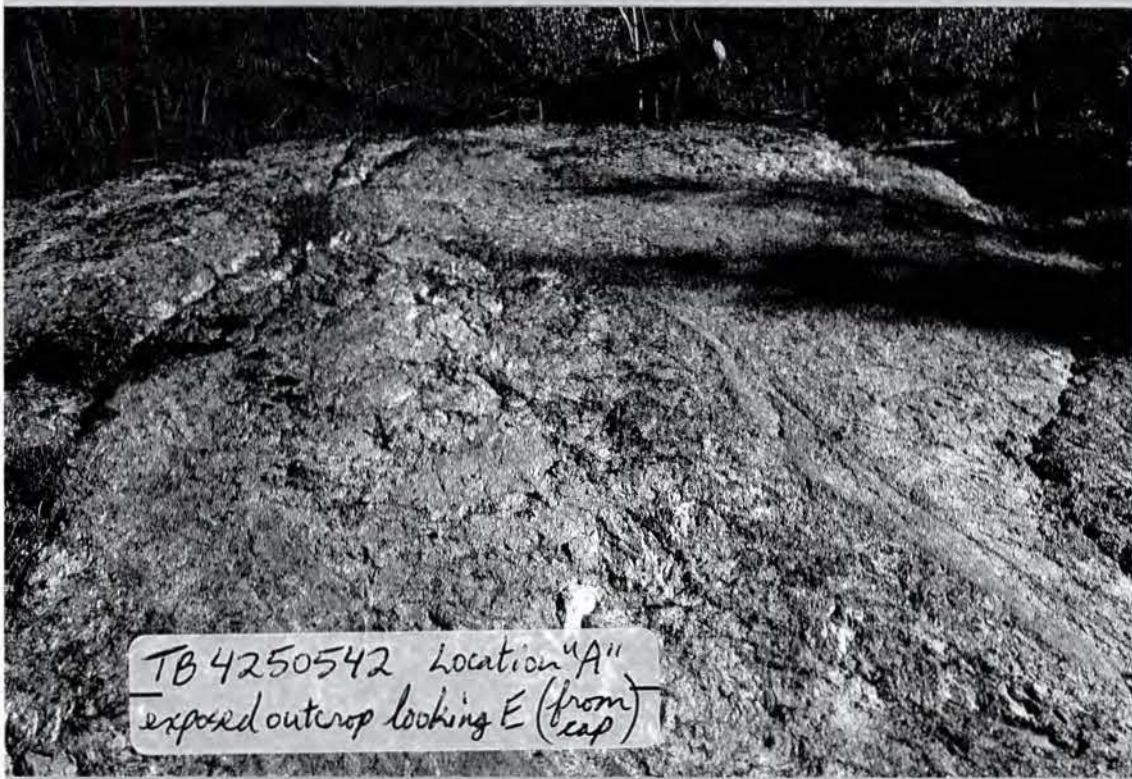
TB 4250542 Location "A"
exposed outcrop looking E (from cap)

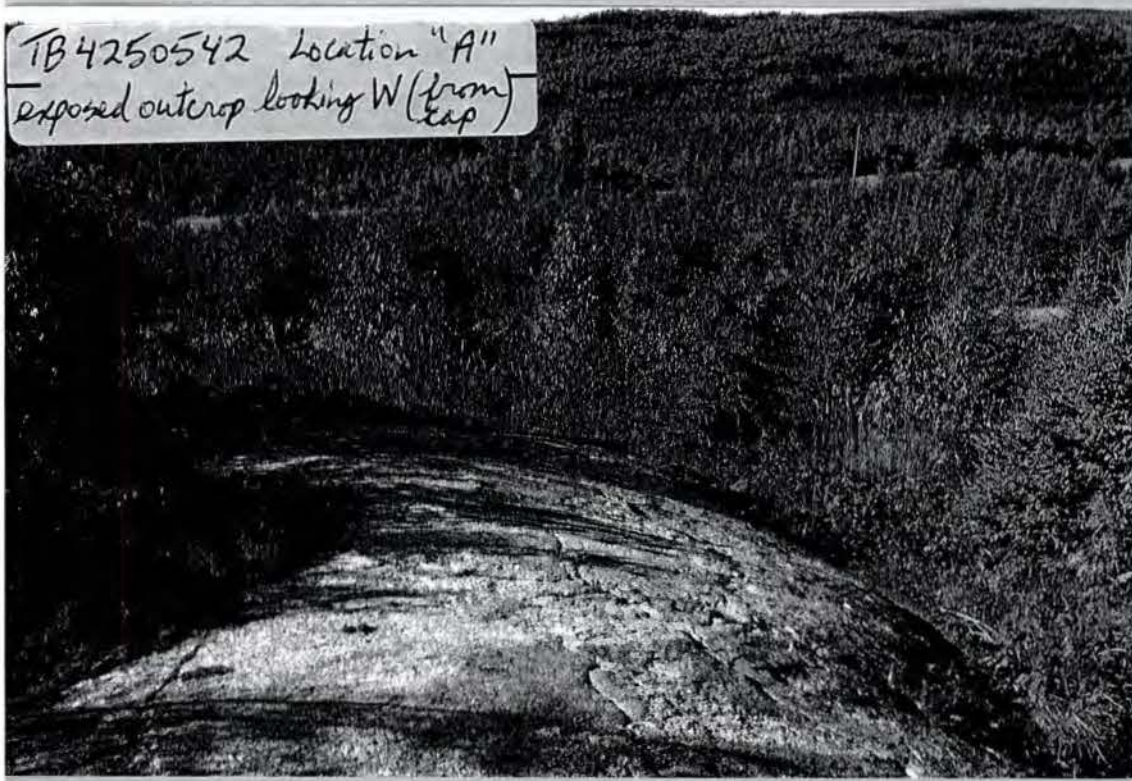
TB 4250542 Location "A"
exposed outcrop looking W (from cap)

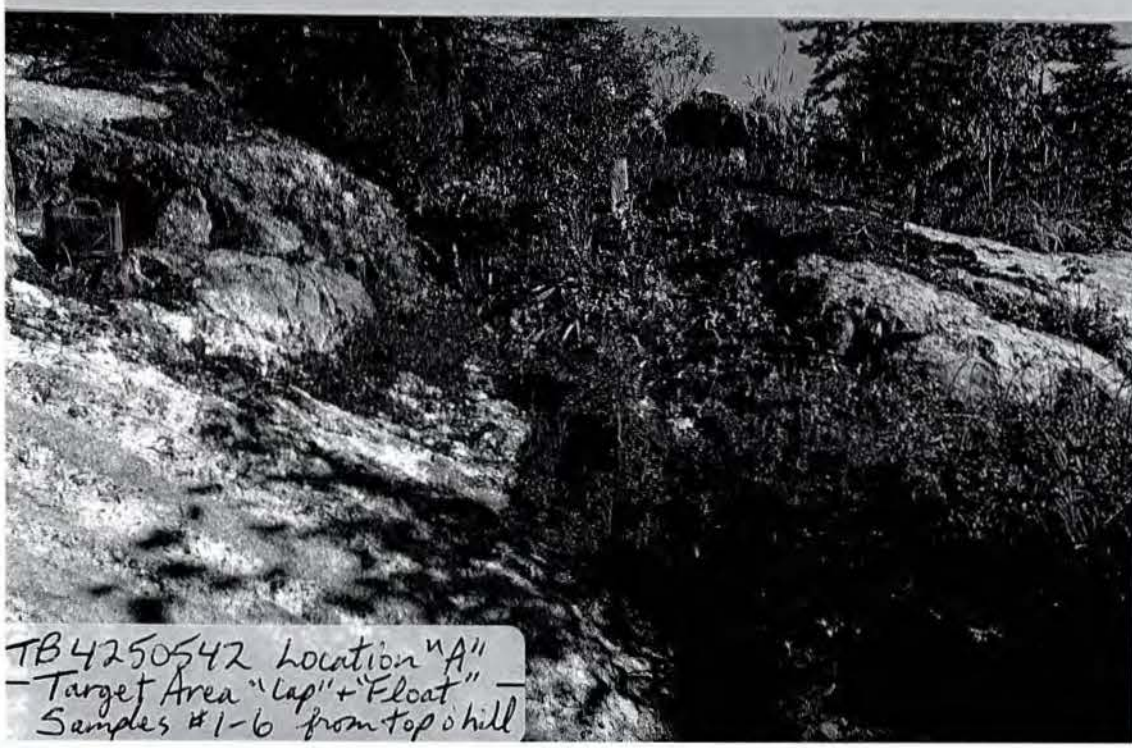
TB 4250542 Location "A"
Target Area "Cap" + "Float"
Samples #1-6 from top of hill

- Observed several large (>100 kilo) float atop cap of outcrop consistent with the pegmatite composition noted above. Also noticed increased presence of almandine, large muscovite books and feldspar crystals in both float and at outcrop surface, which is highly fractured and irregular with many vugs; enough to warrant sectioning off an area (15 m x 15 m) for only manual assessment and prospecting.

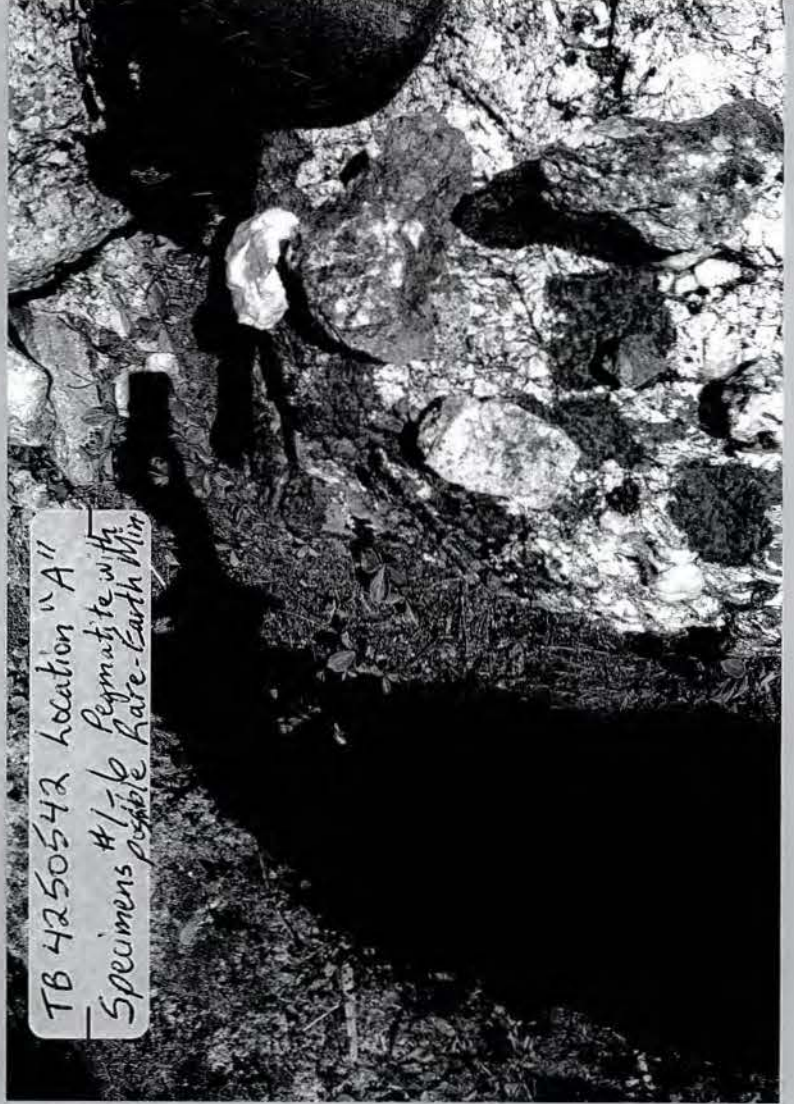
TB 4250542 Location "A"
Specimens #1-6 pegmatite with possible Rare-Earth Min

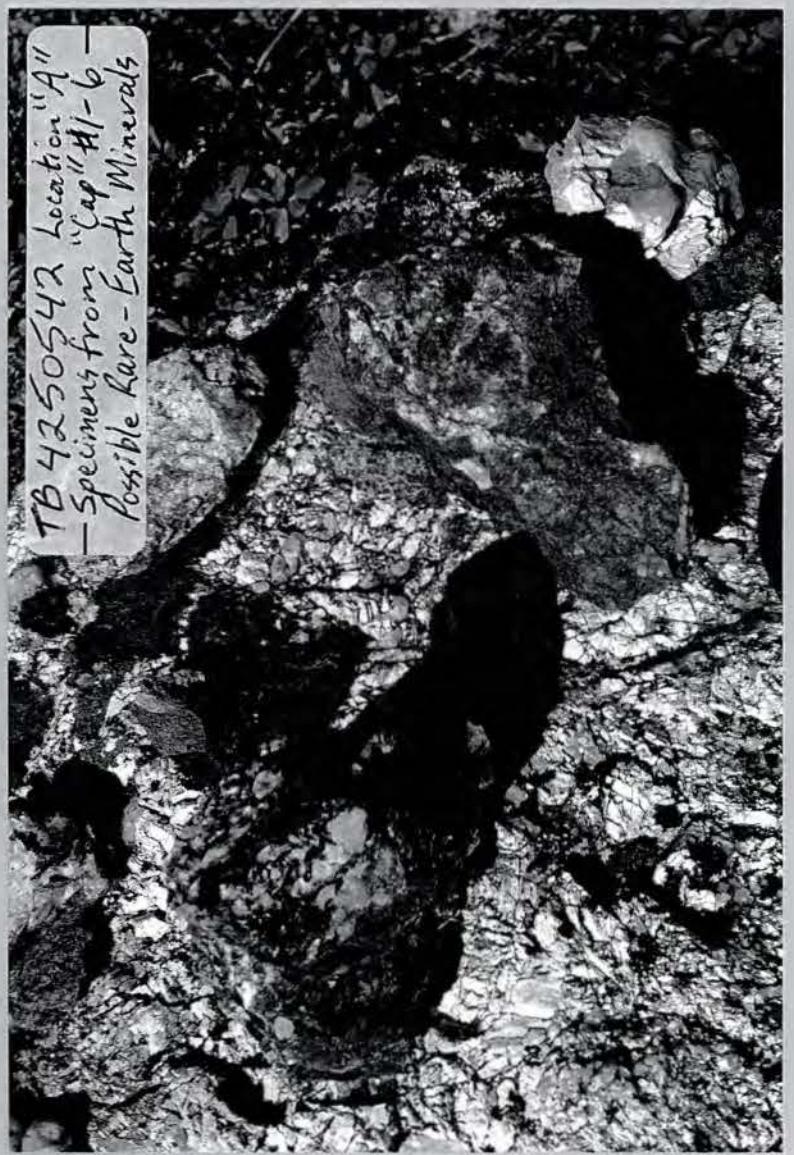
TB 4250542 Location "A"
Specimens from "Cap" #1-6
Possible Rare-Earth Minerals
