Work Report
LORRAIN PROPERTY
(2014 - 2016)

Lorrain Township
Larder Lake Mining Division
Ontario, Canada

Completed for: Timothy Martel

February 29, 2016

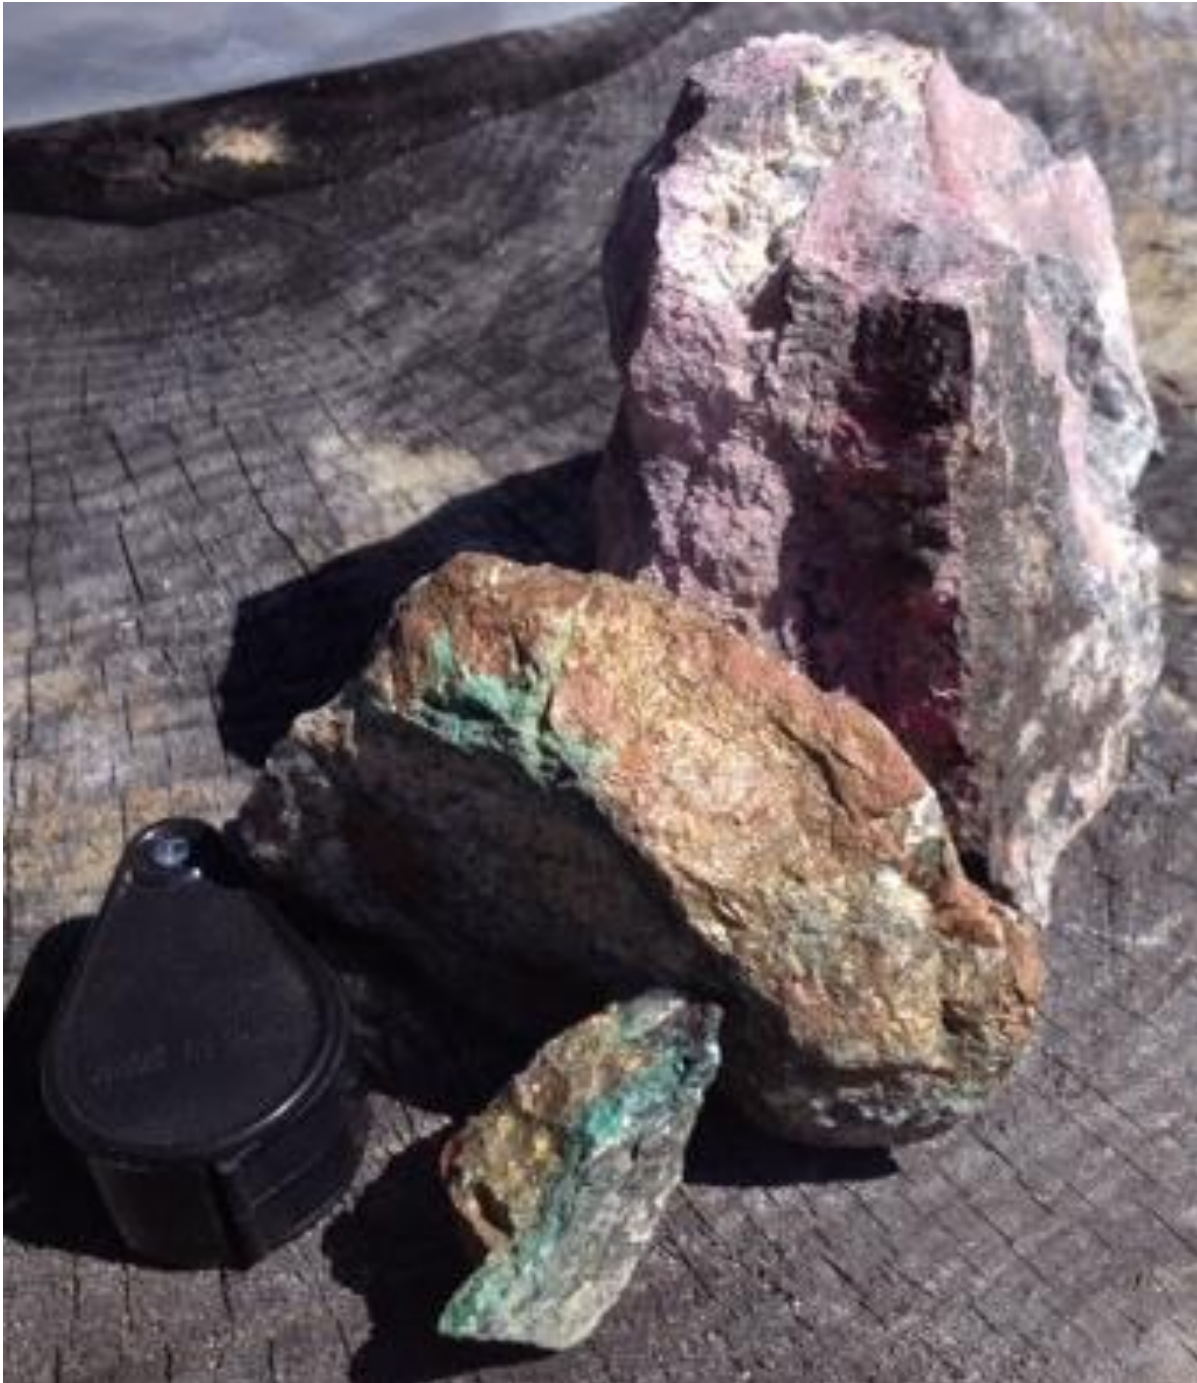
Figure 6: Selected Samples from Muck Pile

Selected samples included visible cobalt bloom and massive sulfides and other pyrite mineralization. Although the samples were taken unbiased the samples that were sent to SGS Minerals Services (Lakefield) did not return values that were within the range for processing the broken rock.
