Rock Quarry and Borrow Pit Material Chemical Suitability Assessment

H346911-0000-07-124-0007

Ontario Power Generation Inc. (OPG) is proposing to implement a shoreline stabilization project along a portion of the Gull Bay (Lake Nipigon) shoreline fronting the Kiashke Zaaging Anishinaabek (KZA) First Nation community (also known as Gull Bay First Nation).

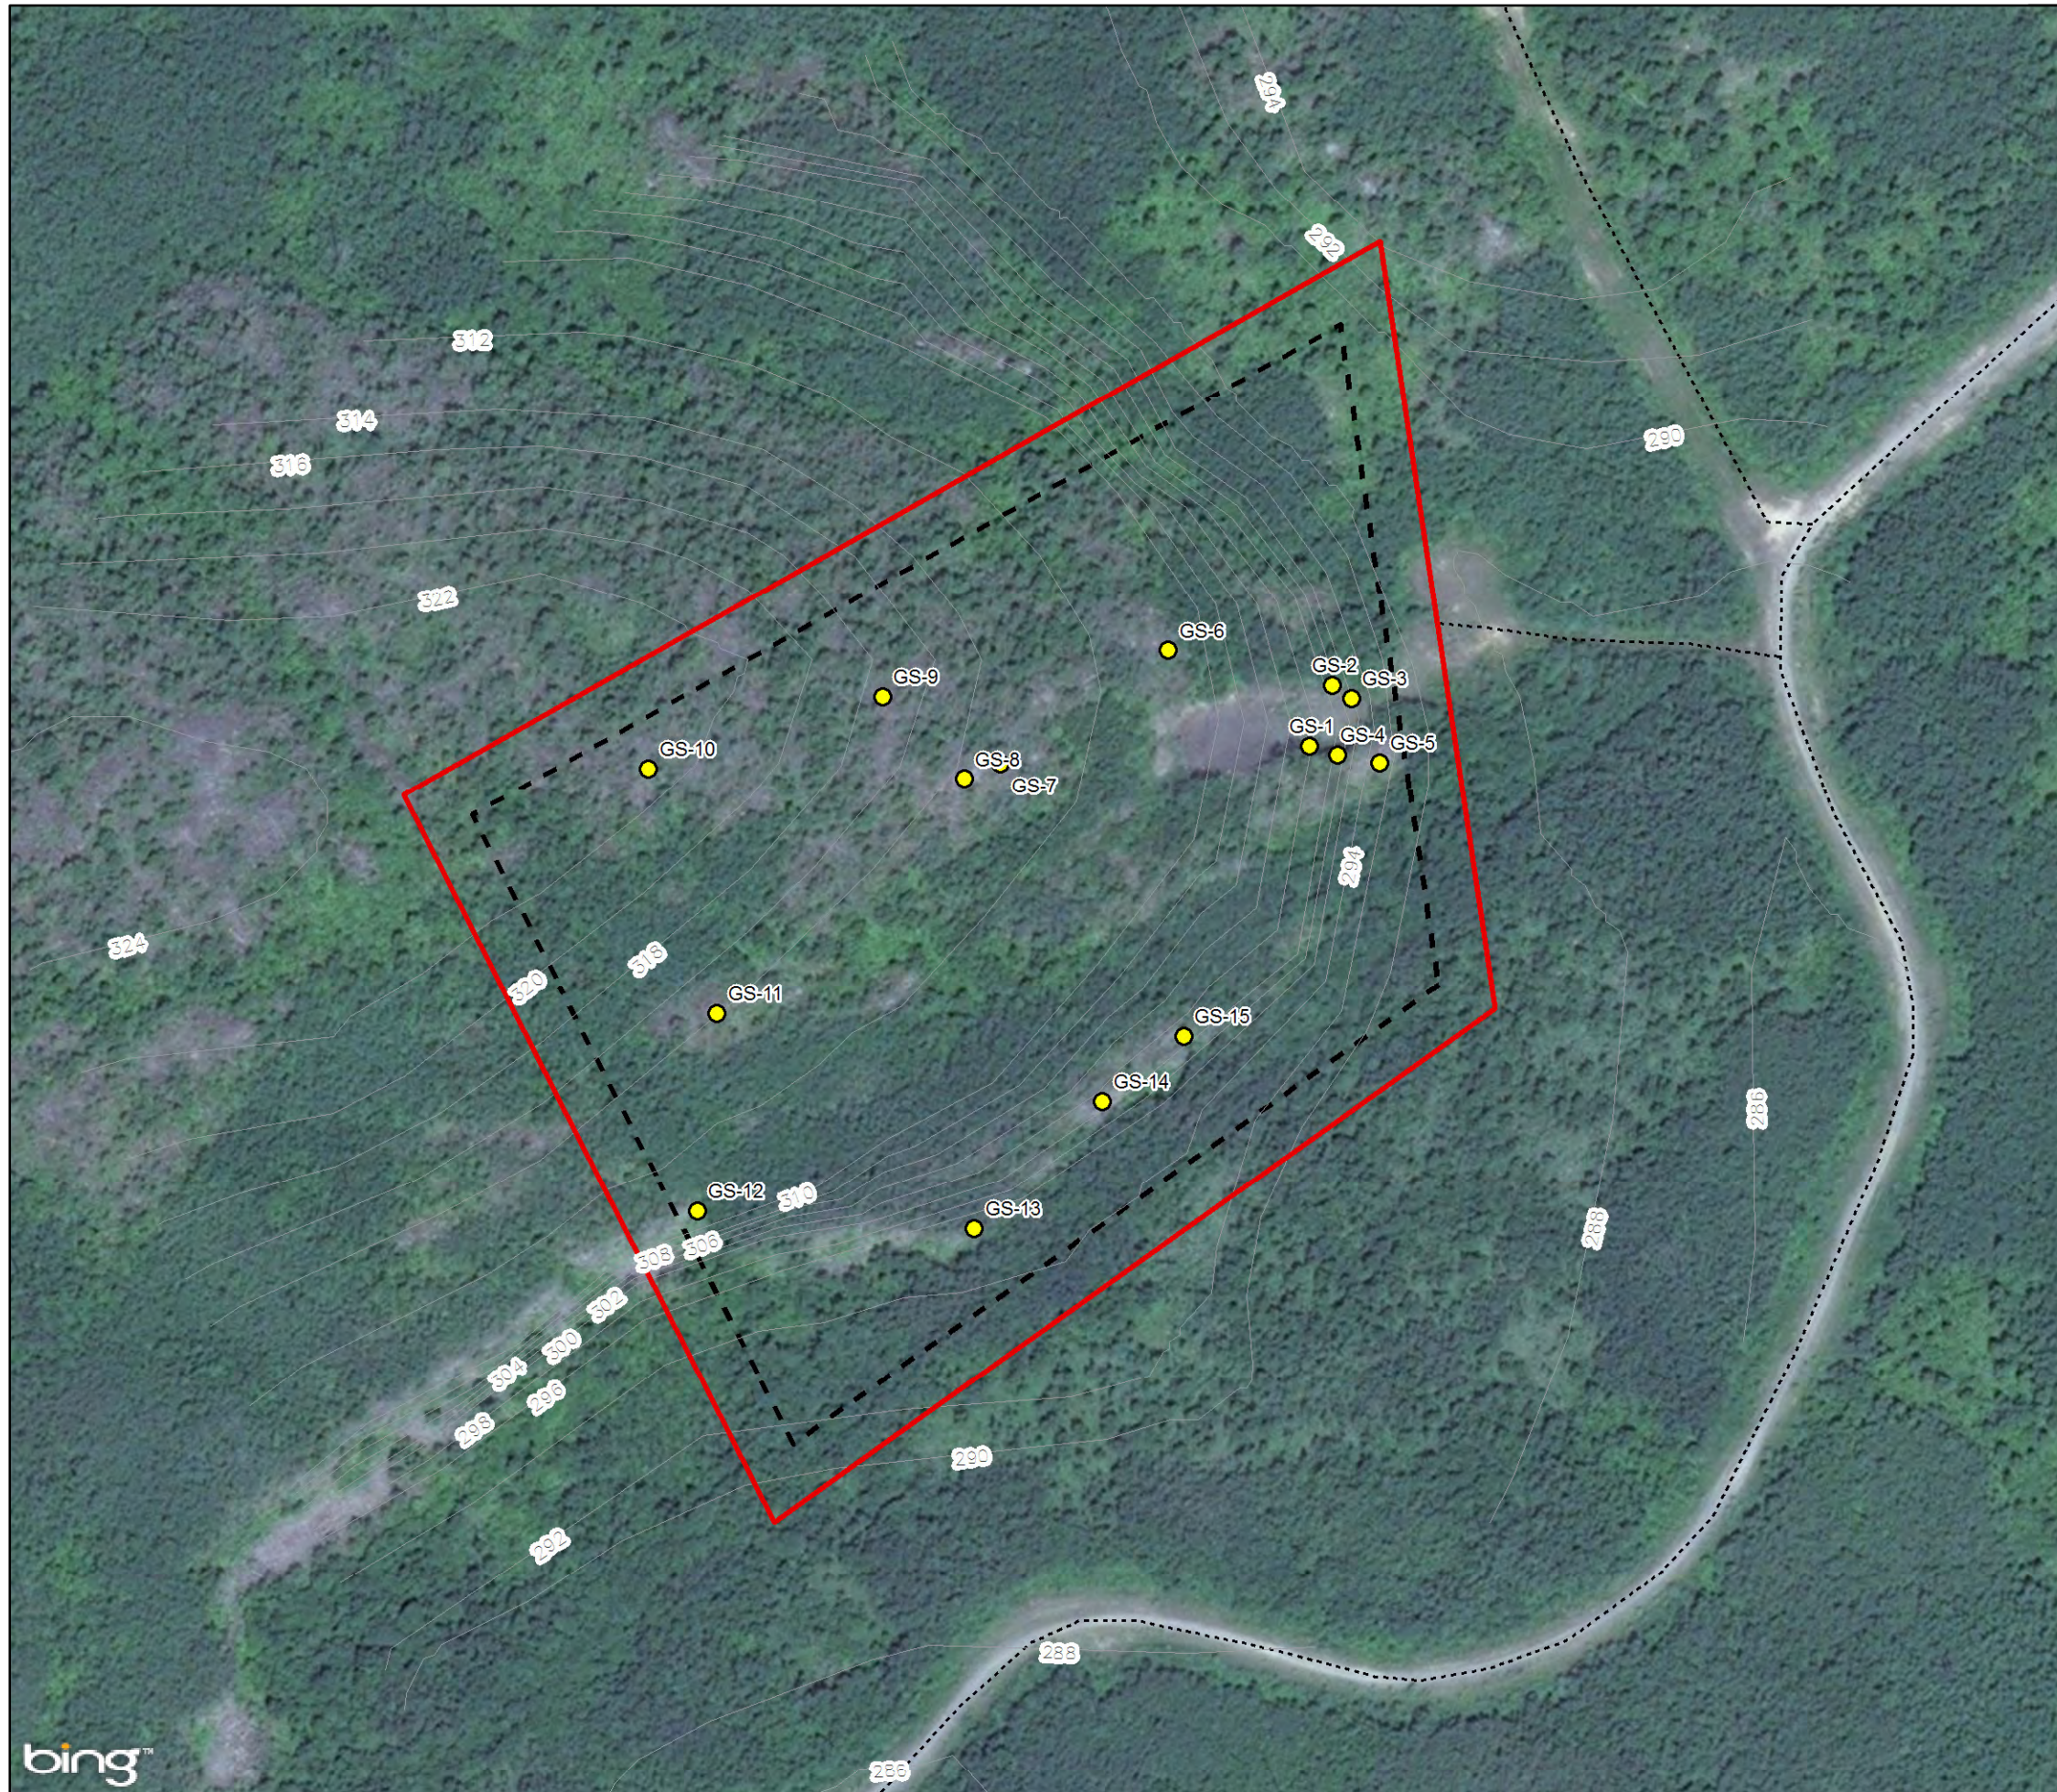
Figure 3.1	Quarry Rock Sampling Location.....	5
Figure 3.2	Borrow Pit Sampling Locations.....	7

- LEGEND**
- Rock Sampling Locations
 - Access Road
 - Topographic Contour (2m Interval)
 - Permit Area (Proposed Quarry)
 - Extraction Area (15m from Permit Area)

- The pre-determined sampling location was located with a hand-held GPS.
- Using a blunt hand tool, fragments from the local outcrop were broken off, ensuring that approximately half of the sample was representative of the weathered surface and approximately half was representative of a fresh surface.
- A minimum of one localized-composite sample per location was collected with an amount of at least 2 kilograms (kg) of material in block form and size of approximately 0.1 m length by 0.1 m depth.
- Samples for rock components were logged and described and it was ensured that the sample was representative of the local rock mass in the area.
- Samples were placed in appropriately labeled, thick plastic bags with sealable tops and placed in a cooler with ice packs.
- Samples were collected, stored and transported as per Quality Assurance/Quality Control procedures outlined in Section 3.3.5.

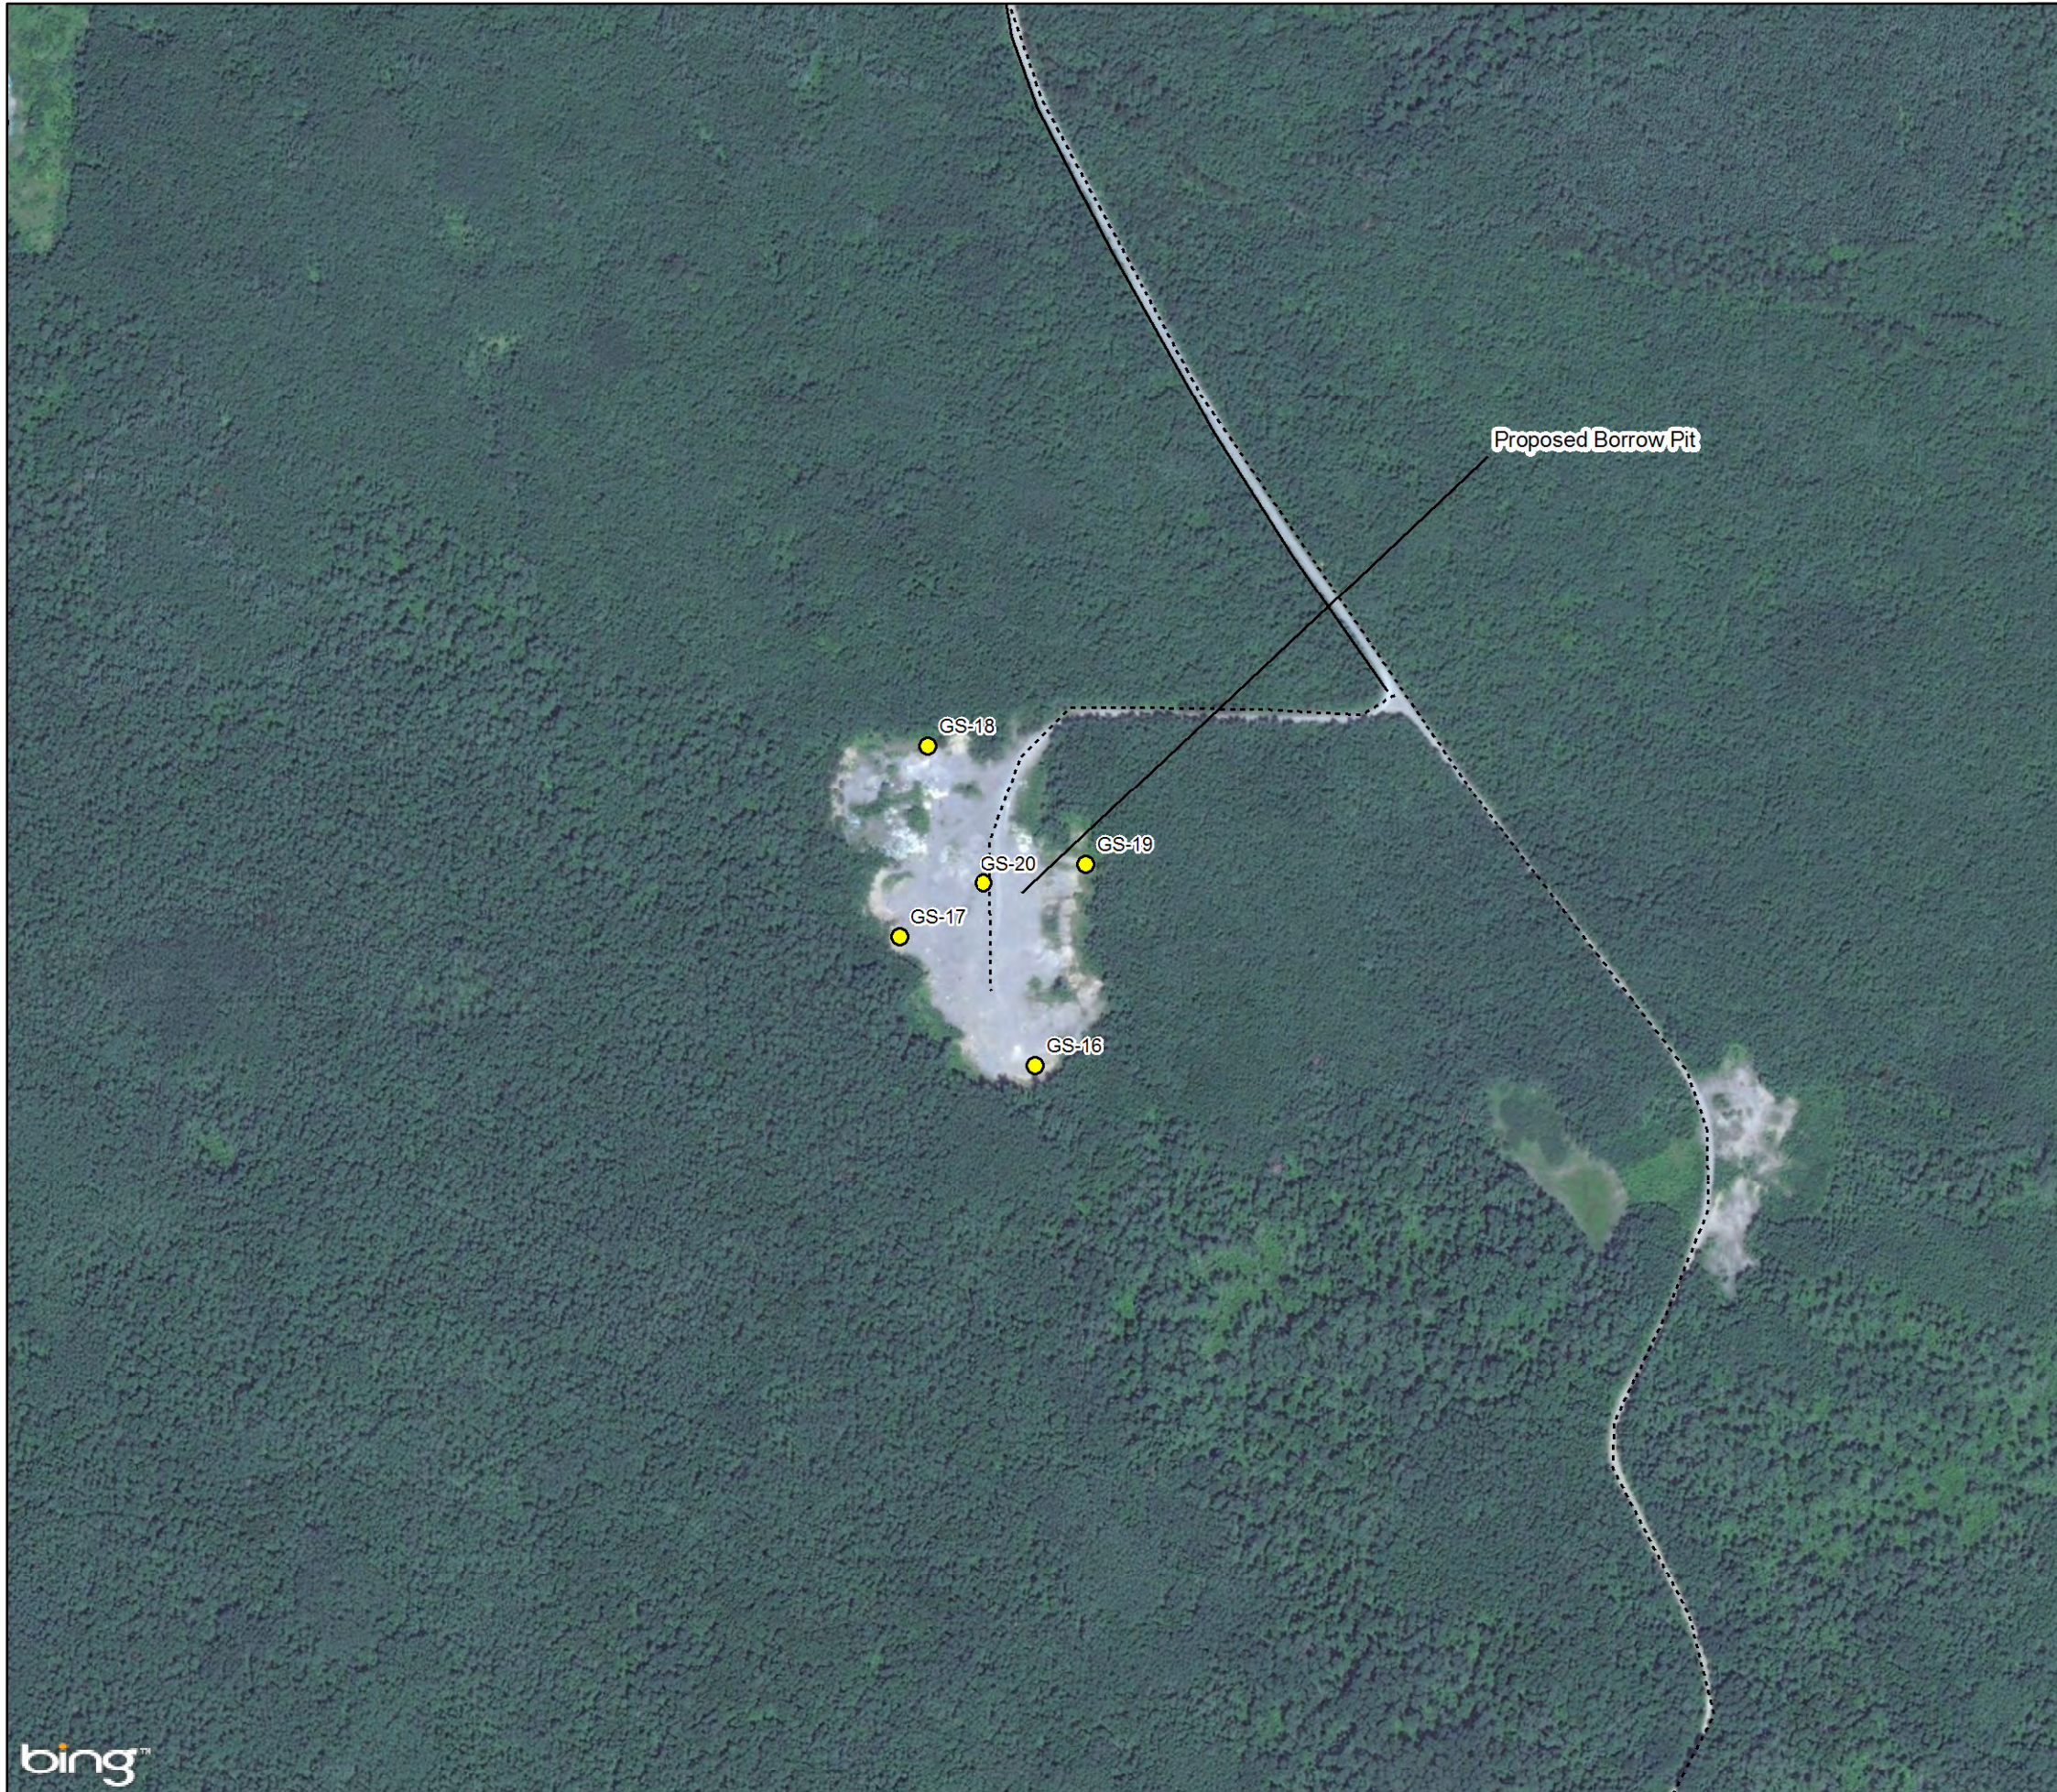
- Proposed Borrow Pit Samples
- Access Road

- The pre-determined sampling location was located with a hand-held GPS.
- A minimum of one localized-composite sample was collected by hand at each sampling location and placed in a thick plastic bag with sealable tops, and placed in a cooler with ice packs.
- Samples were logged for components and description (colour, texture, moisture content) and it was ensured that each sample was representative of the local borrow pit material in the area.

locations at the northern end of the pit and it is possible that this could have resulted in sample contamination. To mitigate this, the Technical Specifications for the project will require the Contractor to extract material from the southern and western walls of the pit and avoid the northern wall where the waste debris was observed.

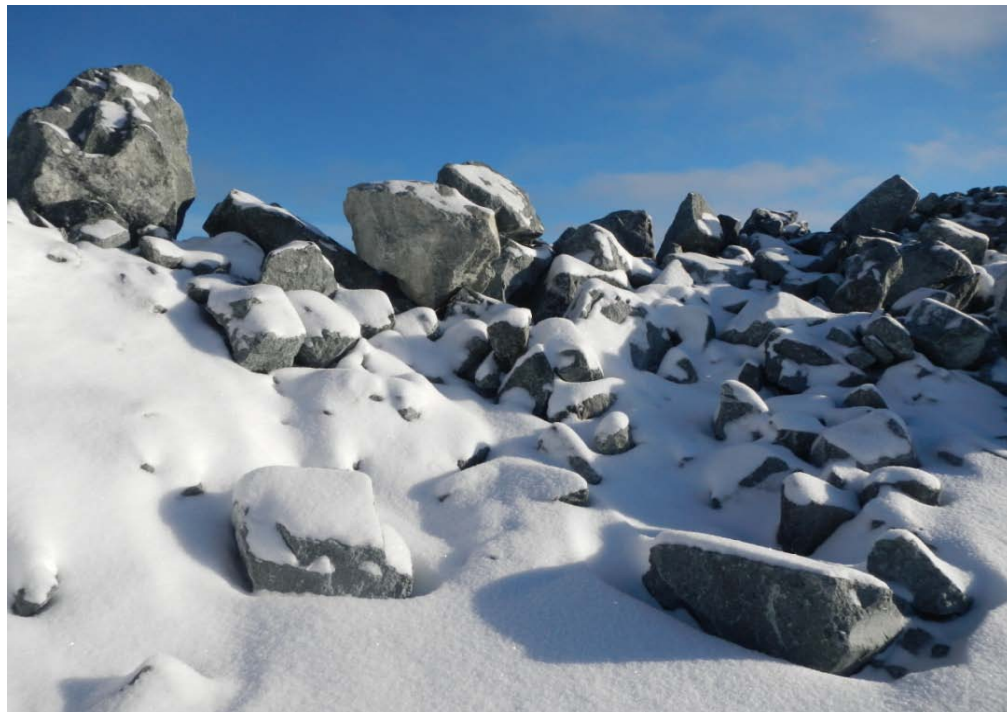
Photo 2: Lac des Iles Mine Site Waste Rock Stockpiles – Typical Rock Dimensions

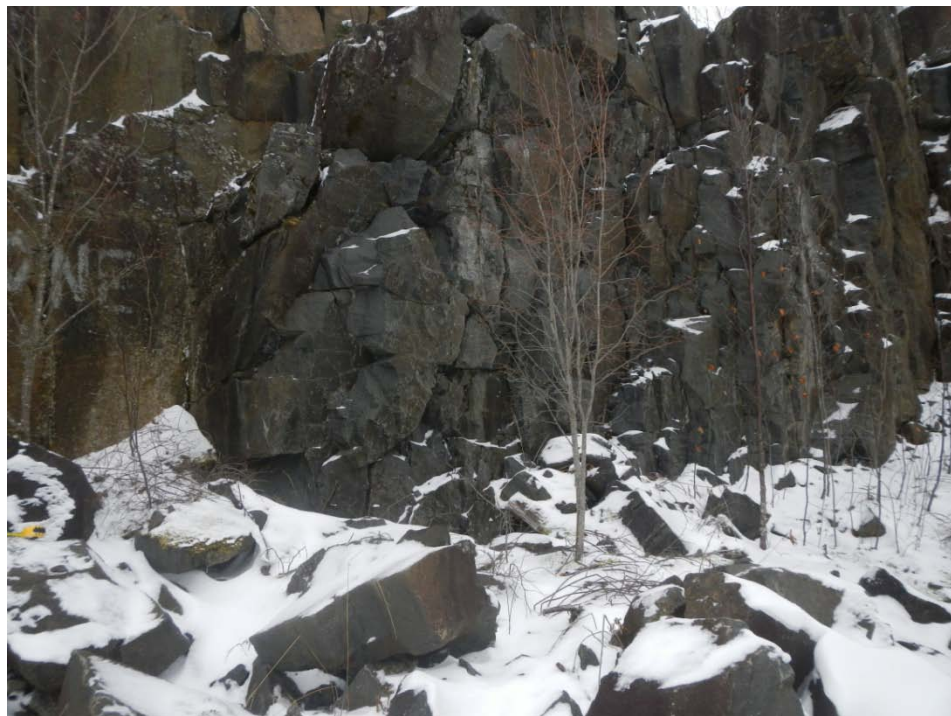
Photo 4: Quarry Site – Variable Jointing from Moderately to Widely Spaced

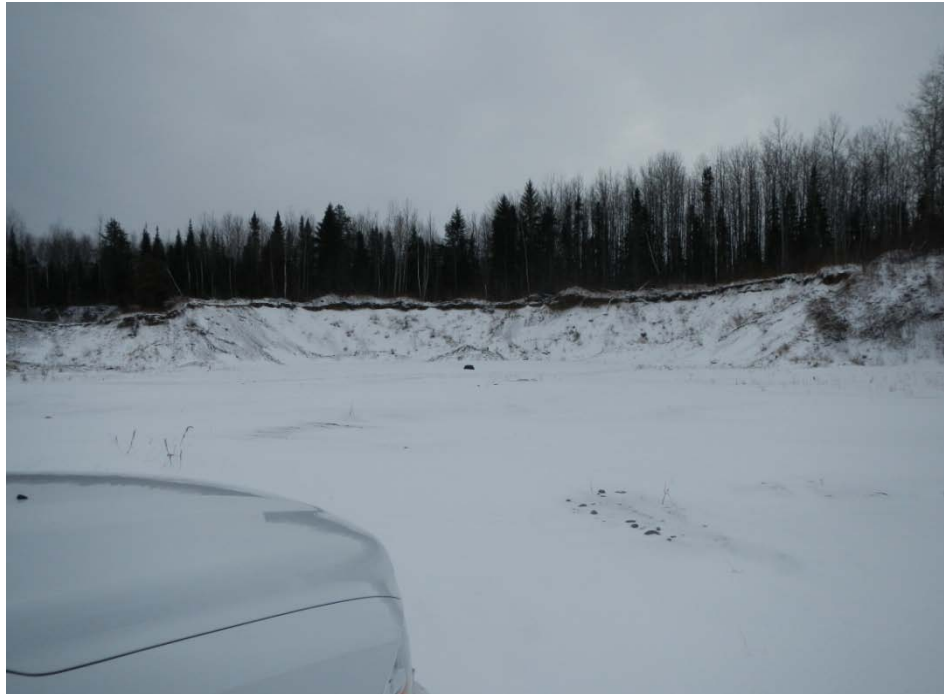
Photo 5: Borrow Pit with Sidewalls Approximately 6 m in Height

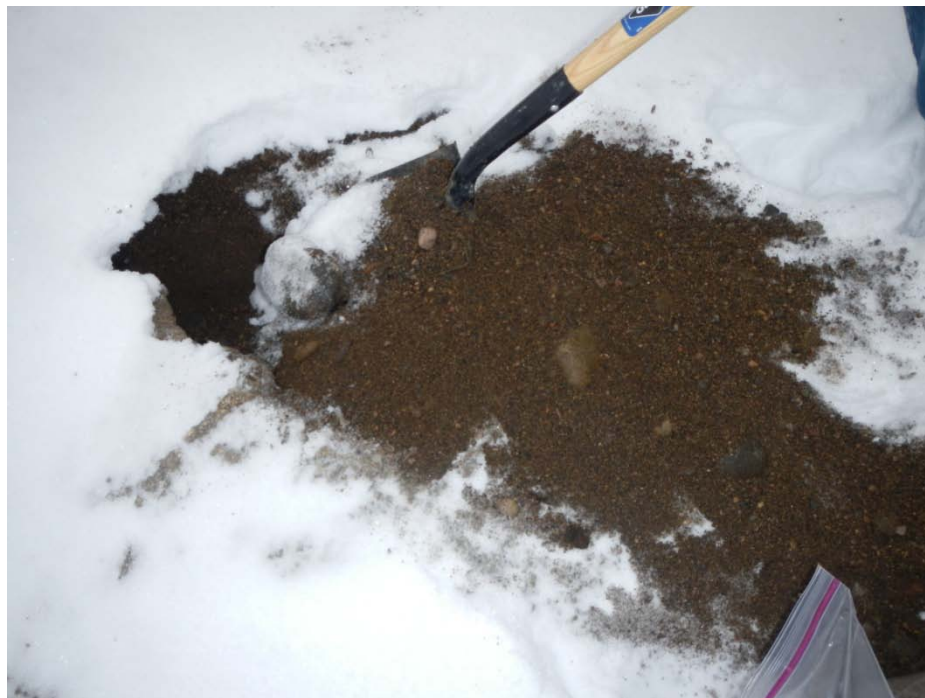
Photo 6: Borrow Pit Sample Containing Medium to Coarse Grained Sand and Fine Gravel with Trace Coarse Gravel

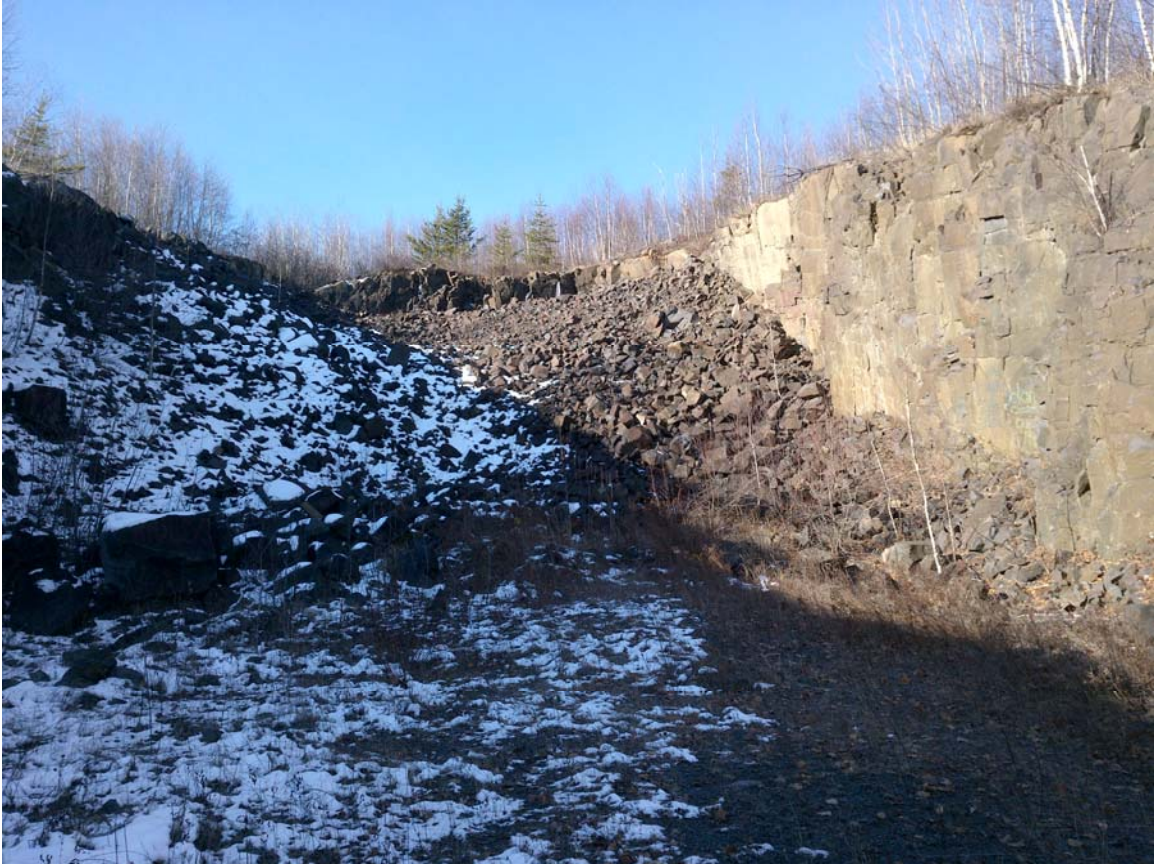
Figure 1: View southwest showing the existing quarry face.

15 metres in height, with a quantity of fractured rock lying within (Figure 1). Above the quarry, thin soils cover the bedrock, and in many places, no soil is present (Figure 6). Thin soil development is due to limited parent material and the erosion resulting from frequent, recurring forest fires. The surface at the top of the rock knob/ridge is irregular (Figure 7). Below, the surface is level, and poplar and alder are the dominant forest cover (Figure 8). This extensive plain is evident in contrast to the rock knob/ridge (Figures 9 and 10). The subject property includes a steep slope, near vertical along the east face, which precludes the formation of beaches at this elevation. While Mollard and Mollard (1983) mark the subject property as bounded by lacustrine deposits, examination of the lower parts of the subject property did not reveal any distinct features resembling relict shoreline features.

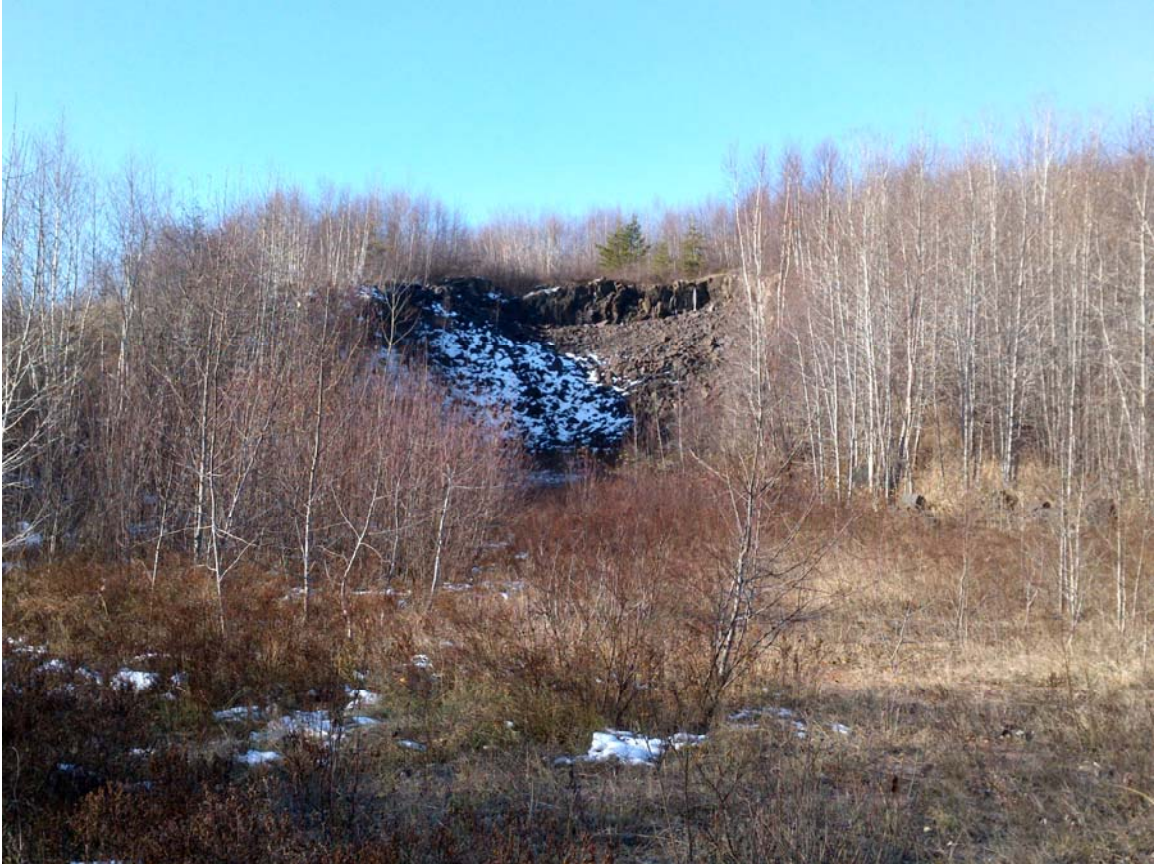
Figure 2: View of quarry showing former processing, loading area in foreground.

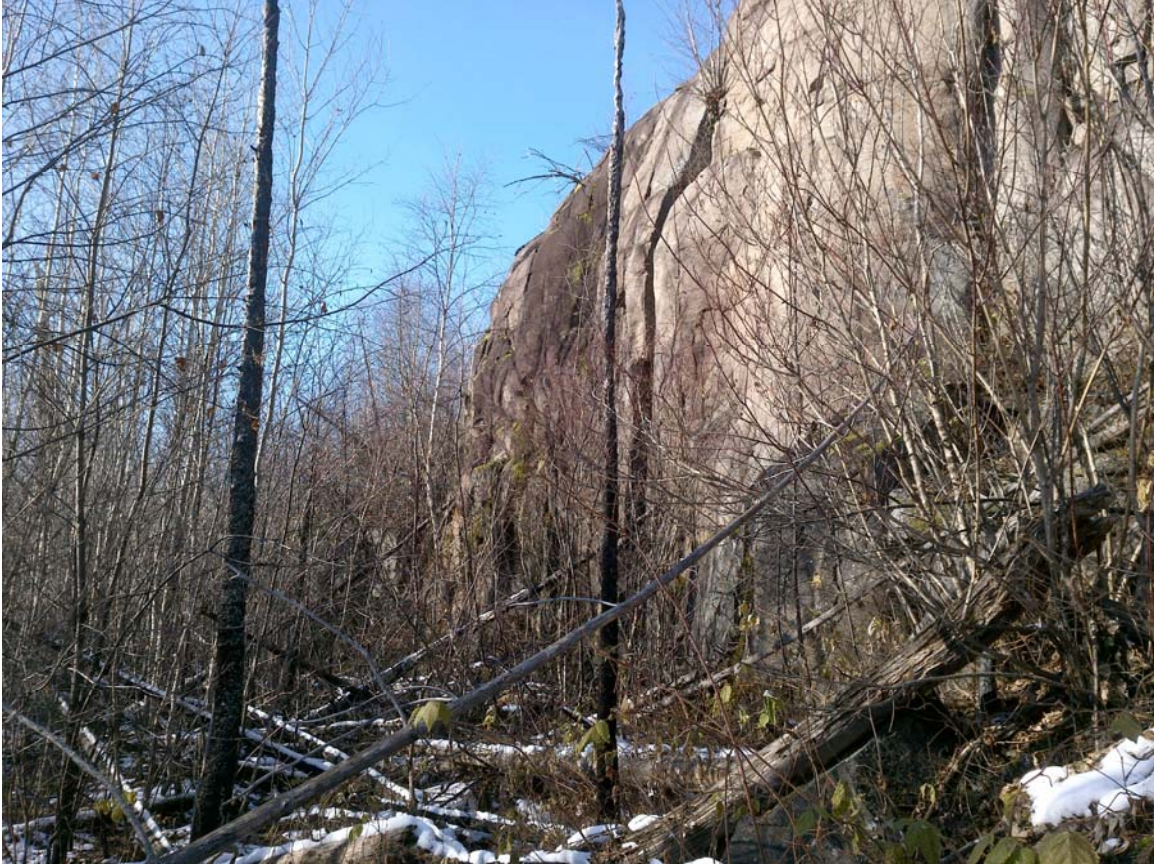
Figure 5: View southwest along near vertical face of rock knob/ridge.

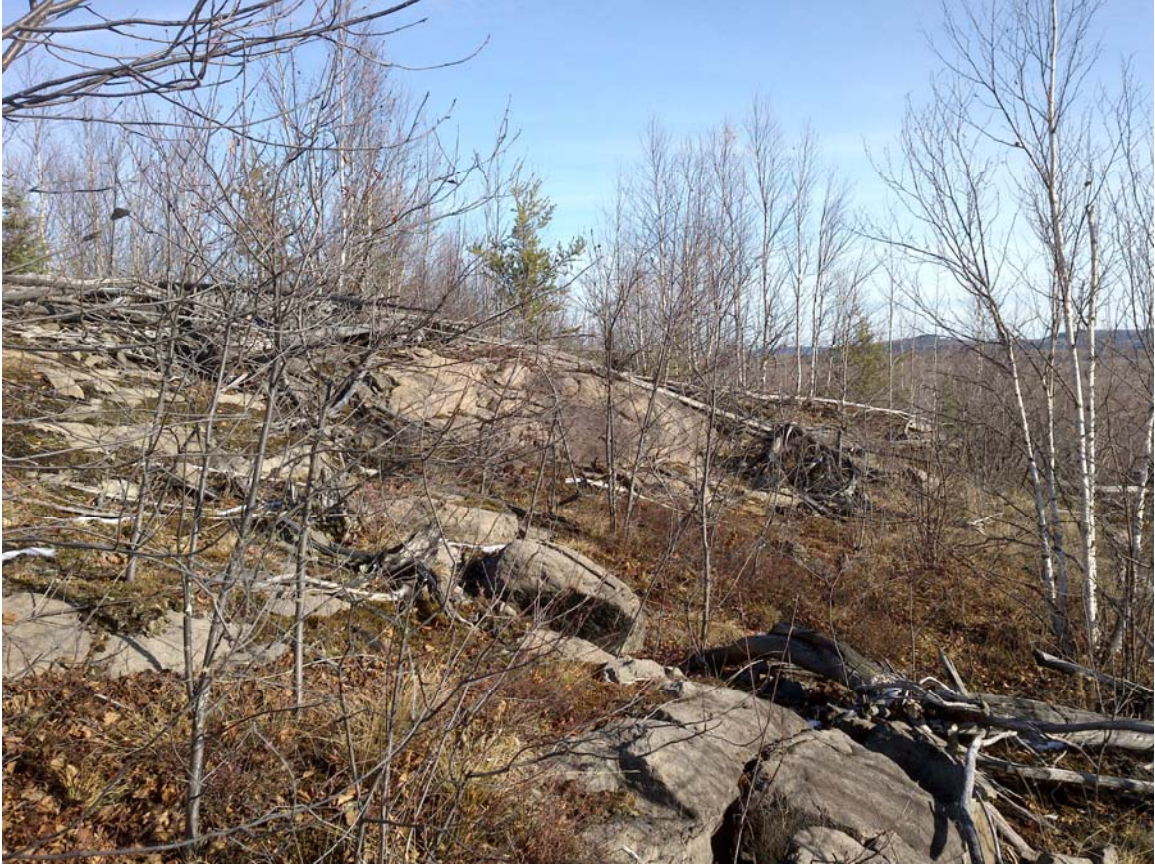
Figure 6: View east showing bare rock interspersed with areas of thin soil.
