Application for Assessment Work Credits

Mining Claim TB 3016678

Watson Quarry

South-East Quarter Section 11 Concession 7, McTavish Township, Shuniah

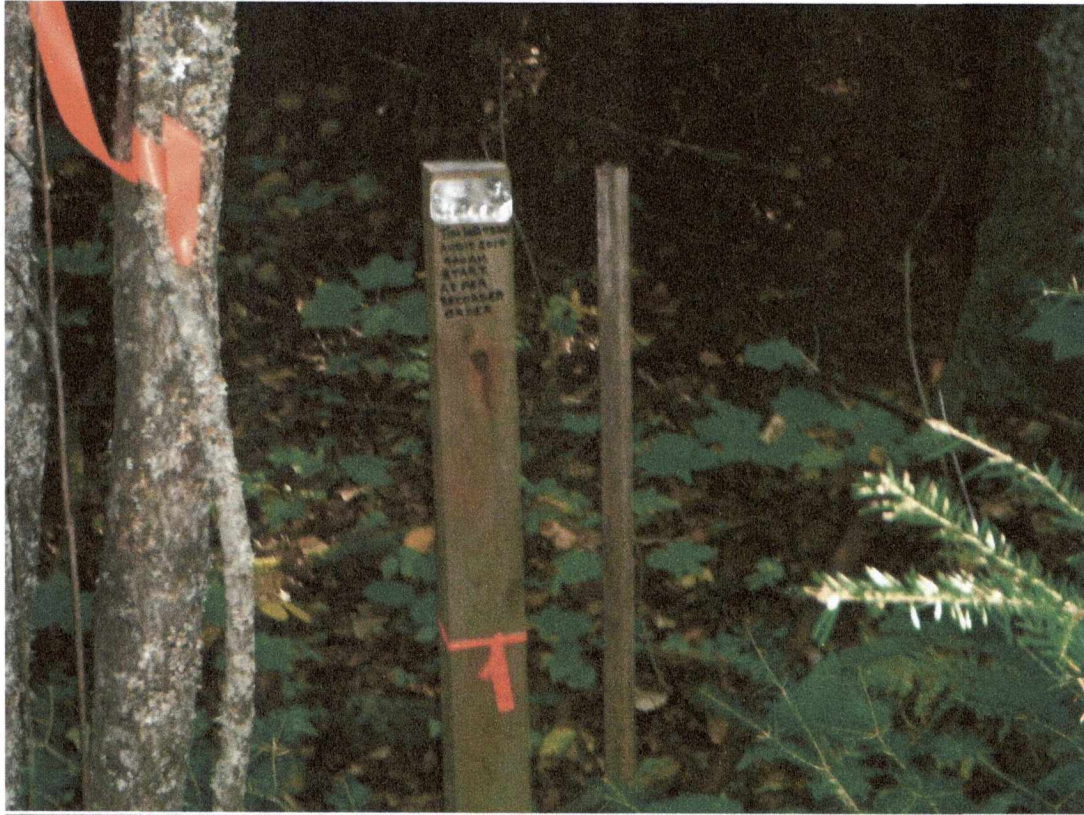
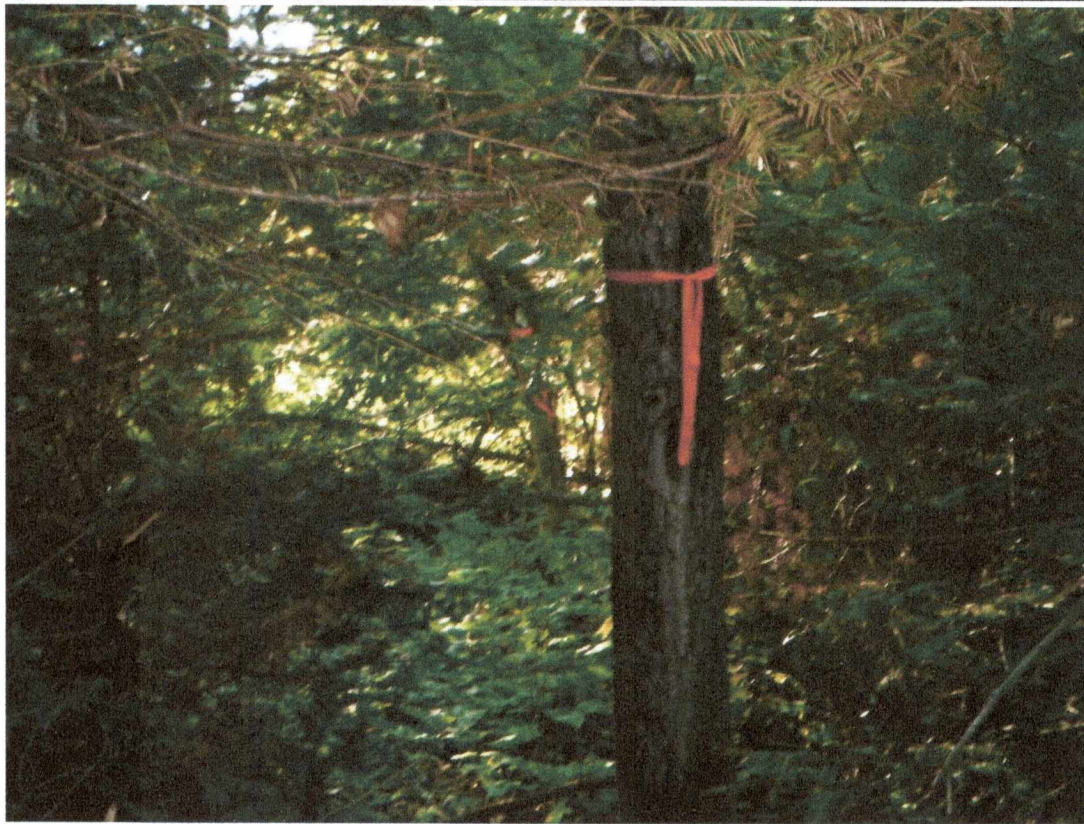
Assessment Work Part 1—Re-cut Claim Lines

As per the included photos, much of the perimeter is dense bush that requires periodic cutting of trees and willows and tagging with flags to establish a clear line delineating the borders of the claim.

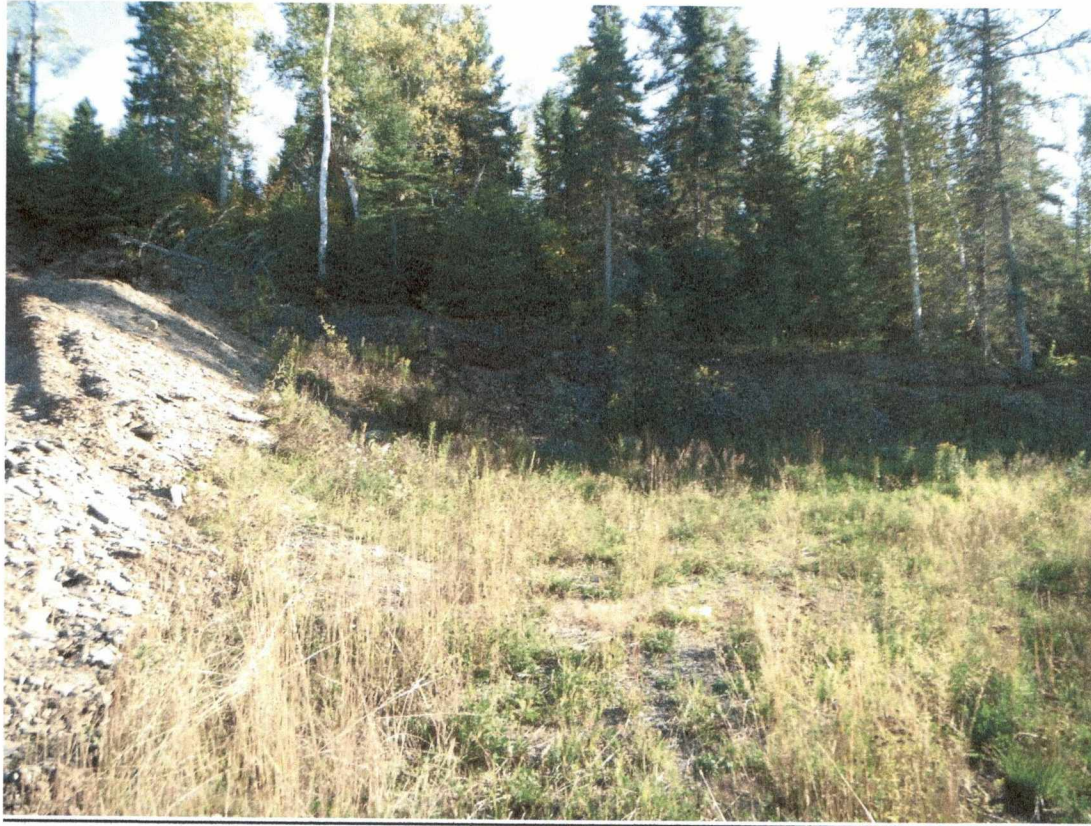
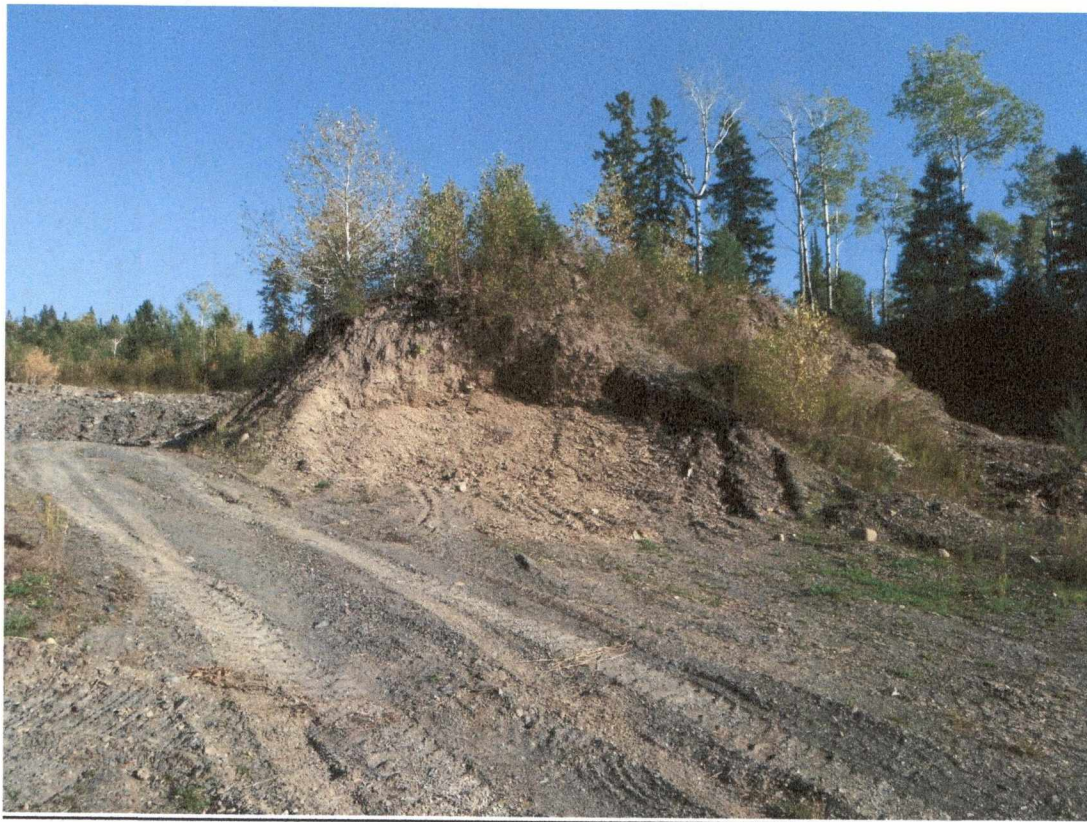
Assessment Work Part 3—Stripping at Location W

A 320 Caterpillar excavator and a 950 Caterpillar front-end loader were used to clear a section of land and strip a section of overburden with a length of 50m and an average width of 12m moving in a southerly direction along the lay of the land. The depth of overburden gradually increased over the distance from 15cm to 1.5m. The Overburden consisted of rock, brush and topsoil.

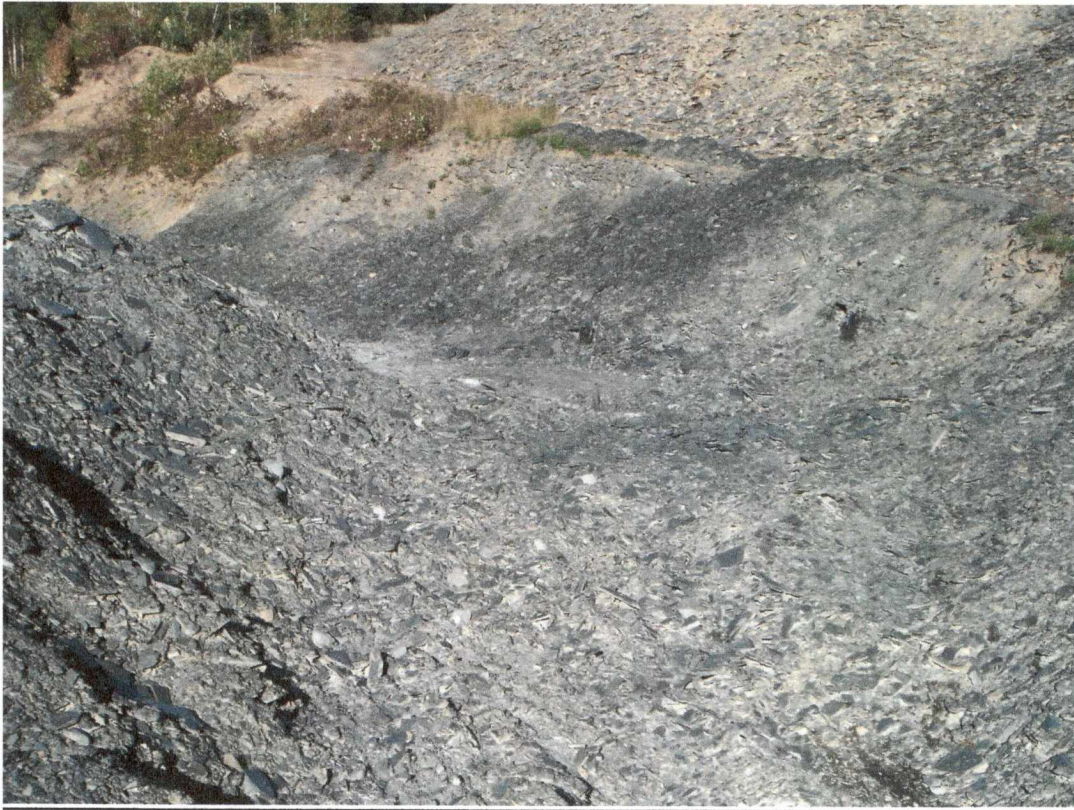
Assessment Work Part 4—Trenching at Location X

Trenched a section of the shale deposit 7m wide by 100m long to a depth of 4m with a 320 Caterpillar excavator. Determined it was 100% consolidated aggregate. As depth increased, so did the density of the deposit. The truck and 950 Caterpillar loader were used to remove former stripping piles.

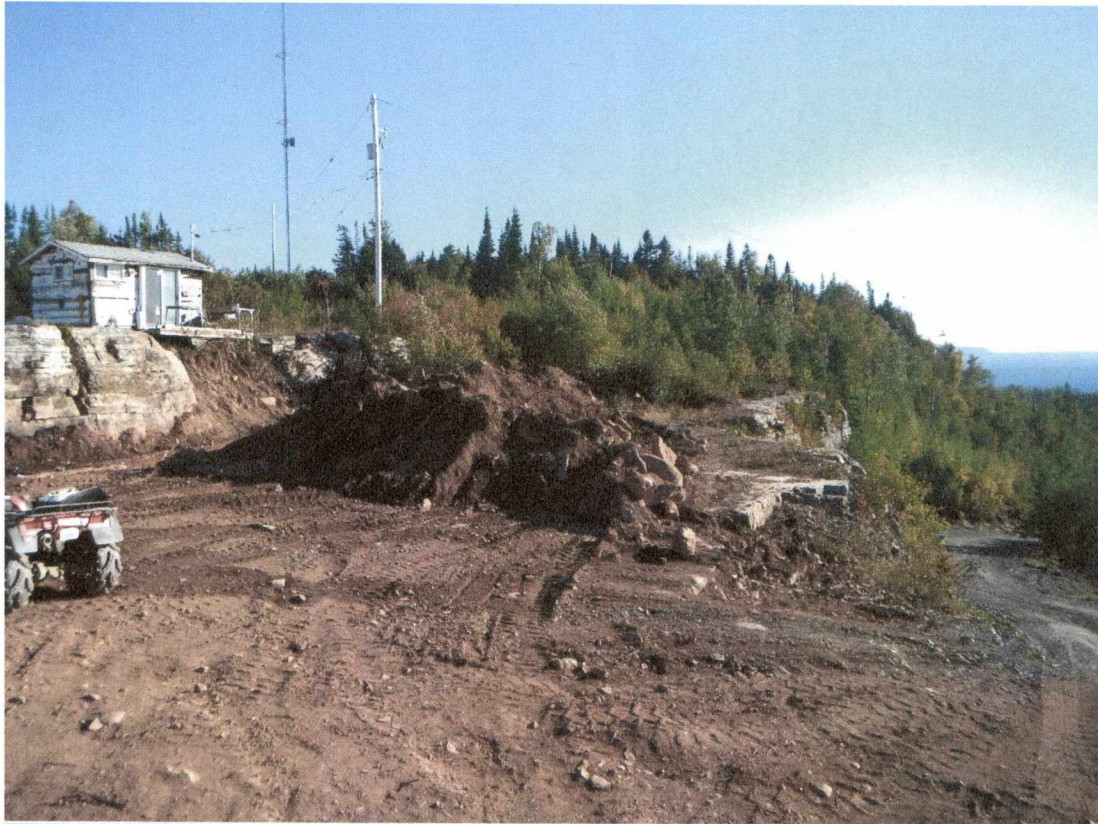
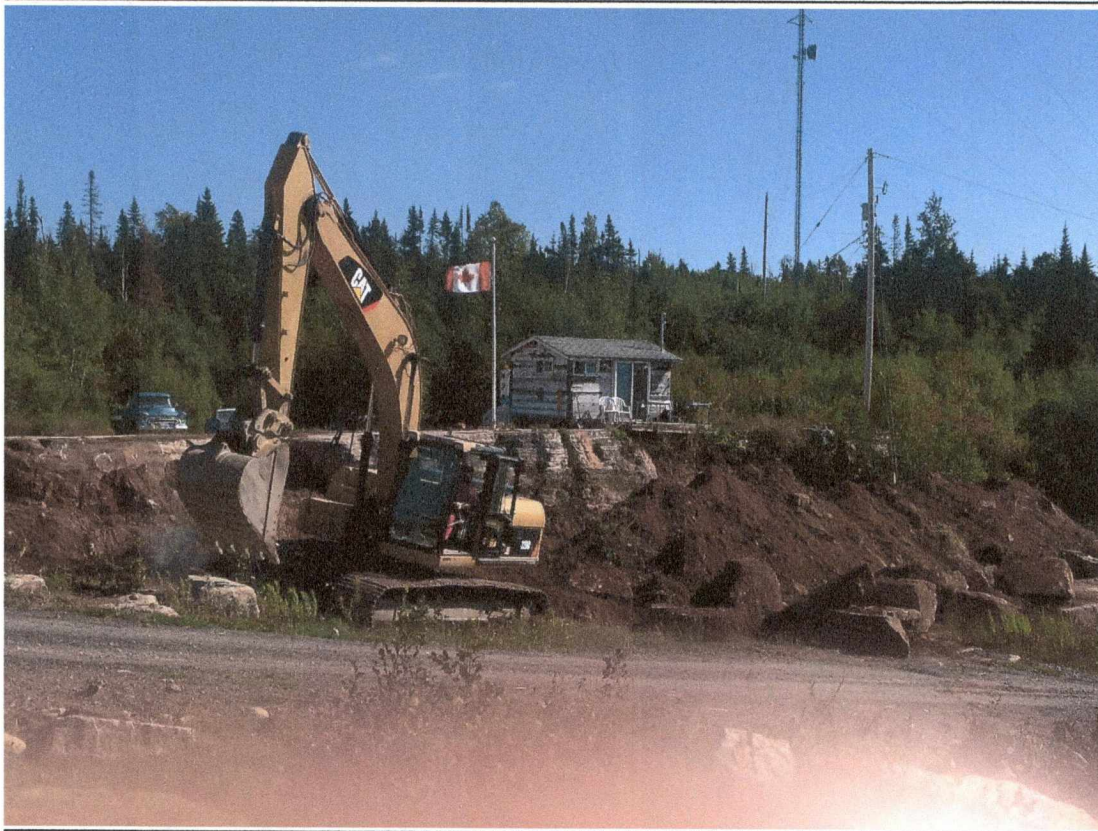
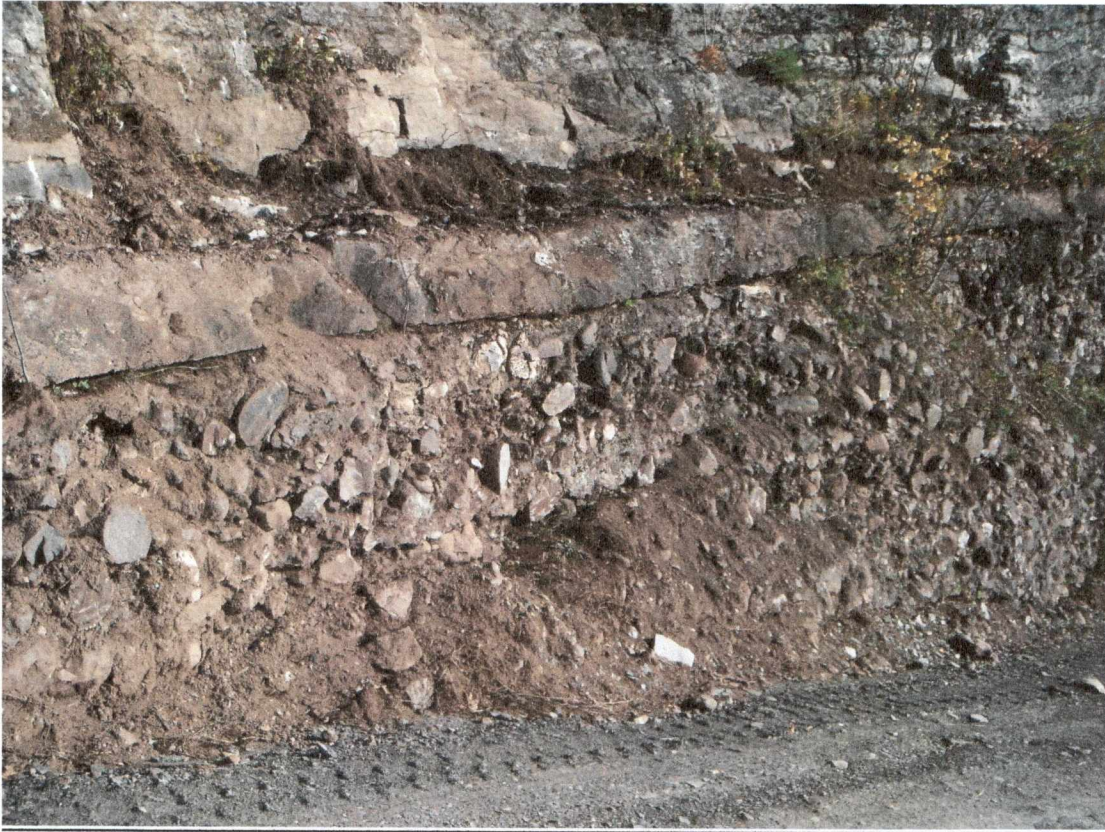
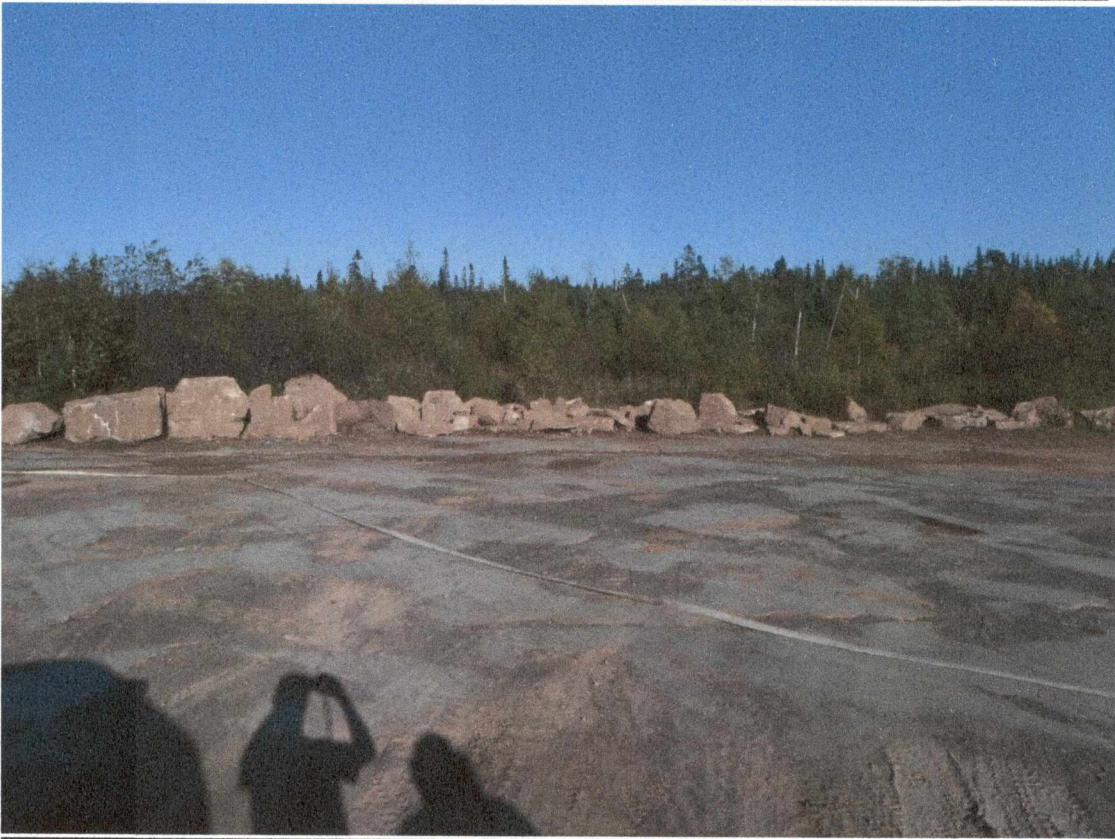
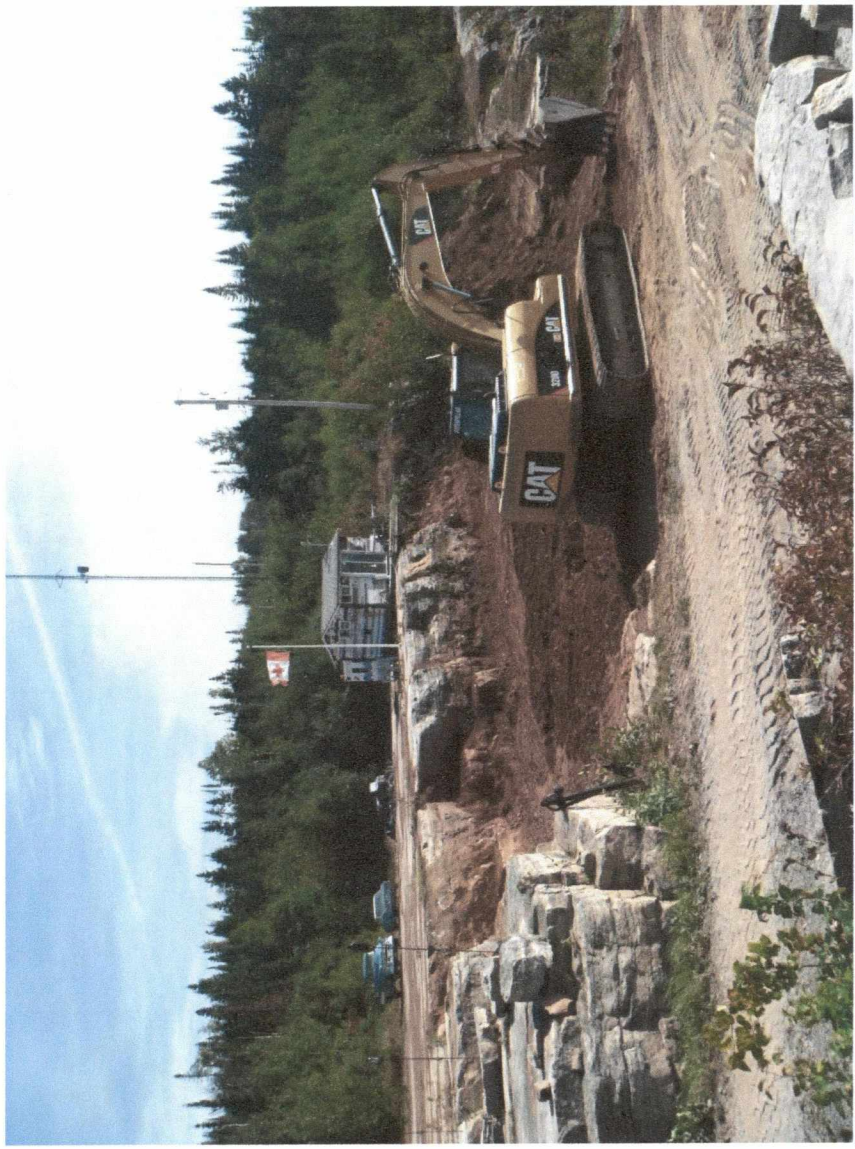
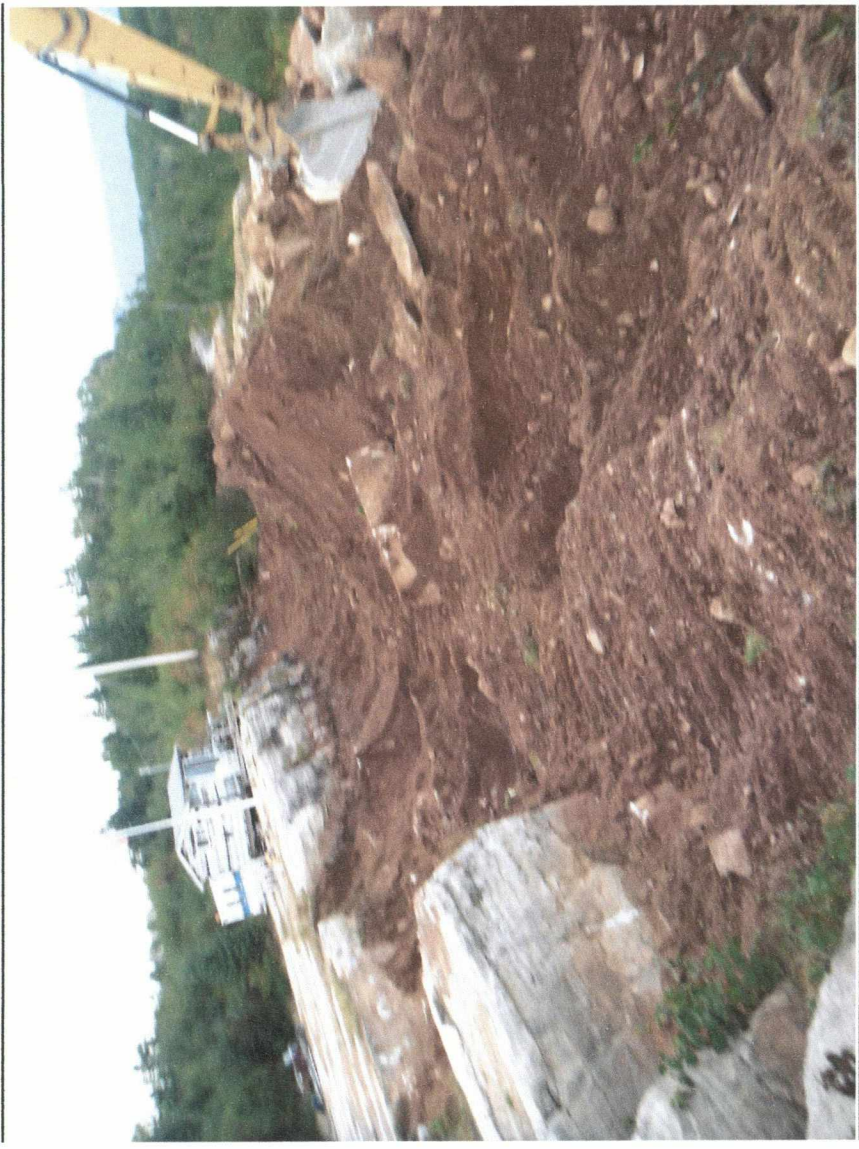
Assessment Work Part 5—Stripping and Trenching at Location Y

A 320 Caterpillar excavator and a 950 Caterpillar front-end loader were used to clear a section of the sandstone on the bluff and strip a section of overburden with a length of 50m and an average width of 12m moving in a southerly direction along the road. The depth of overburden was fairly consistent over the distance at 9m. The Overburden consisted of 4m of sandstone on top followed by 5m of conglomerate. The top of the shale deposit was then accessible. Approximately 300tonnes of sandstone was removed and stock piled.
