**TECHNICAL REPORT FOR PROSPECTING, MECHANICAL STRIPPING &
PITTING & TRENCHING**

ON THE DIAMOND WILLOW AMETHYST MINE PROPERTY

LEA107759

MAY 10, 2018 TO JUNE 10, 2018

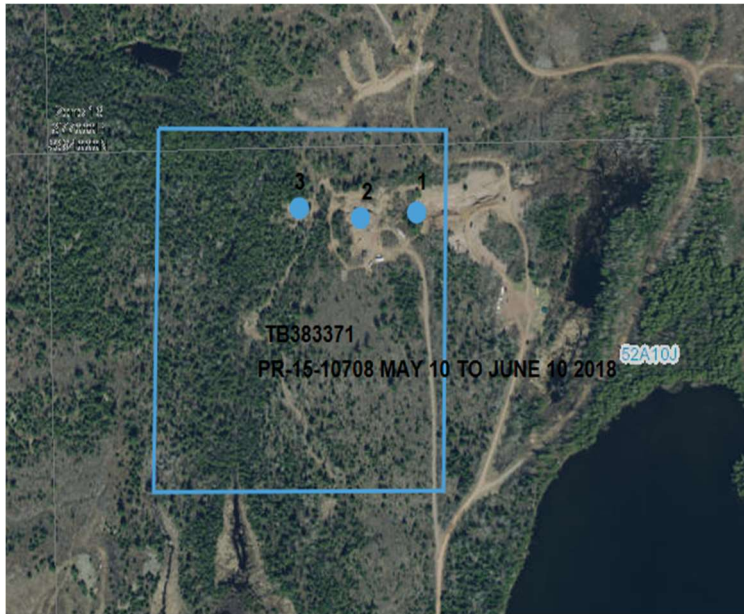
Diamond Willow Amethyst Mine
Surface & Mining right lease TB-
383371 Outlined in blue

Exploration work areas

AREA 1 ,2 & 3 Blue dots identified
by blue dot with #

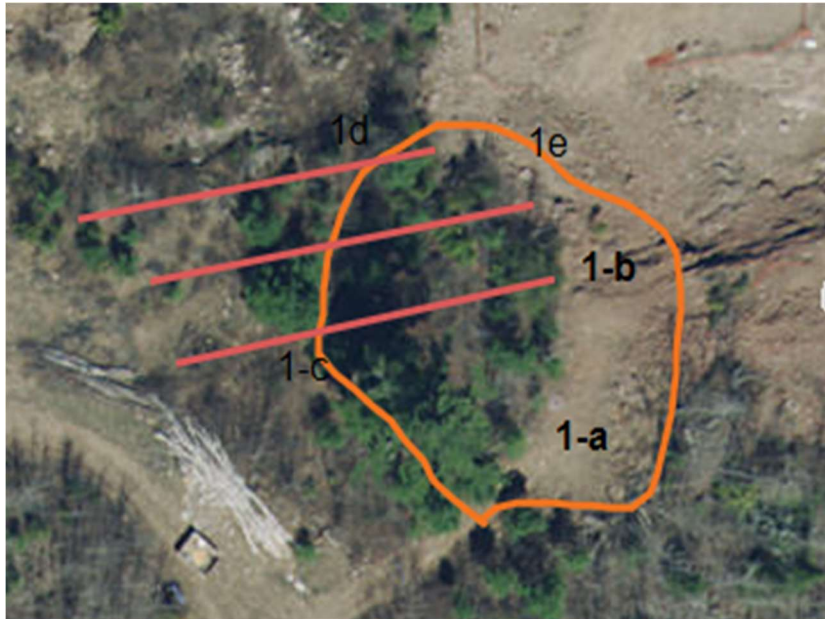
1-a 10'x 60' mechanically stripped area

1-b-pitting and trenching

1-c-prospecting vein

1-d prospecting vein

1-e prospecting & stripping against bank.

Red line= new veins exposed

Orange line=outline of Area 1

Area 1 -Prospecting showed that there was possible veins veering off to the south from the main vein. The main vein of the mine runs east to west. We walked thru **Area 1-a** and discovered some potential veins that we uncovered with grub hoes with further investigating in the treed area we discovered the vein running about another 40' did a little exposing of the veins with grub hoes. **(Area 1-c)**. From that point we had walked north and found 2 more veins **(Area 1-d)** and this prompted us to do a little more Mechanical stripping to the North west **(Area 1-e)**. This location we used grub hoes to expose the 2 extra veins and then mechanically stripped.

We started with **Mechanically stripping** an area approximately 10' wide x 60' long and this is identified as **Area 1-a**. This stripped area is generally running in the North east to South west direction as the Main vein typically run east west thru the area it makes sense to cross strip to see what was possibly there. The trees in this location were cut in Fall 2014 and the soil and roots were not mechanically stripped until 2018. We exposed bed rock and was a sandstone which local geologists call it mudstone. There was a mixture of roots, smaller vegetation and soil to be stripped approximately 1' of soil, moss and smaller trees, the overburden was put to the east side, the surface was not flat, noticing quartz showing up in the mudstone pieces and also after stripping we noticed we had a 6" to 12" wide vein of Amethyst exposed identified as **Area 1-b**. Lastly for Area-1 we mechanically stripped against the bank in **Area 1-e** And exposed 2 more veins, More Exploration will be required for this area.

We decided to perform **Pitting and trenching** to see the potential of this exposed Vein, we performed drilling and blasting with 7 holes for the first blast to open it up and 11 holes for that were slightly delayed for the second blast. The first set of 7 holes were 1' apart 2' deep and drilled on a slight angle, and the second set of 11 holes were placed behind first set back about 2' and these holes were 3' deep. The vein appears to be more that just on the surface after trenching this out and appears that it will run deep. The vein had thick solid quartz with drusy amethyst crystals varying from violet to red on both sides and also on the mud stone host rock.

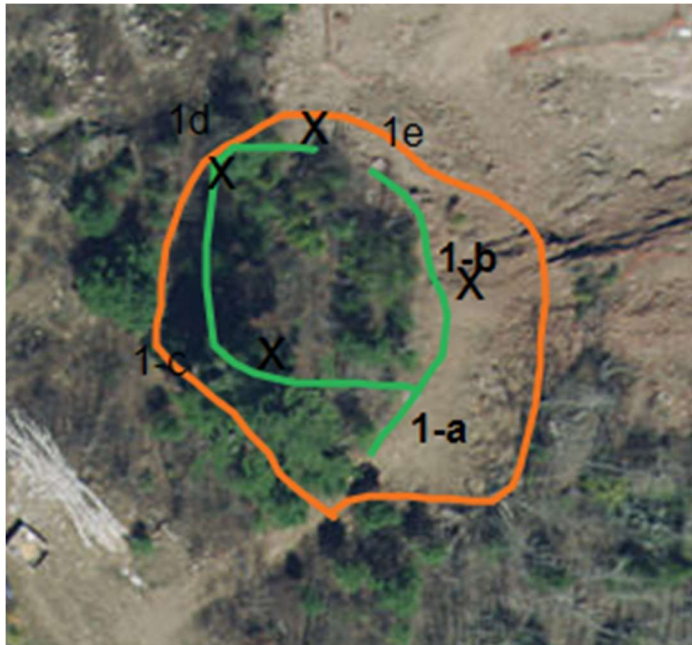
Area 1 Prospecting path

Green Line indicates walking path and grub hoeing 1' x 2' patches exposing vein prior to Mechanically stripping.

Orange line=outline of Area 1

X=grub hoe

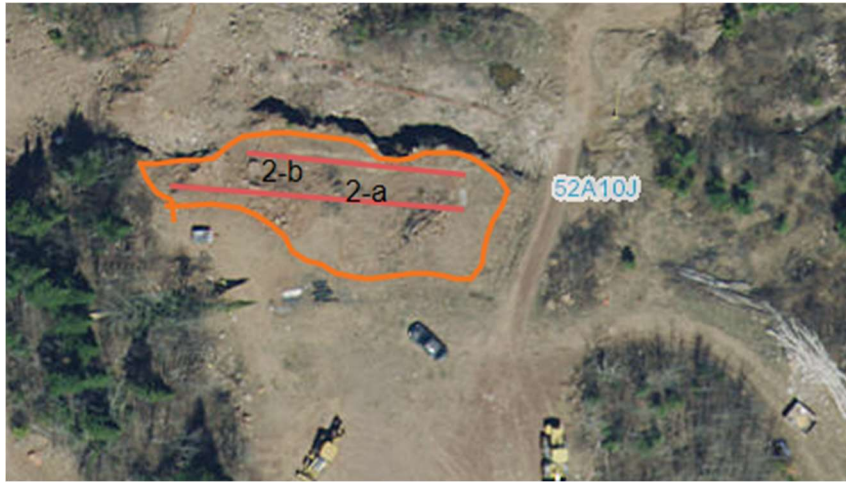
Area 2

Orange line= outline of area 2

Red lines=new veins

2-a = pitting and trench

2-b=over burden pile

Location 2-We performed some prospecting as we noticed the vein and exposed the vein with the grub hoes in a few locations. We then mechanically stripped the area south of the Main Amethyst vein, this vein was about 2" up to 4" wide, as we were stripping we also found extra veins more to the south and Mechanically stripped this area as well. The total area size we stripped was about 30' x 60', we will call this area Location 2-a. the small trees were stripped in fall 2014 we mechanically stripped 6" to 8" of soil piled up at the west side on this location. We also performed some pitting and trenching using blasting in the center of Location 2-a. and just beside 2-b These holes were approximately 3' deep and 12" apart.

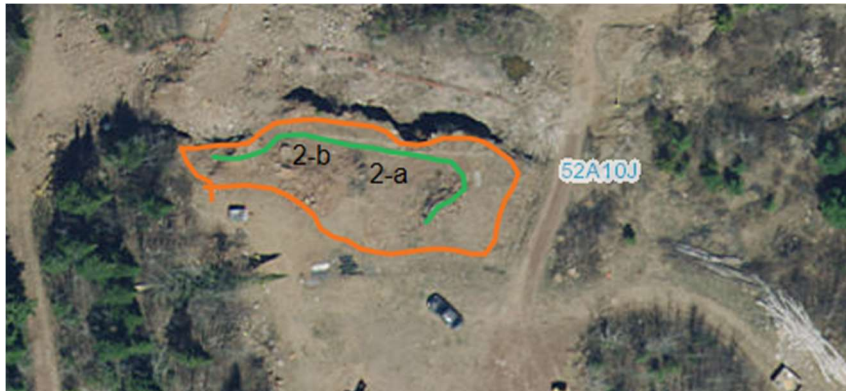
Prospecting

Green line= walking path

Noticed Vein exposed and did light grub hoeing prior to stripping.

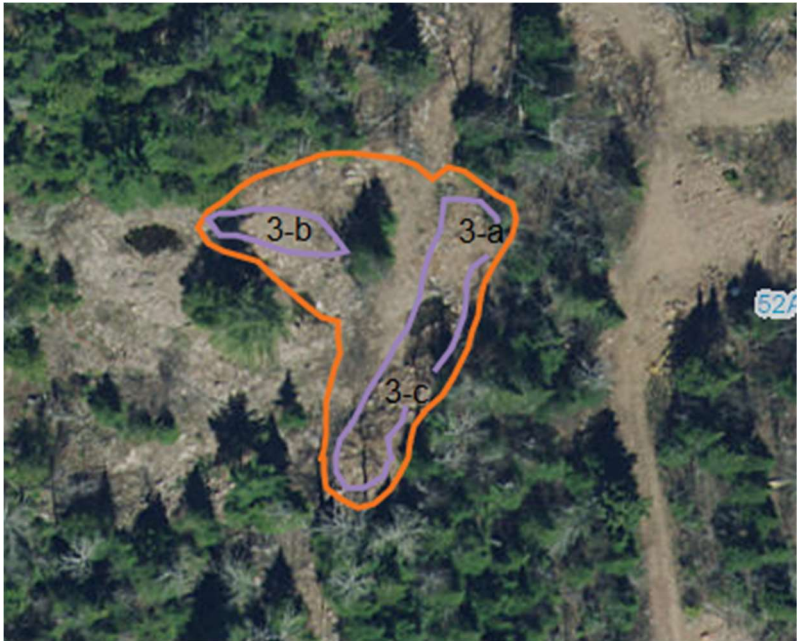
Area 3
Purple lines= Mechanically stripped area
3a=pit and trench
3b=pit and trench
3c=overburden

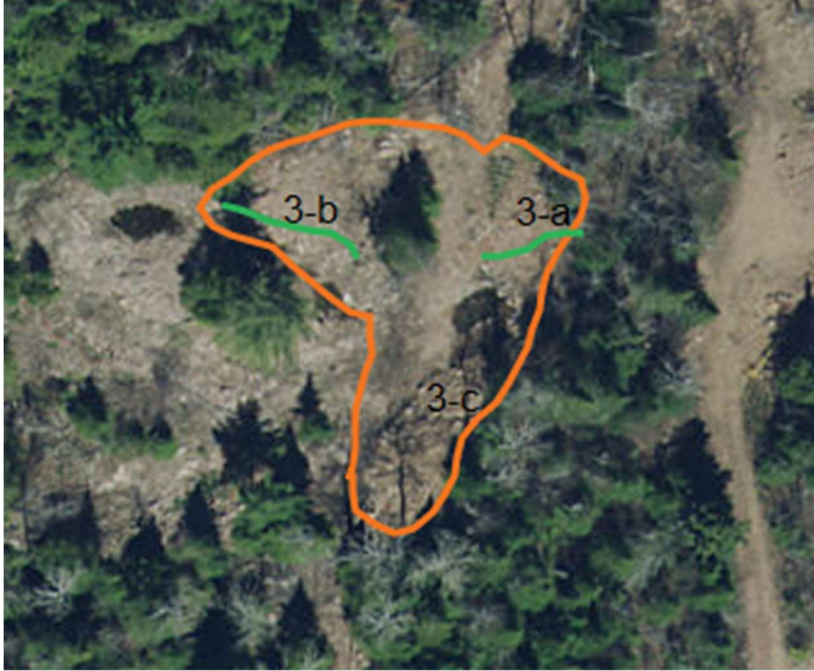
Area 3

Green line=prospecting walking path

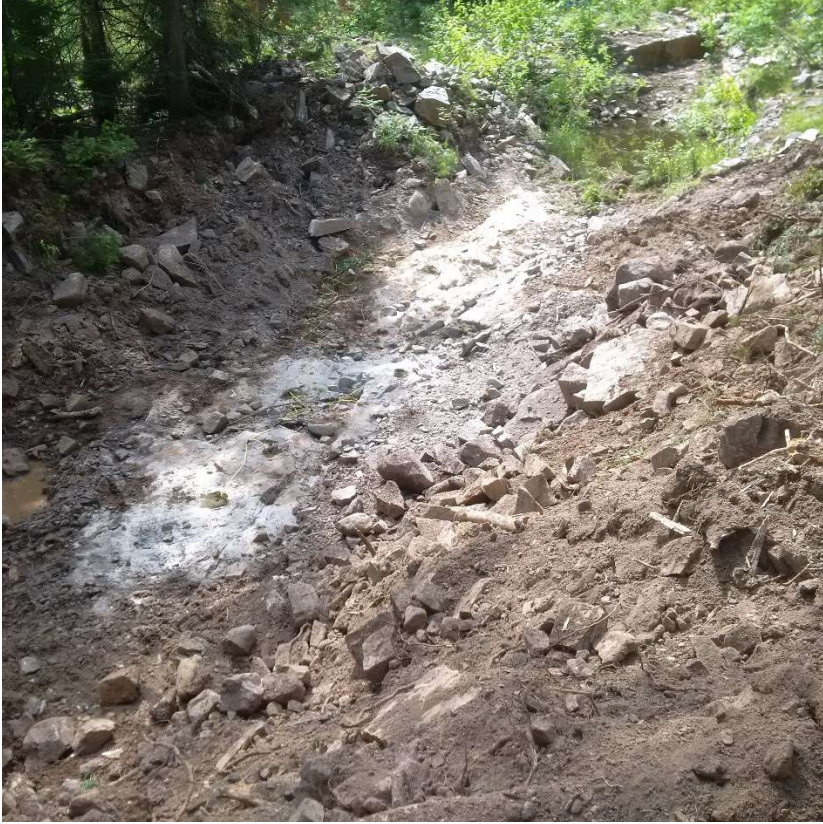
Area 3-b-Mechanical stripping partially complete.

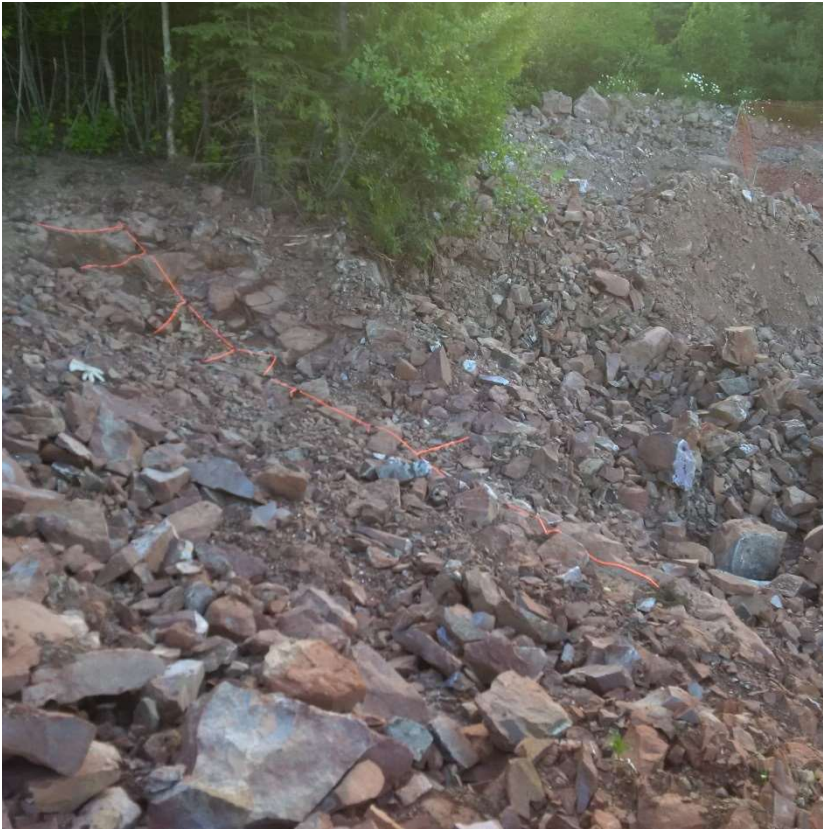
Area 1-b Ready to blast new trench

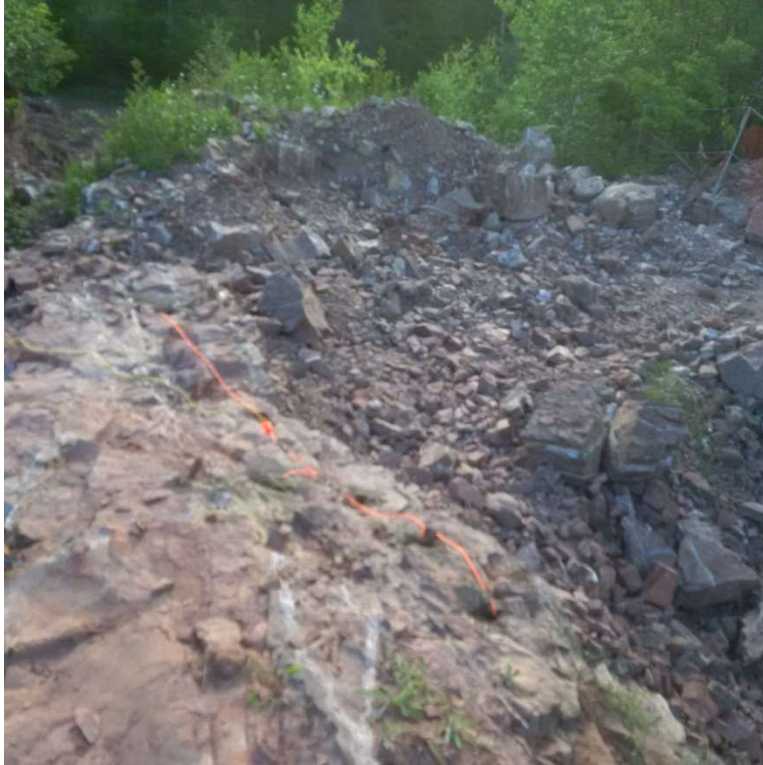
Area 2 End of the Quartz vein, opening the face to see if the vein runs deeper than the surface. Just on the n.w. of Area 2 b

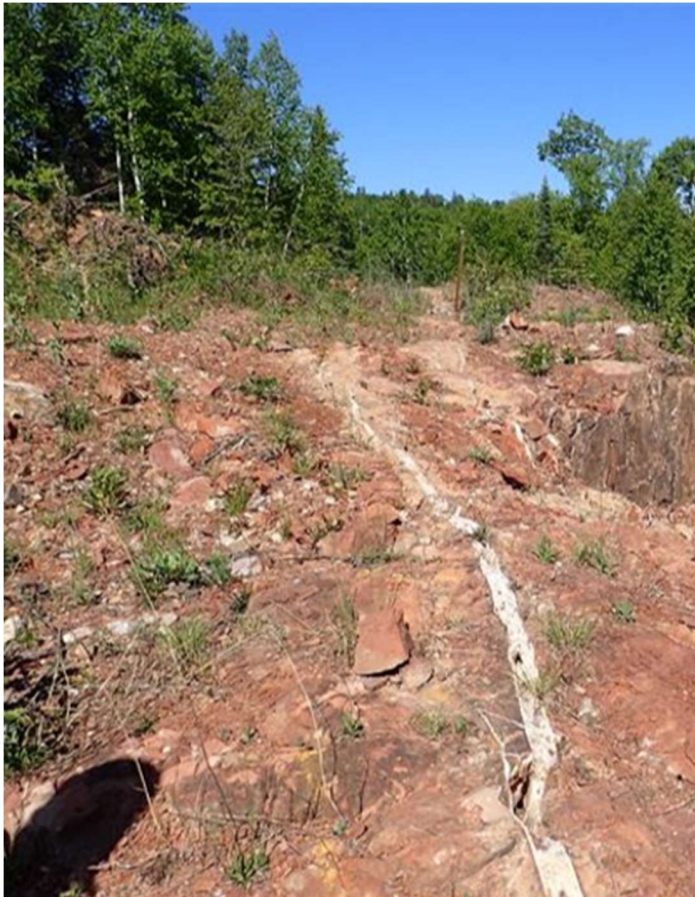
Area 2 vein half way thru Mechanical stripping, vein appears to have small vugs showing from surface.

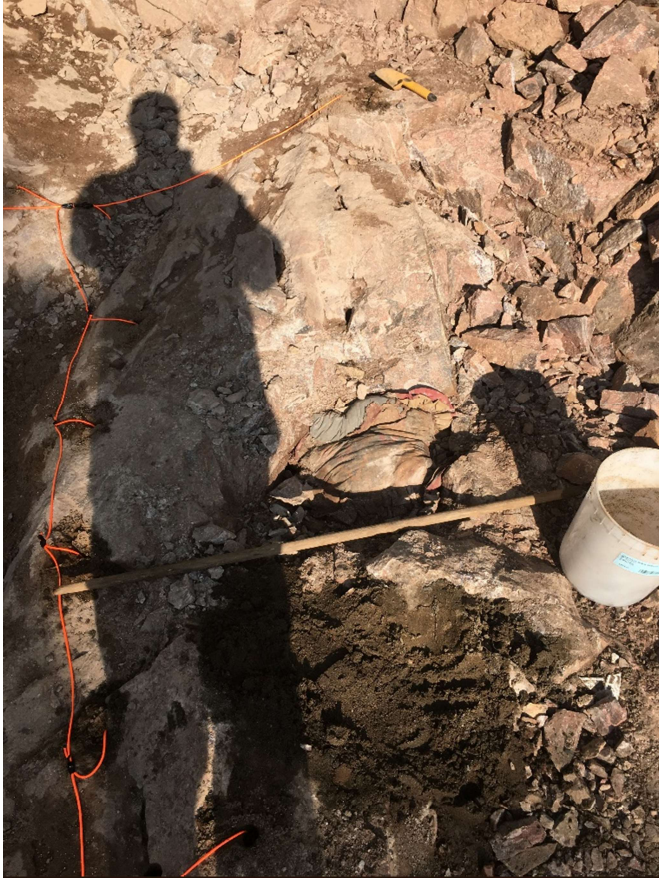
Area 3-a Opening up a pit/trench to see potential.

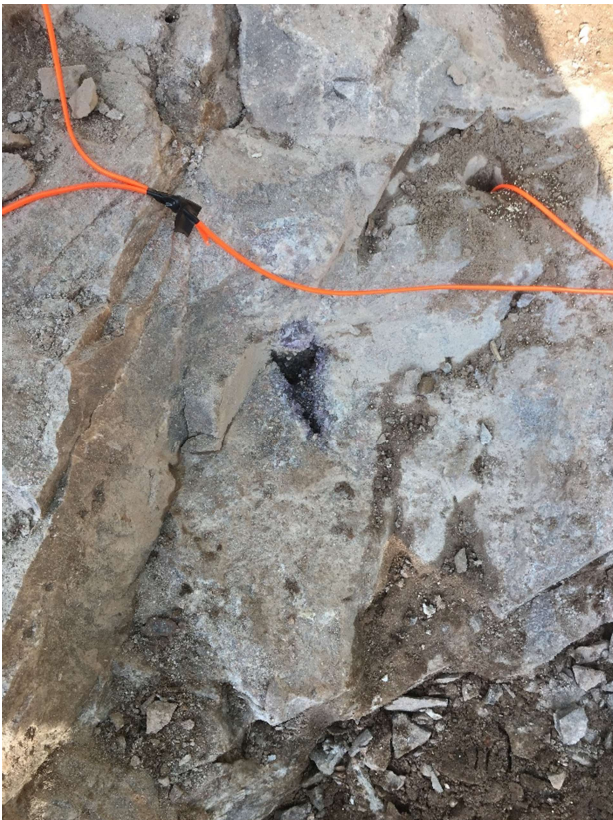
Area 3-a Notice the triangular opening in the middle of the picture, this ends up opening with the veining going in all direction, we call veinlets.

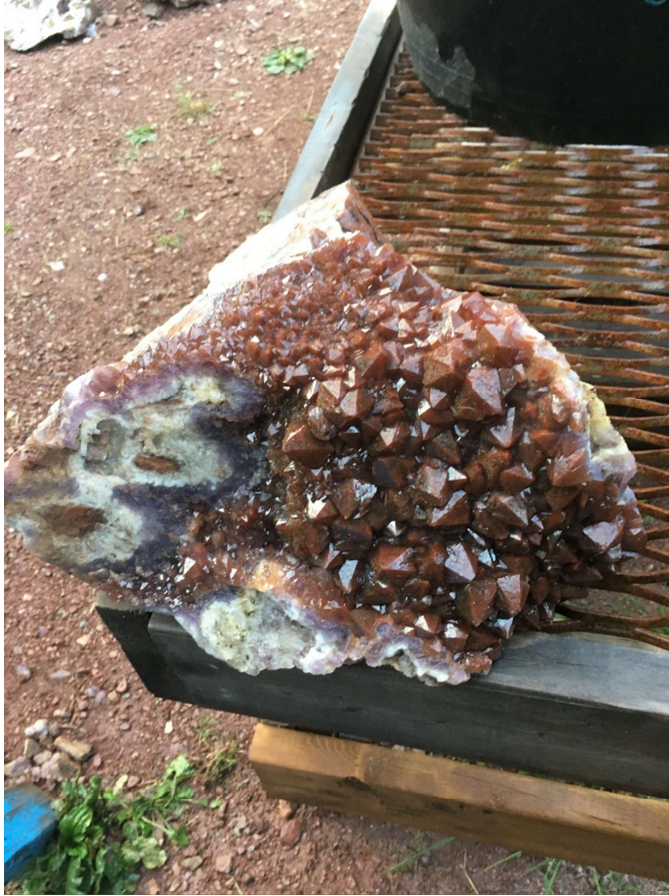
Area -3 a The result of a blast a vug (pocket opened up and we dug this out, a reddish brown colour.

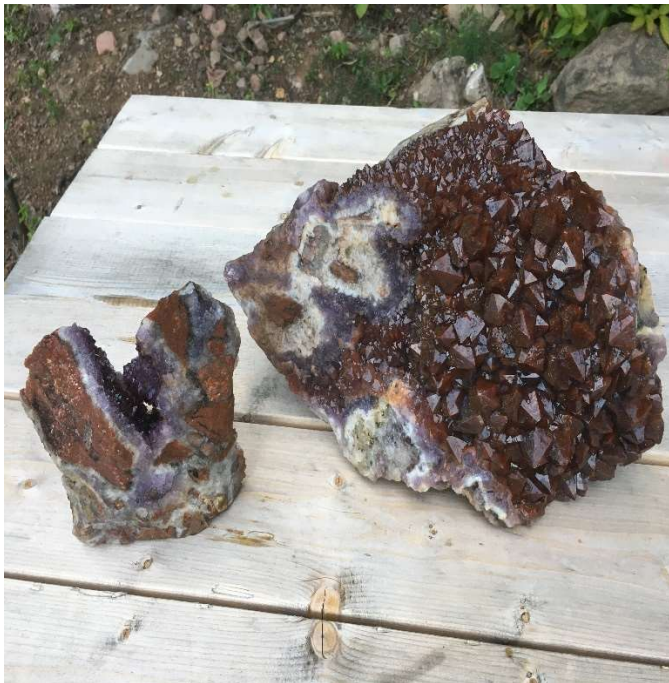
Area 3, same piece as in previous picture, a smaller piece beside it has nice purple crystals on this piece, these were right beside each other, area 3 is at a lower elevation than Area 1 and 2. In area 1 and 2 the host rock is mostly mudstone and conglomerate while area 3 has mostly granite.

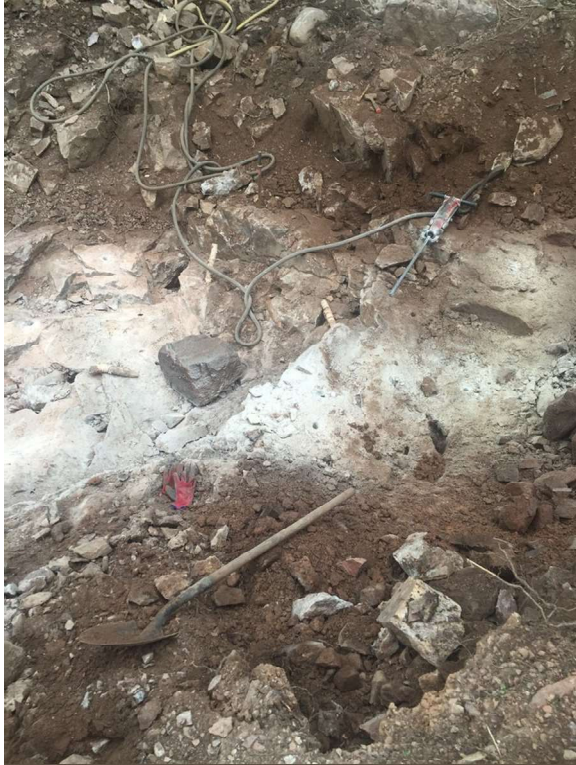
Area 3 a

Starting of Pitting and trenching

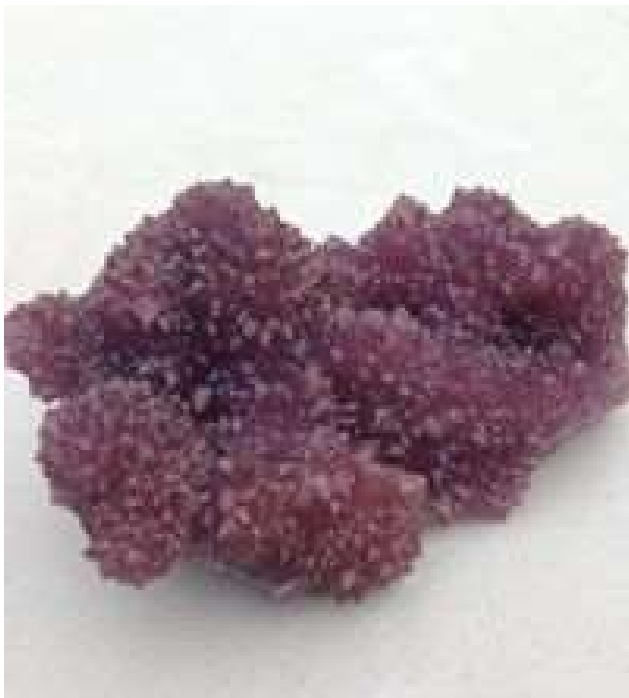
Area 1-b Specimen close to surface from trench.

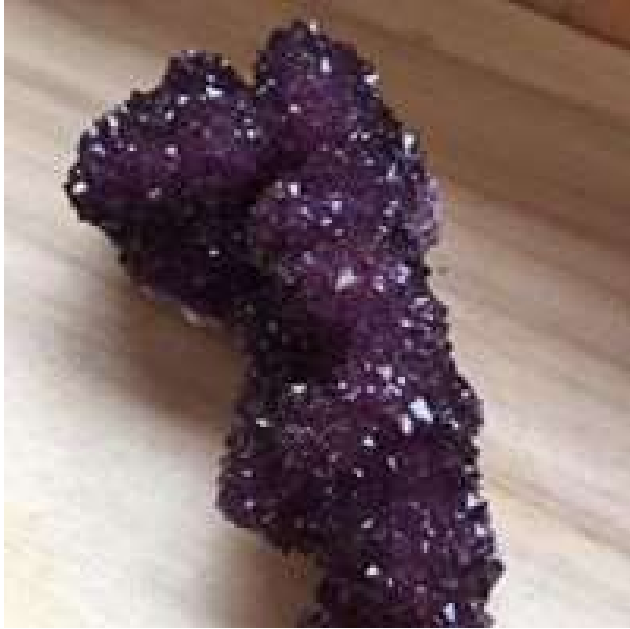
Area 1 b

Specimen from trench close to surface from trench.

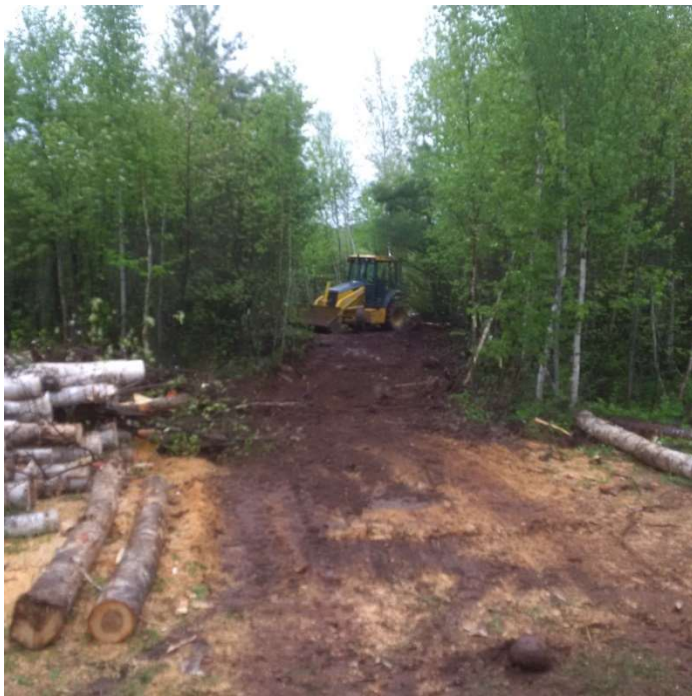
Area 1 a to b, Area starting to
Mechanical strip.

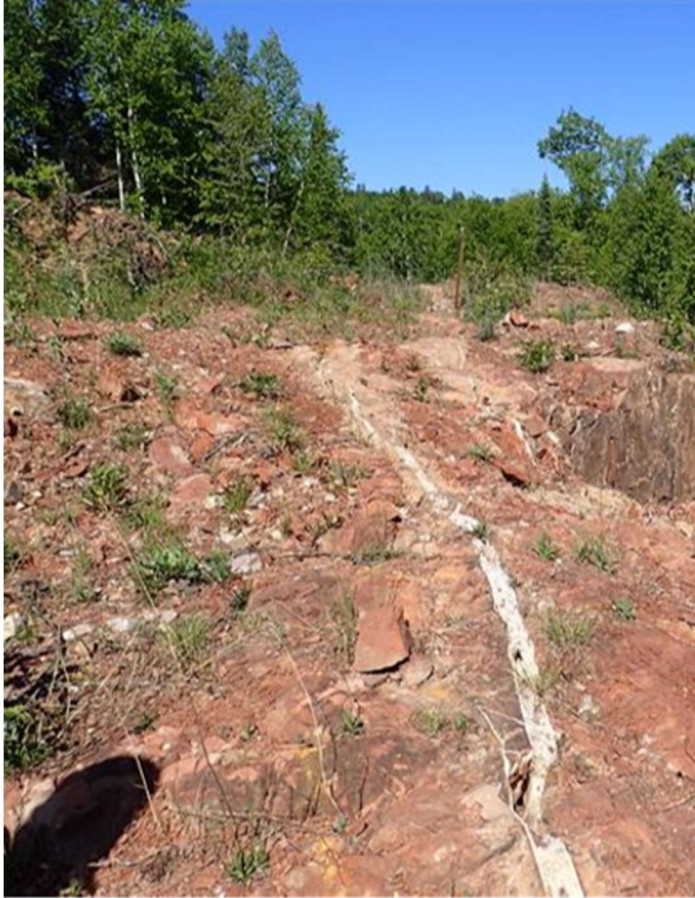
Area 2 vein half way thru Mechanical stripping, vein appears to have small vugs showing from surface. This vein is 2" to 4" wide.

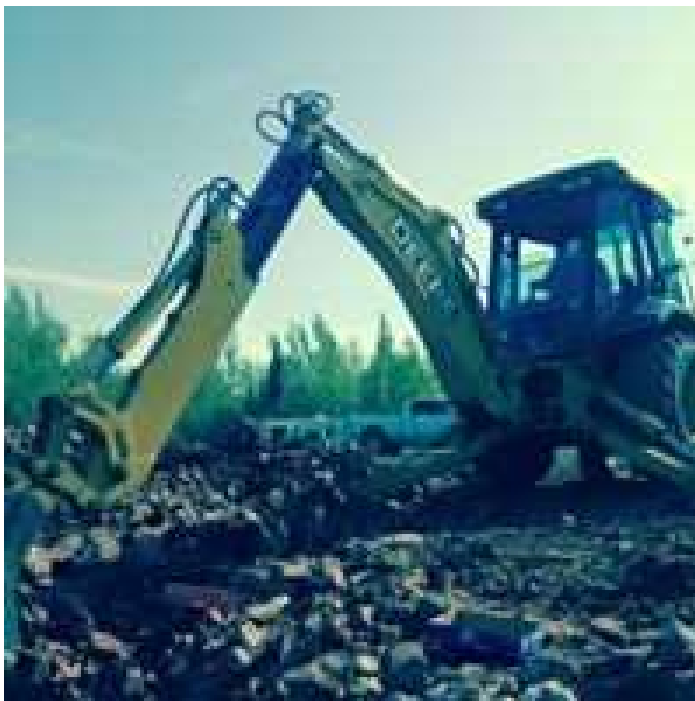
Area 2 a + b

Cleaning up blast.

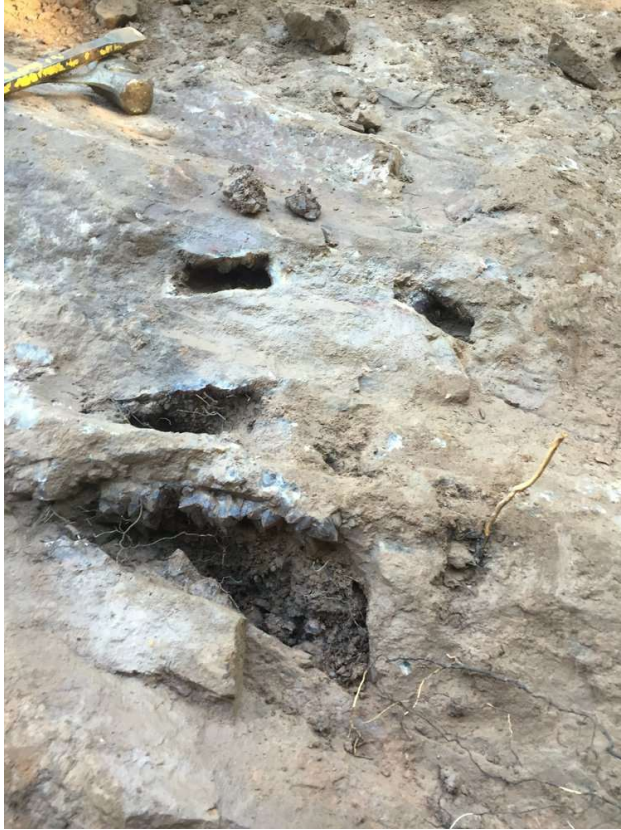
Area 3 a

Face like impression on bedrock, no real signs of normal veining. This is difficult to mine due to the abundance of amethyst everywhere below.

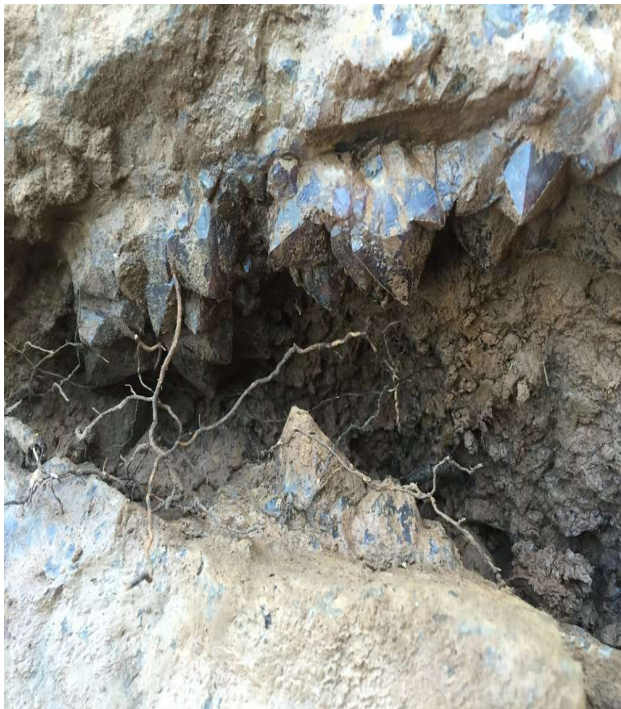
Area 3 a

Closer look, vug opening from the surface.

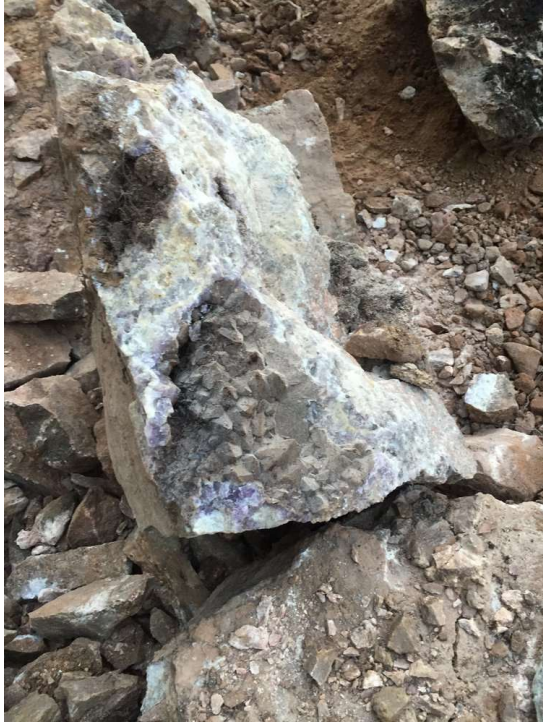
Area 3 a

Post blast look at piece, this trench does not seem normal, this may be due to veins running east and west as well as intersecting veins running at 55 degree thru this area.

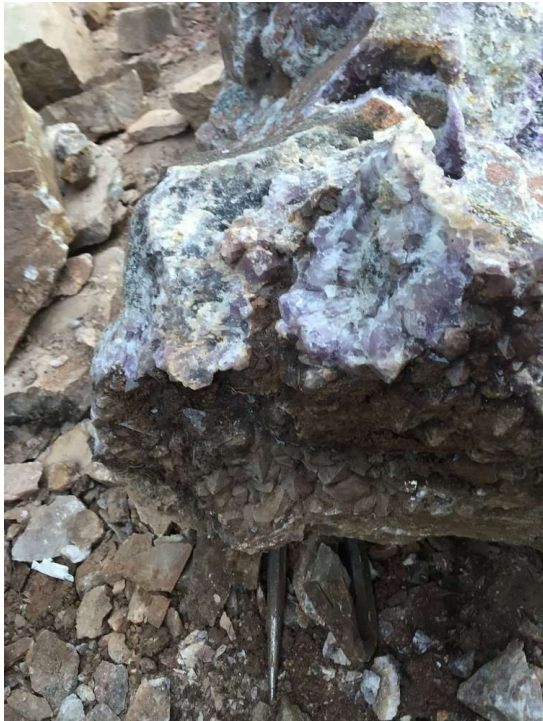
Area 3 a

Post blast look at piece, lots of granite piece, that cooled within the quartz(breccia)
