## 2016-2018 Assessment Work Report - Mitchell Noyes

### **Gunnard Project in McTavish Township, Thunder Bay District**

**Mining Claim #:** 252295, 216027, 214383

**Exploration Permit #:** PR-16-10934

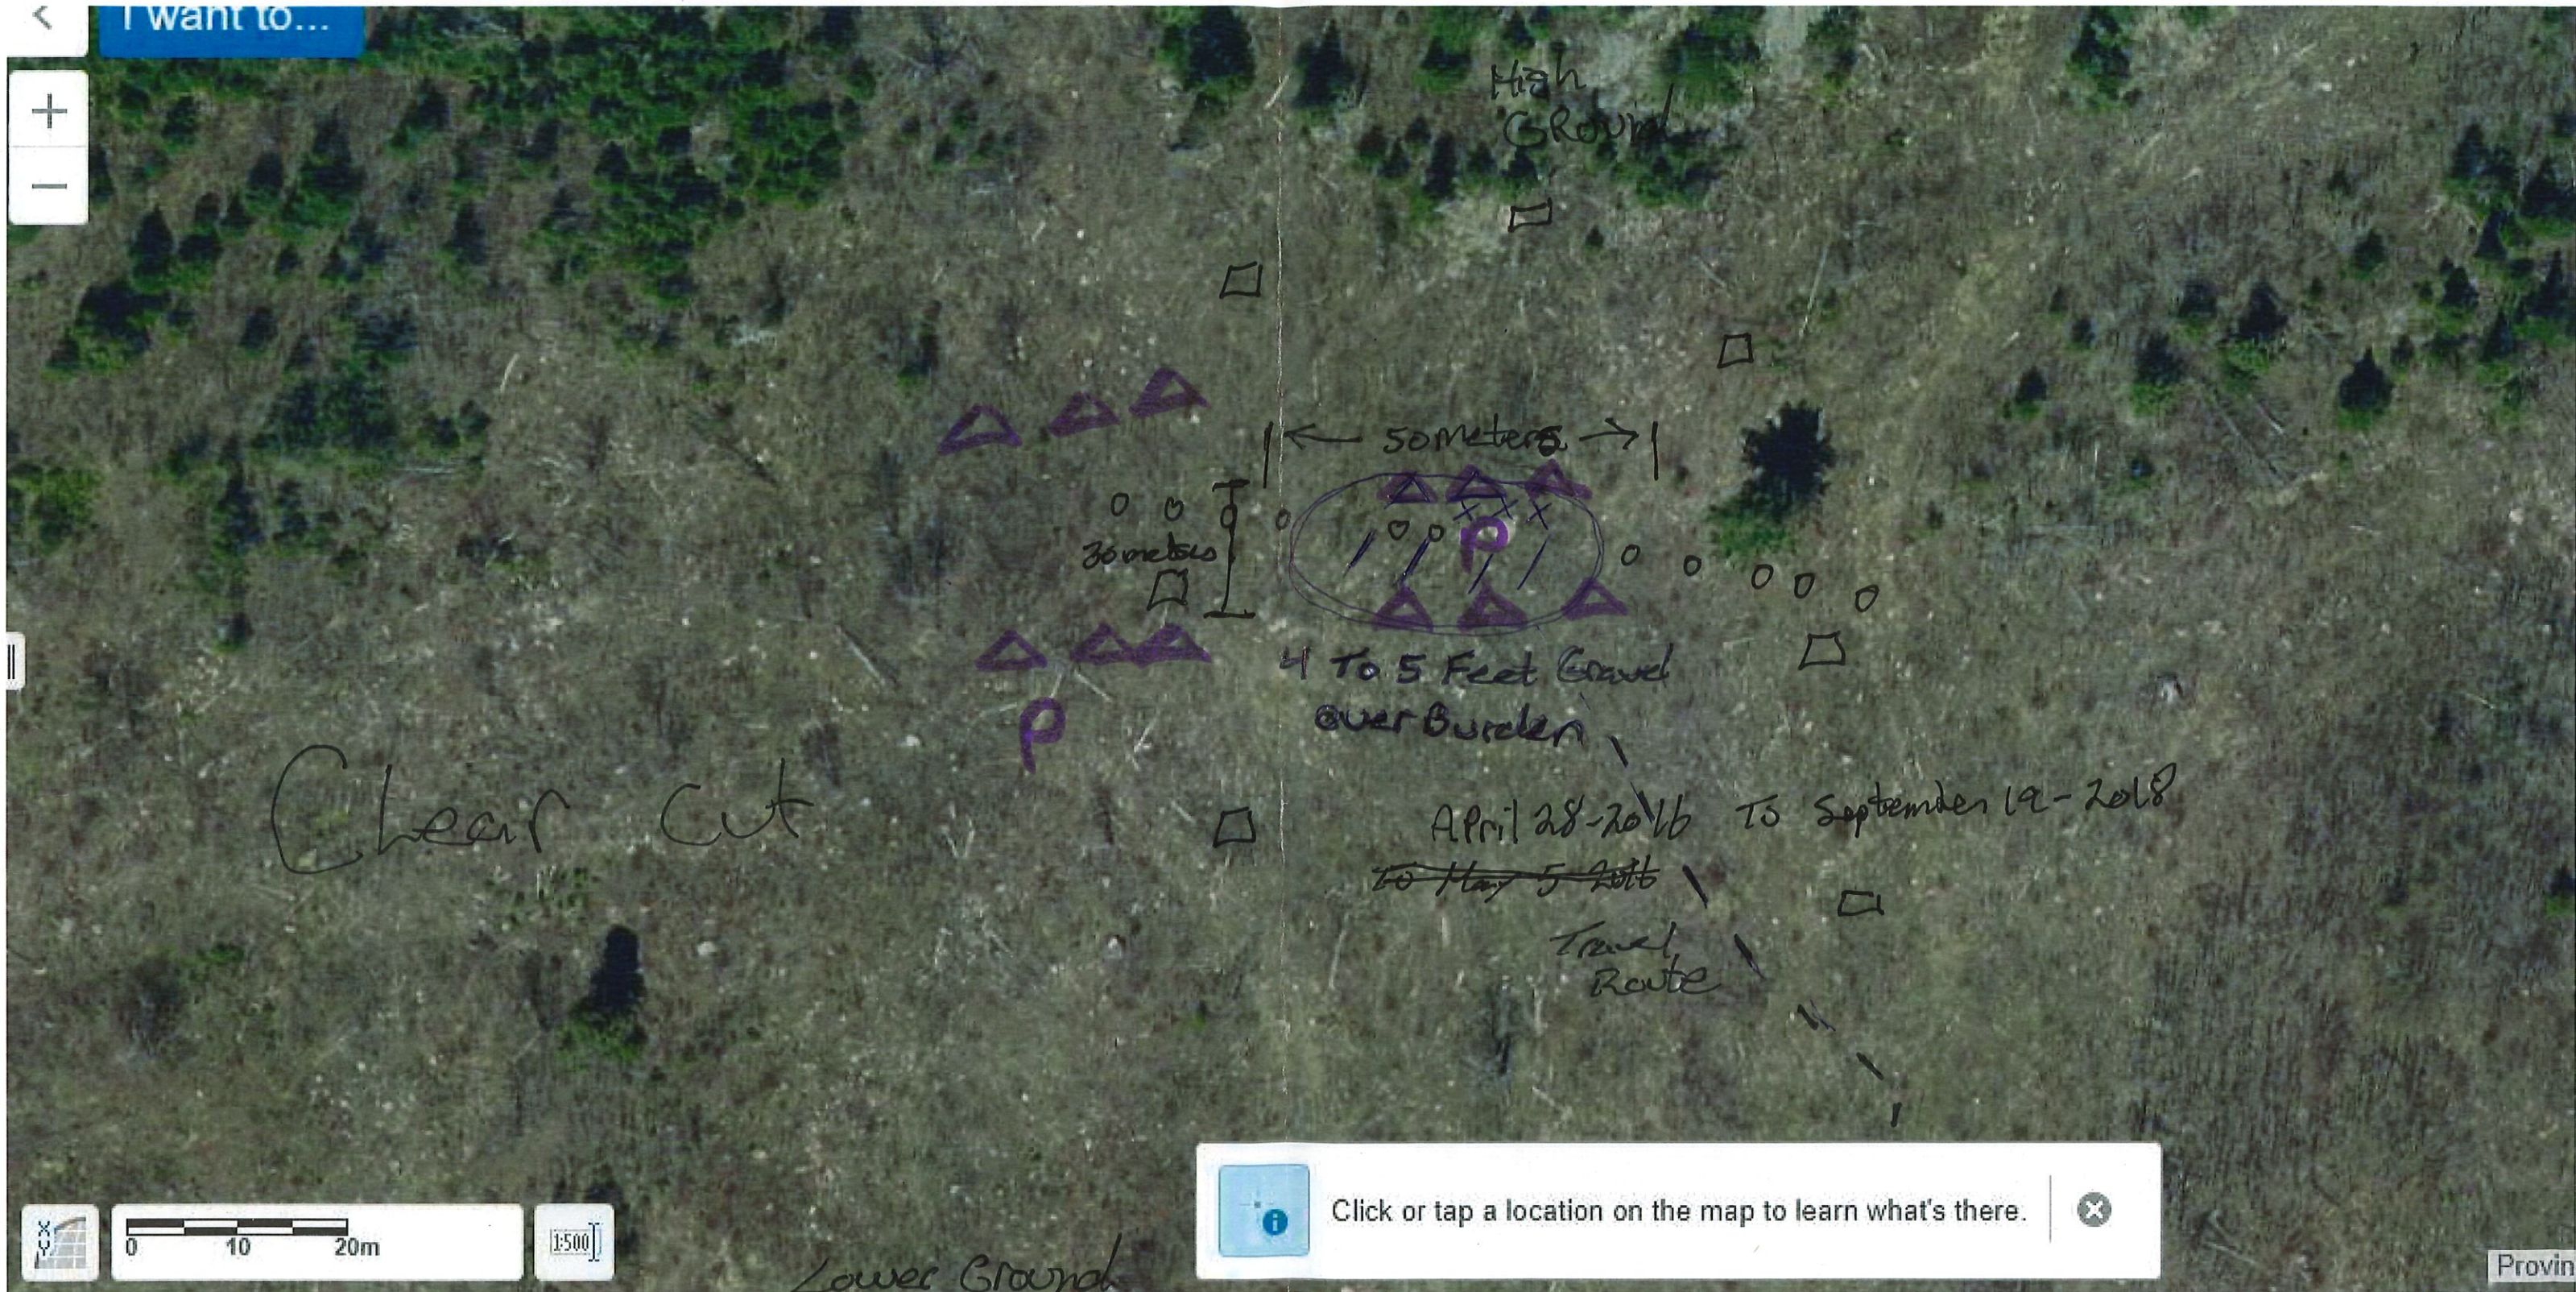
Map 2

As I have prospected the area for many years, my 2018 prospecting concentrated on the work area depicted on Map 1 with more detail on Map 2. The work dates are indicated on the left margin of Map 1. The work area was excavated in May of 2018 with manual work to collect amethyst specimens from the work area, see picture #2 below. Amethyst and white quartz veins were observed throughout the work area, see picture #3 below. In the centre of the work area a granite breccia containing light to dark purple amethyst was observed adjacent to the area of the quartz veins, see picture #4 below. Pale pink and red amethyst was also seen in this area. An overview picture of the work area is included as picture #5.

/// work Area stripped ○○○ vein Direction

□ □ prospect Area

April 28 To May 5 2016 Dates of Traverse  
AREA of photos TAKEN P

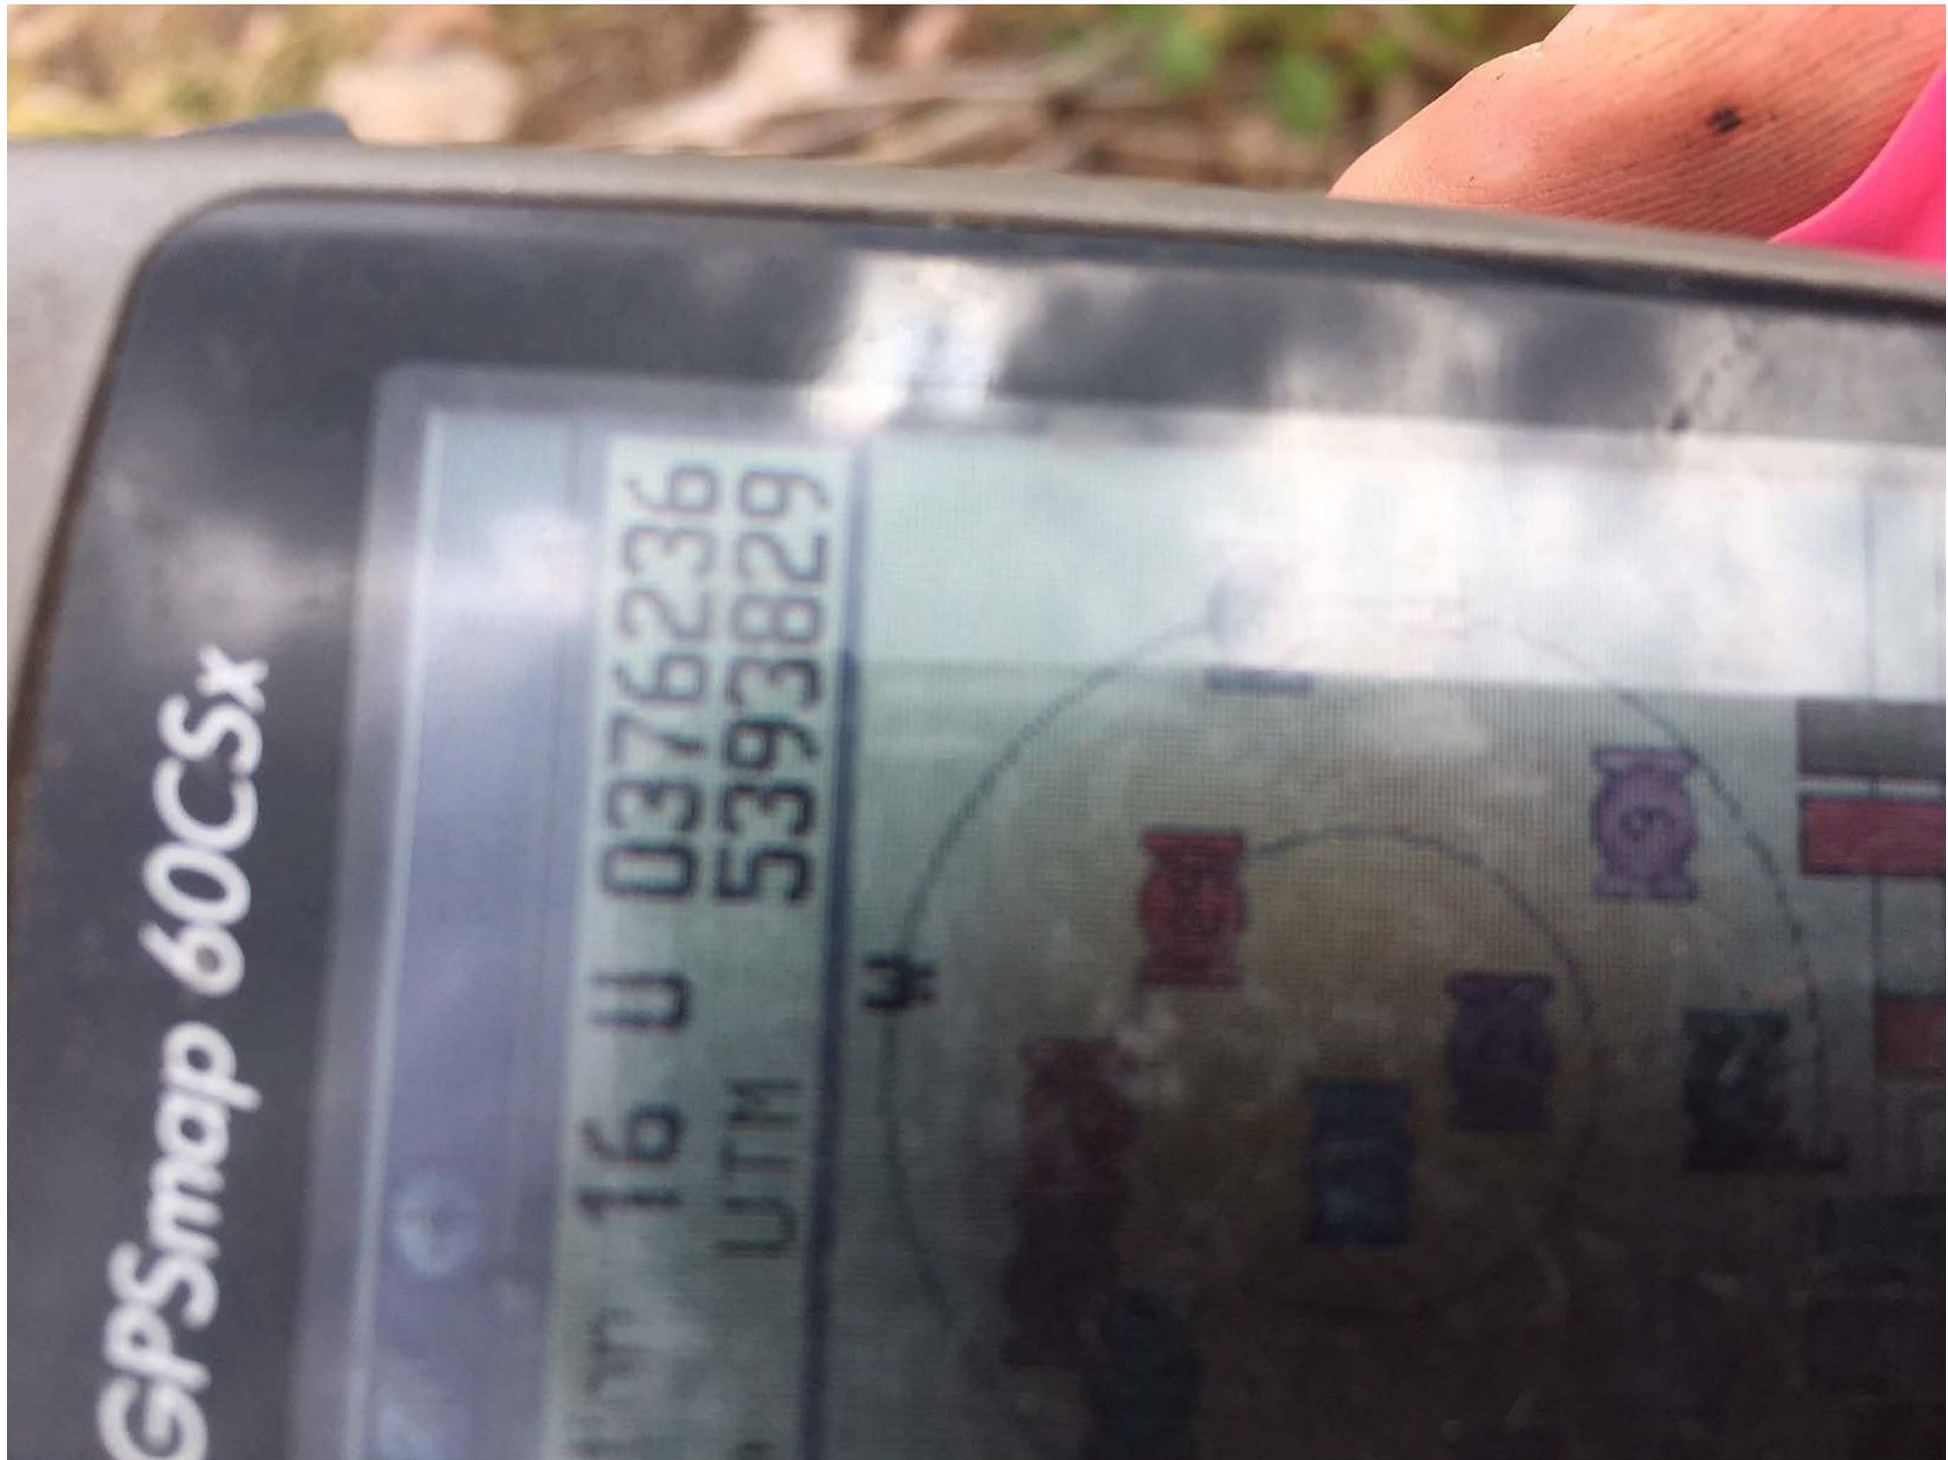
Picture #1 - GPS Coordinate for work area

The mining claim can be accessed from the nearest population center known as the small town of Pearl. Once turning off highway 17 onto Road 5 North travel about 200 meters crossing the railway tracks and just after that turn left onto what is called the Amethyst mine road. Travel for approximately 3km crossing a small bridge then just after that turns left onto a gated road that accesses the claim onto my private property. Once passing through the gate the road begins to get ruff and travel along the road for about 2 km where you will come to a right turn in the road that heads up onto higher ground to my work area. as you are getting closer you will be able to see the high granite outcrop where I have been working. When you reach the top you can look directly to the south and see Sword Lake down below. Coordinates of the work area are 16u 0376236 5393829, shown as a purple G on Map 1 included as Picture 1.
