Technical Report
For Reporting Assessment Work
On Claims 210008 and 312588

Whitney and Shaw Townships, Ontario
Porcupine Mining Division

April 15th, 2022
Hamilton, Ontario

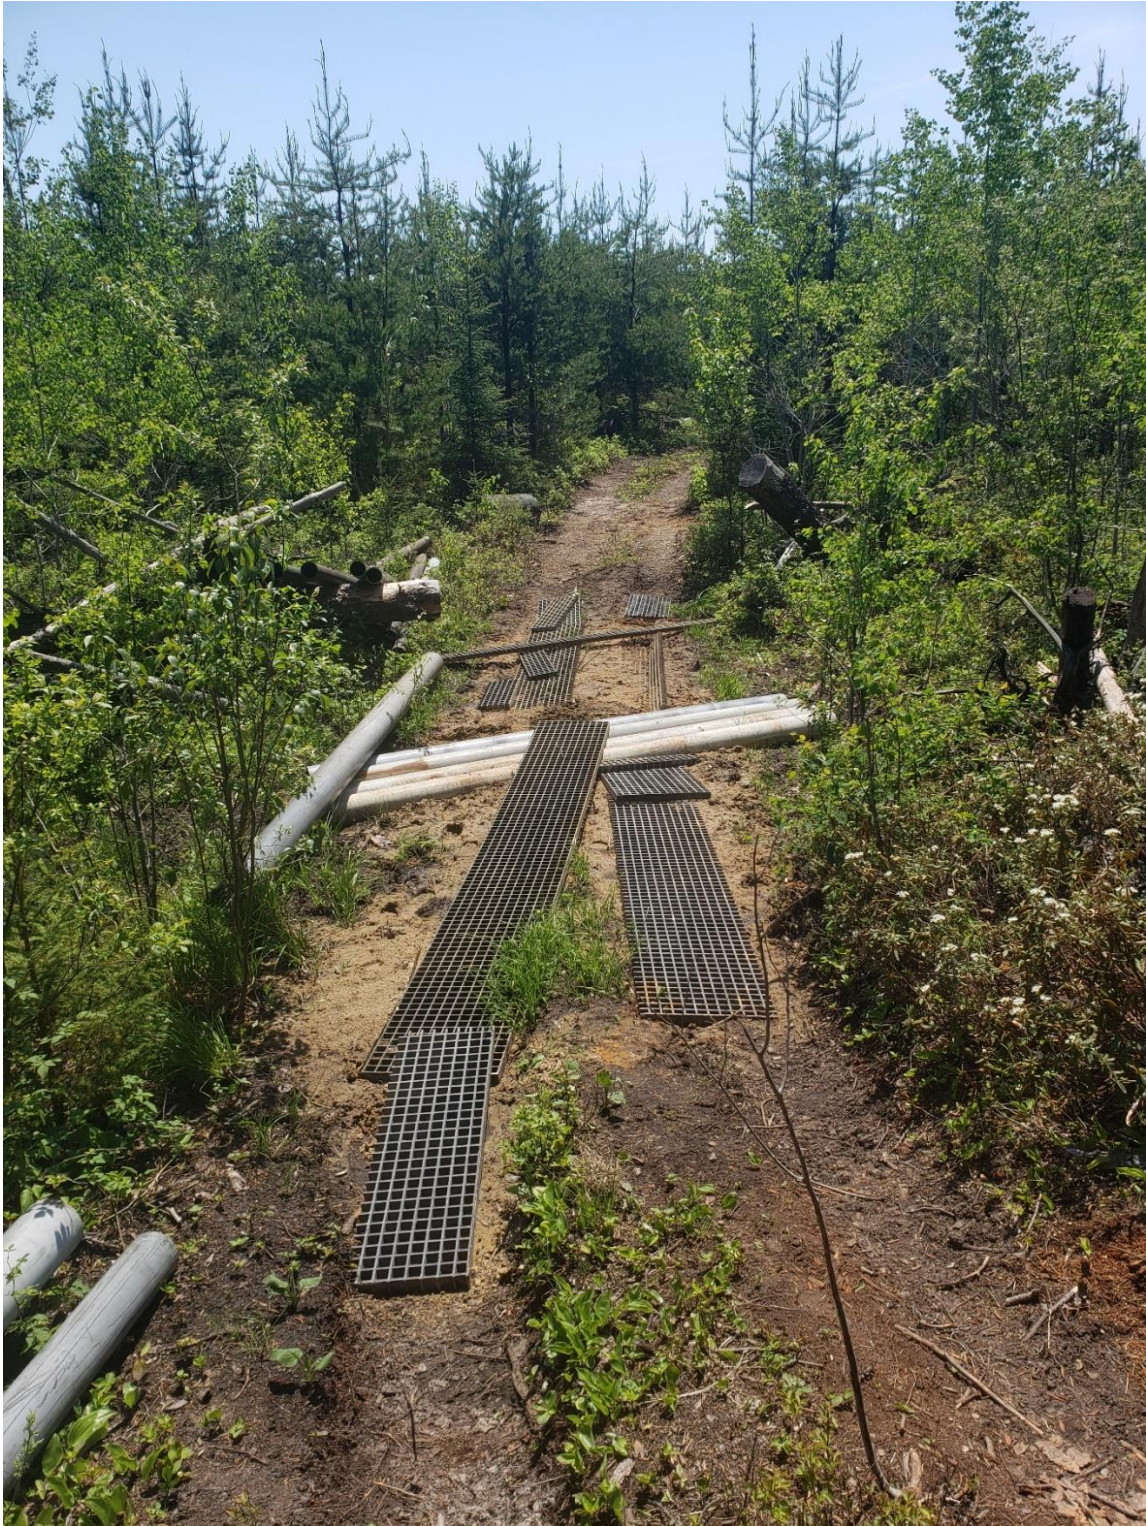
Figure 5. Shows initial site with fiberglass grating being initially and temporarily laid down to allow walking across the creek bed without sinking down.

- Fiberglass grating was initially laid across the creek bed to facilitate wading across the bottom soft muddy bed without sinking down (see figure 5). The pipes were then temporarily laid across the creek bed, longitudinally and in line with the natural flow of the creek, Westerly to Easterly flow, (see figure 6). The pipes were later removed to allow exposing the natural bottom of the creek bed (see figure 7).

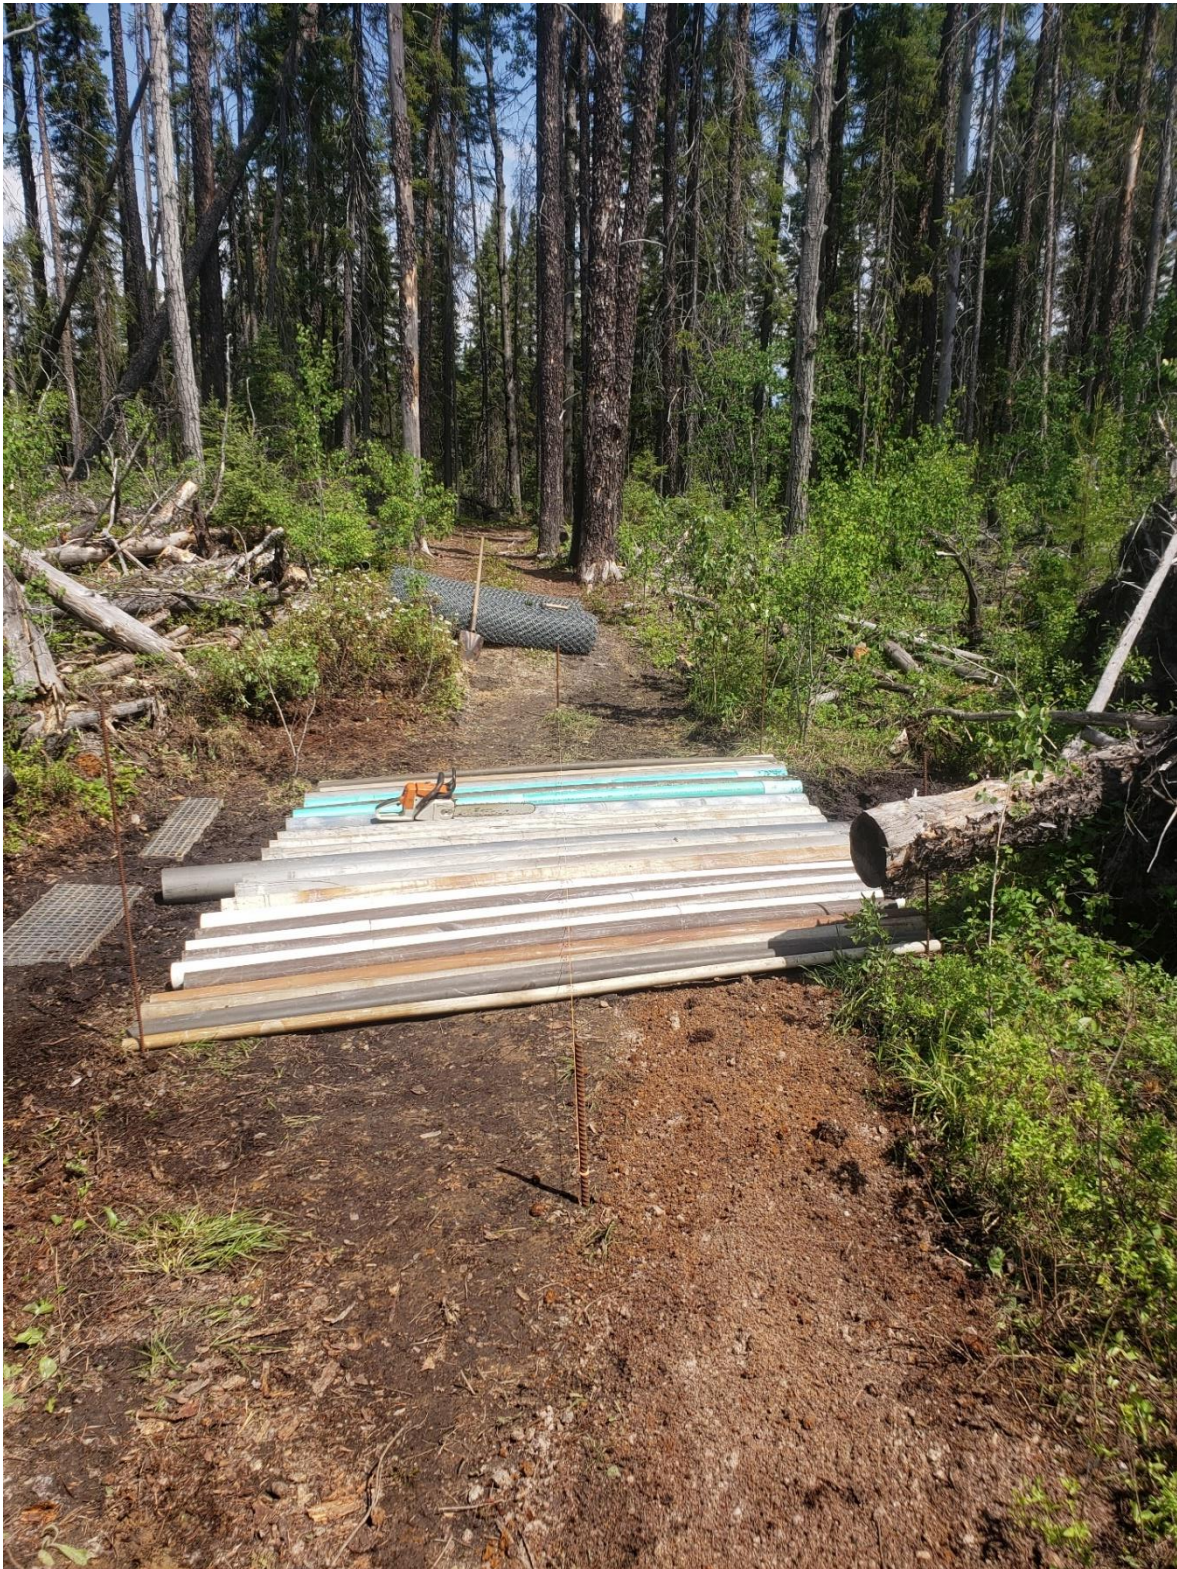
Figure 6. Shows initial and temporary laying of pipes longitudinally and in line with the natural flow of the creek (Westerly to Easterly flow). Pipes later removed to allow exposing the natural bottom of the creek bed.

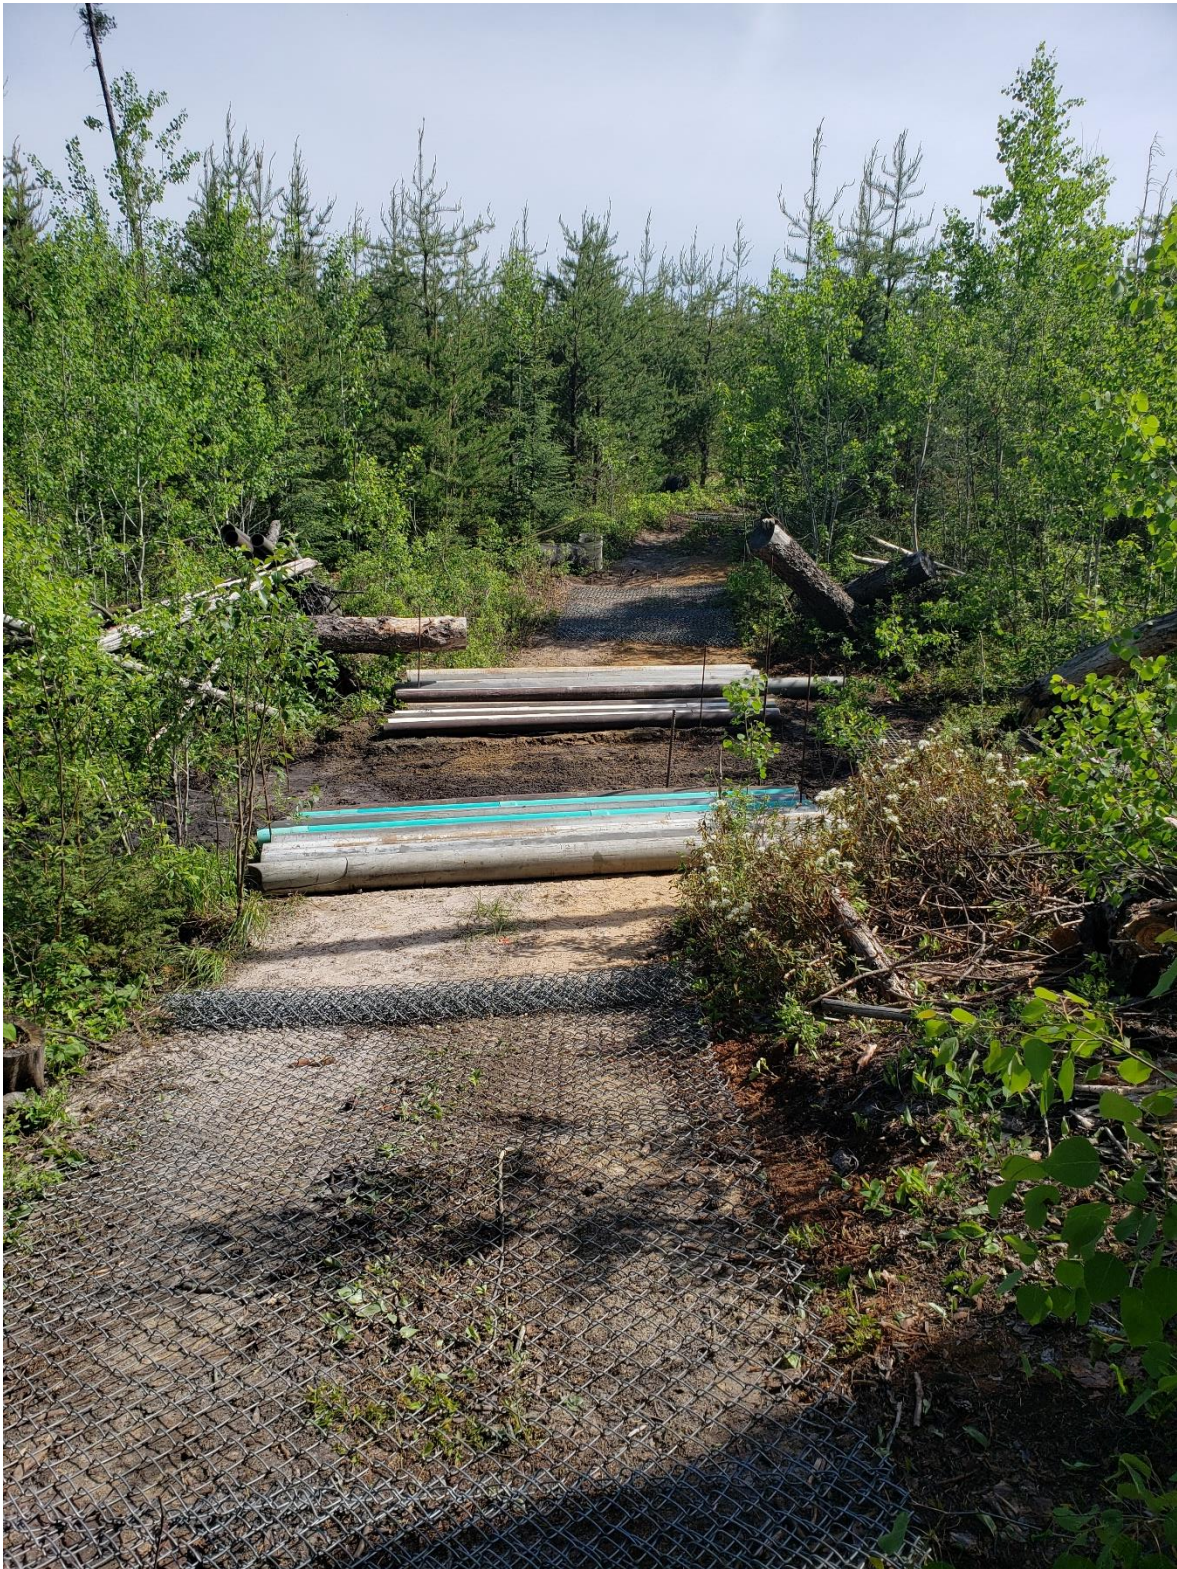
Figure 7. Shows some of pipes removed to allow exposing the bottom of the creek bed. Also shows the initial laying of the galvanized fence on both the North and South slopes of the creek to prevent erosion.

- The entire creek bed plus both North and South slopes were overlaid with a total of 4 large rolls of galvanized fencing to prevent the pipes from sinking down in the soft bottom of the creek bed and to prevent the North and South slopes from eroding. All this fencing was anchored down with rebar which was bent over in a “U Shape” (180 degrees on itself). The rebar was driven down 6 feet below with sledge hammers to really anchor the grating and the fencing securely to prevent being washed out by the creek during spring thaws or during times of heavy precipitations (See figures 7, 8, 9, 10, 11 and 12)

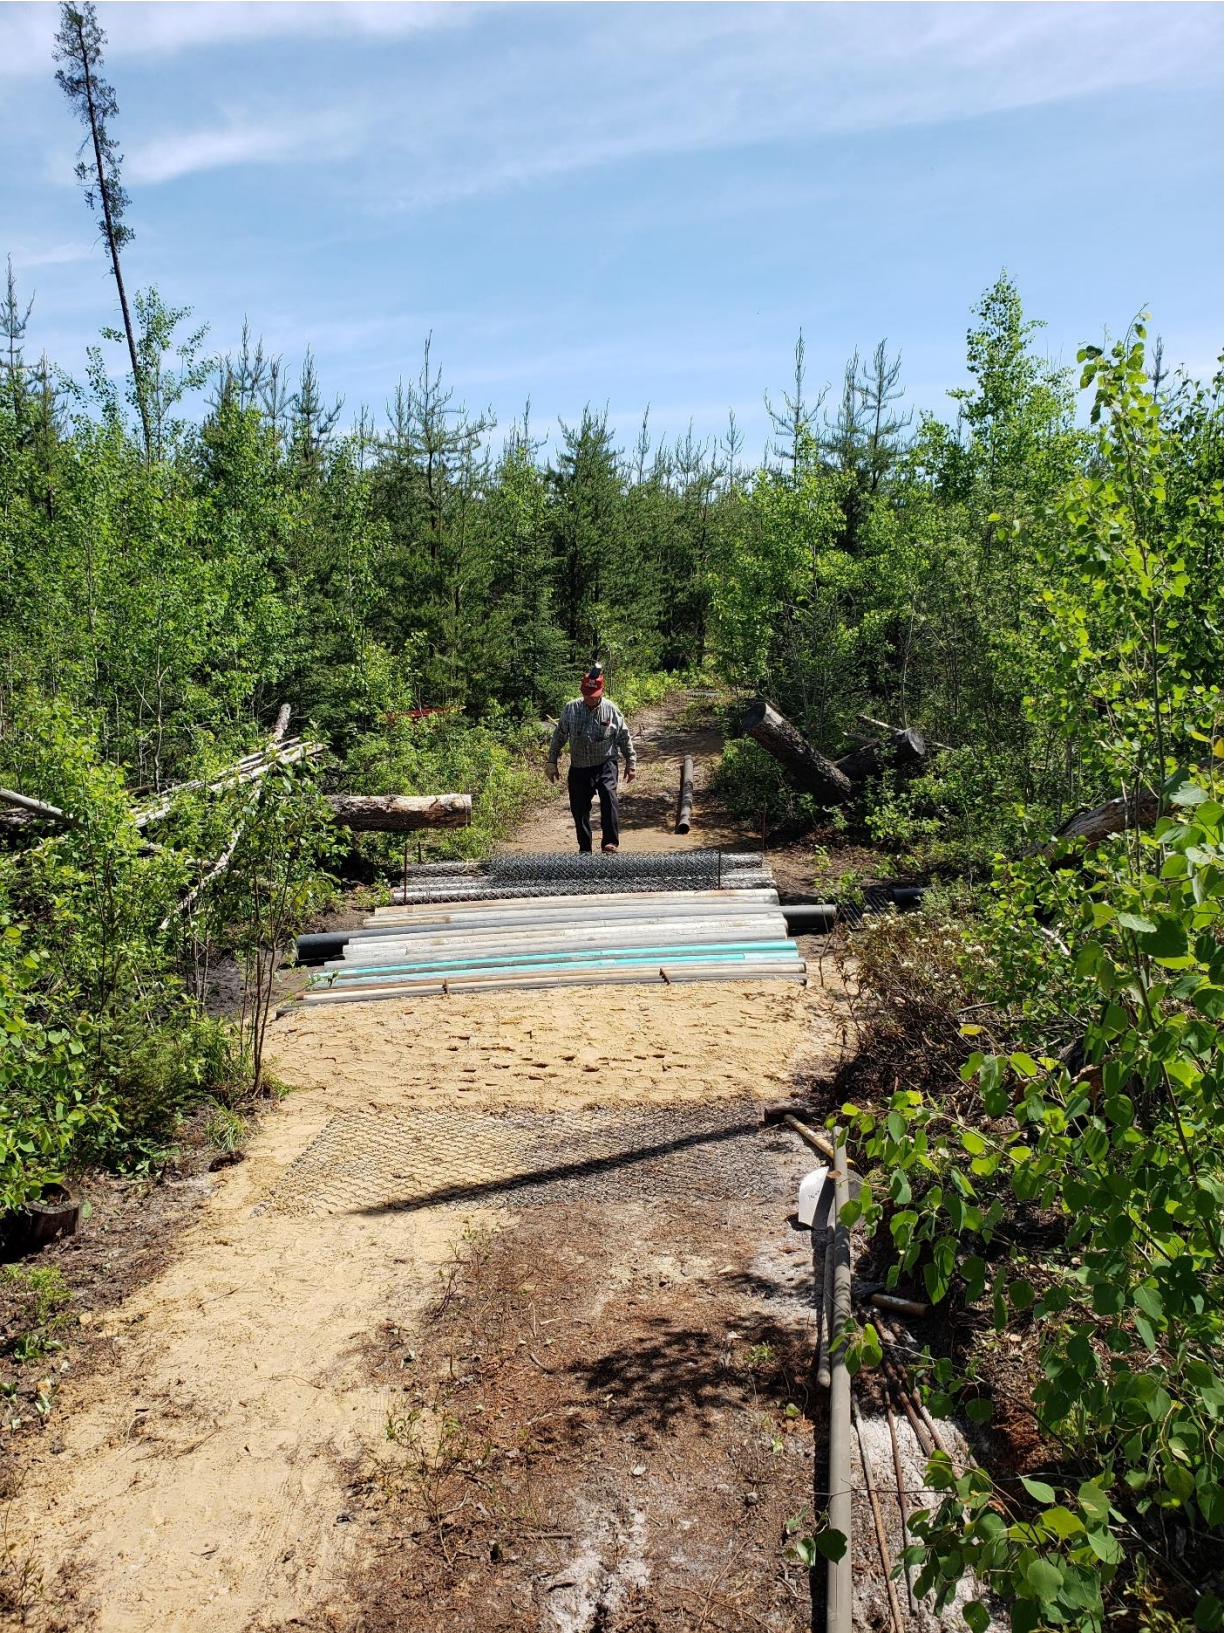
Figure 8. Shows the continued laying of the galvanized fence across the bed and slopes.

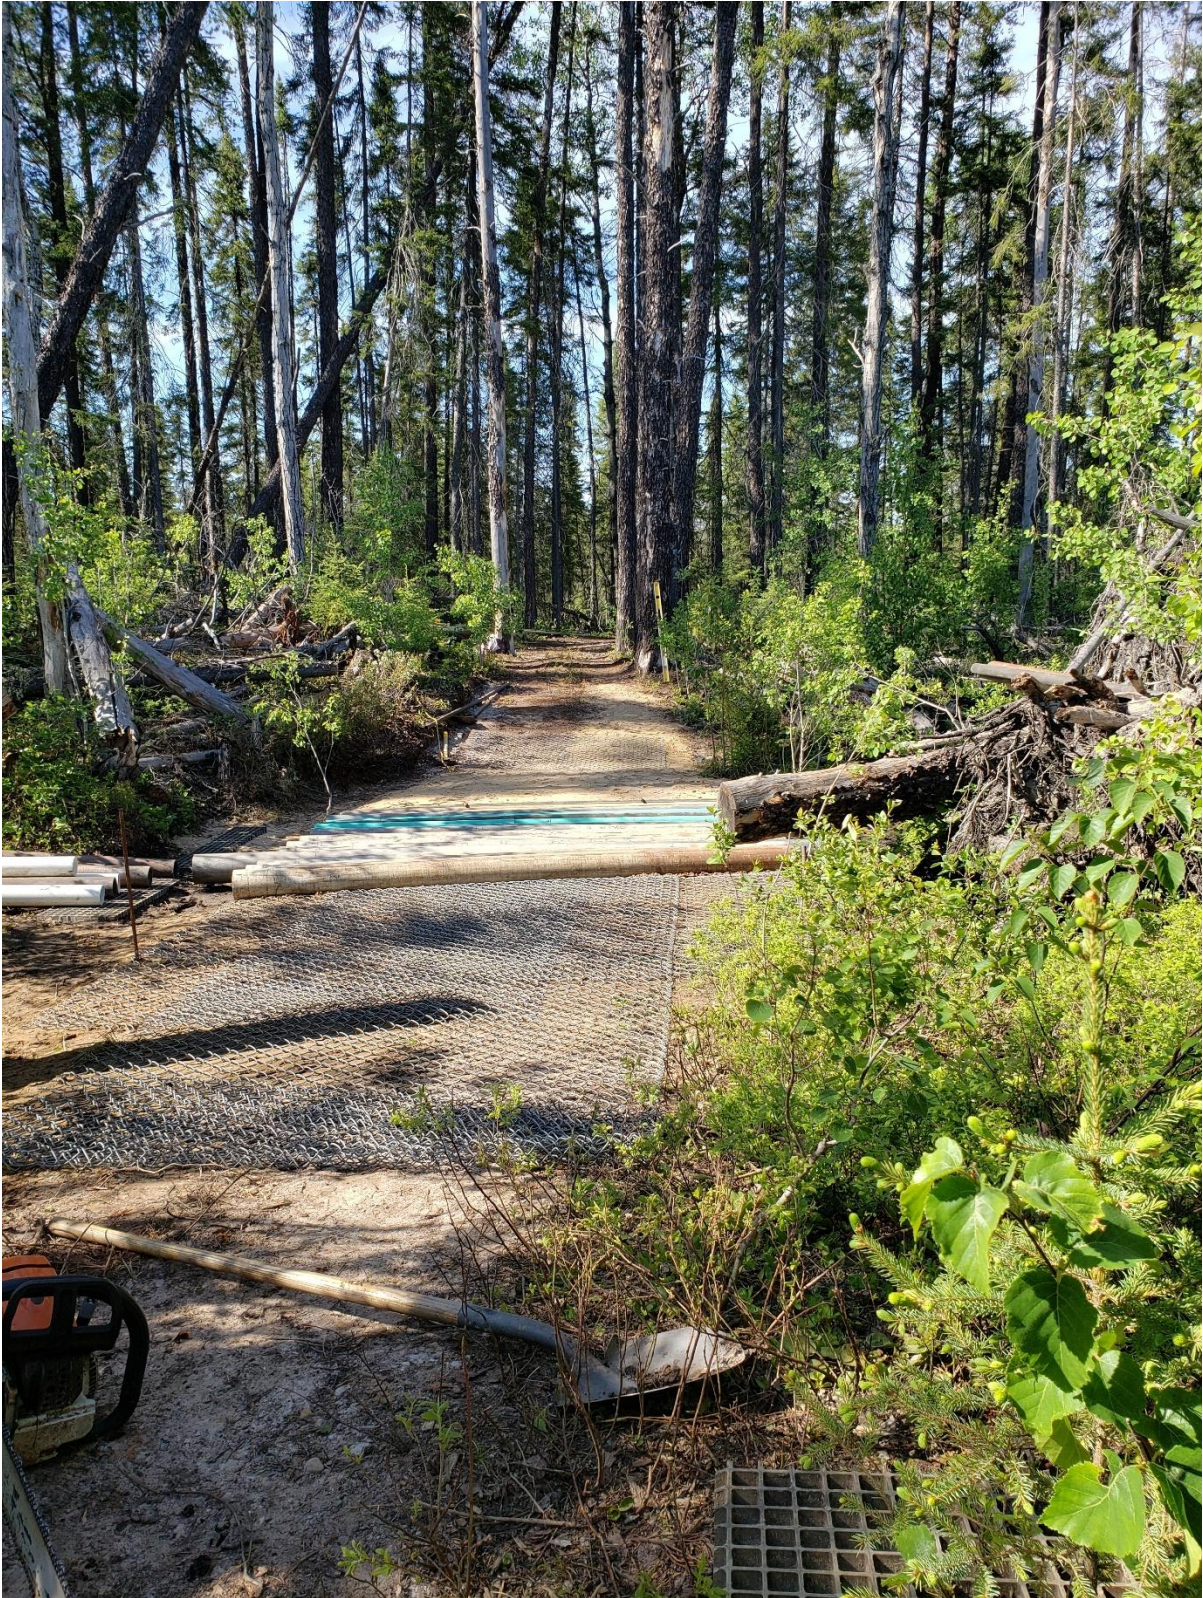
Figure 9. Shows the continued laying of the galvanized fence across the bed and slopes.

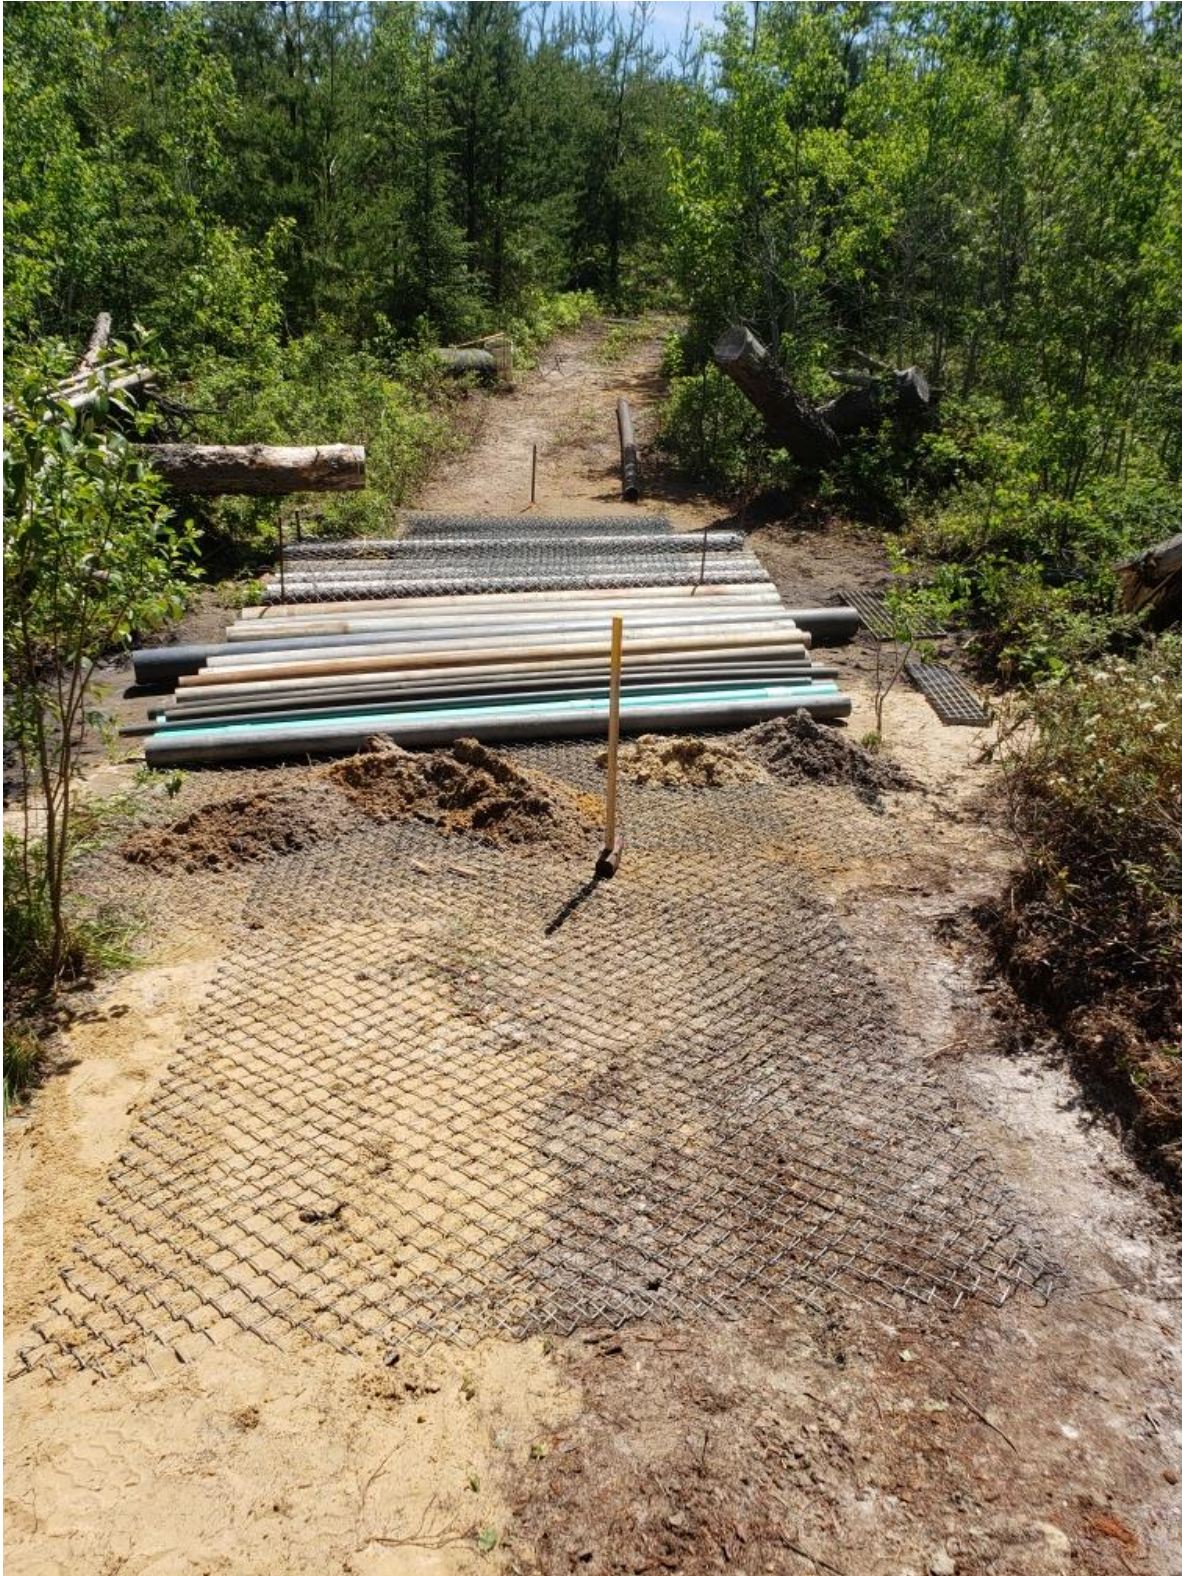
Figure 10. Shows the continued laying of the galvanized fence across the bed and slopes. Sand from a nearby sand pit was continuously added to the approach slopes.

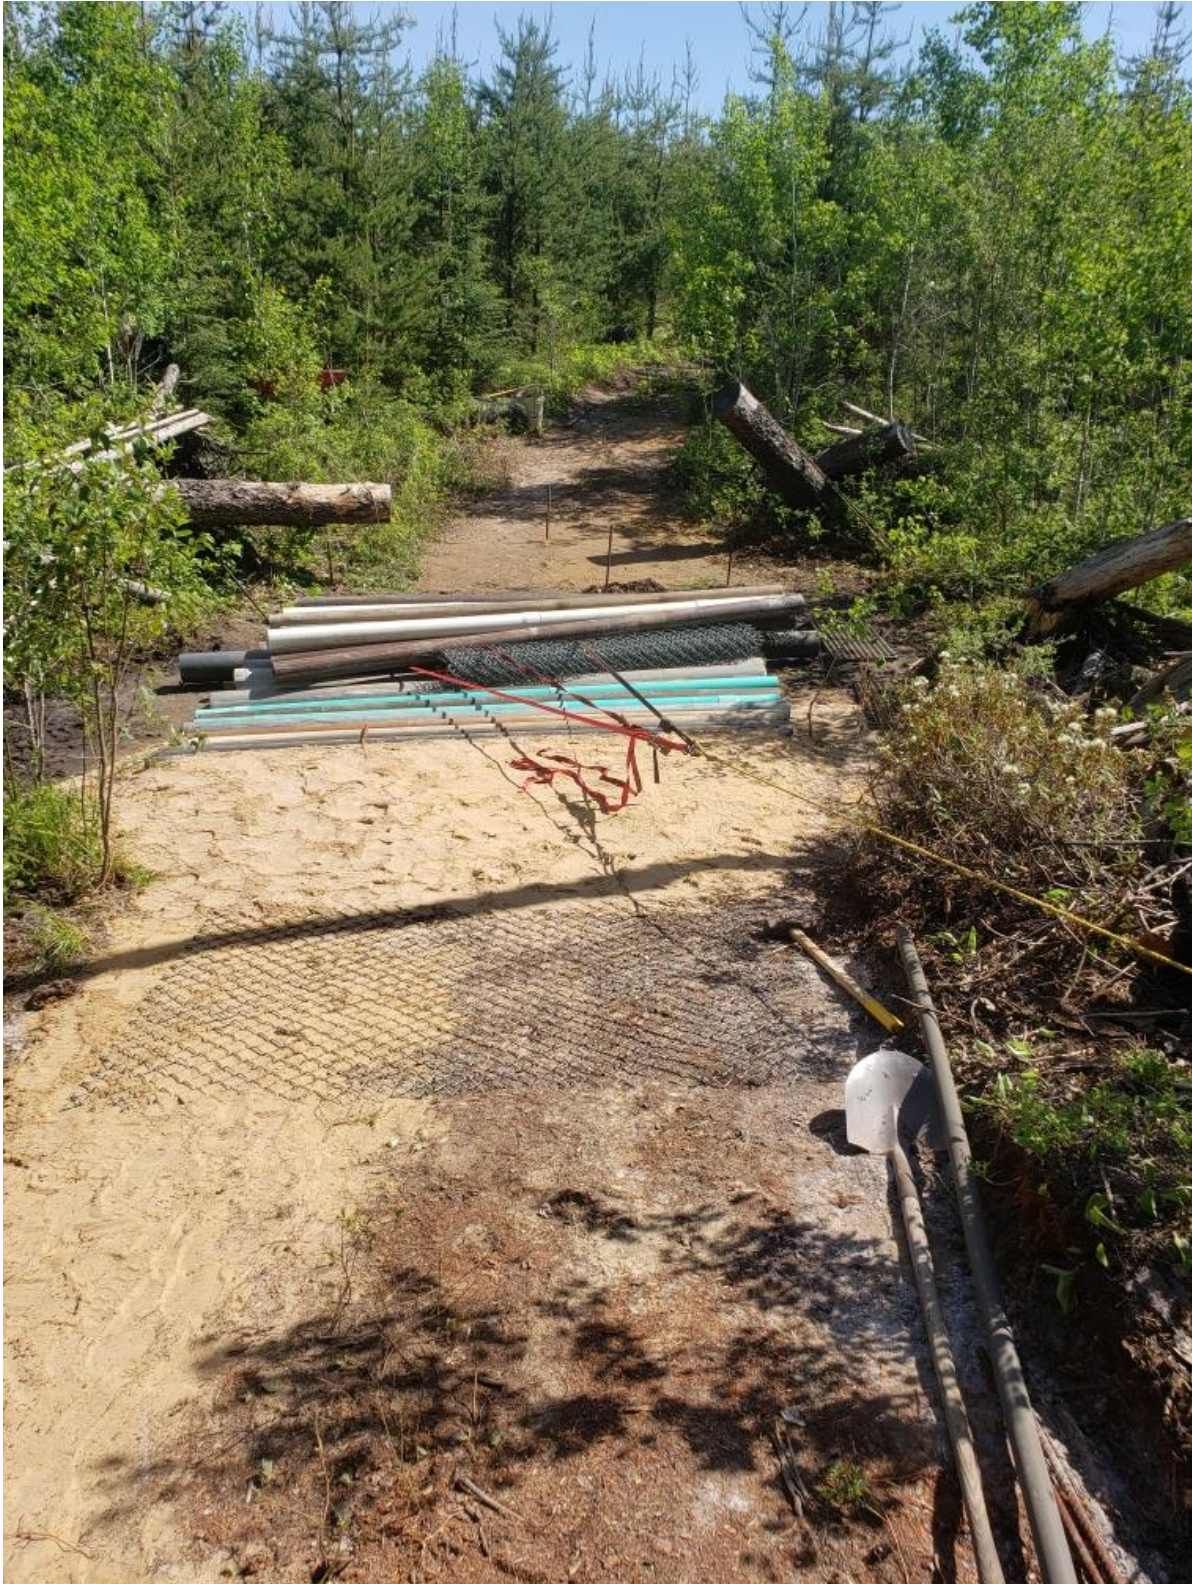
Figure 11. Shows the galvanized fence being pulled taught under the PVC pipes via a come-a-long and slings.

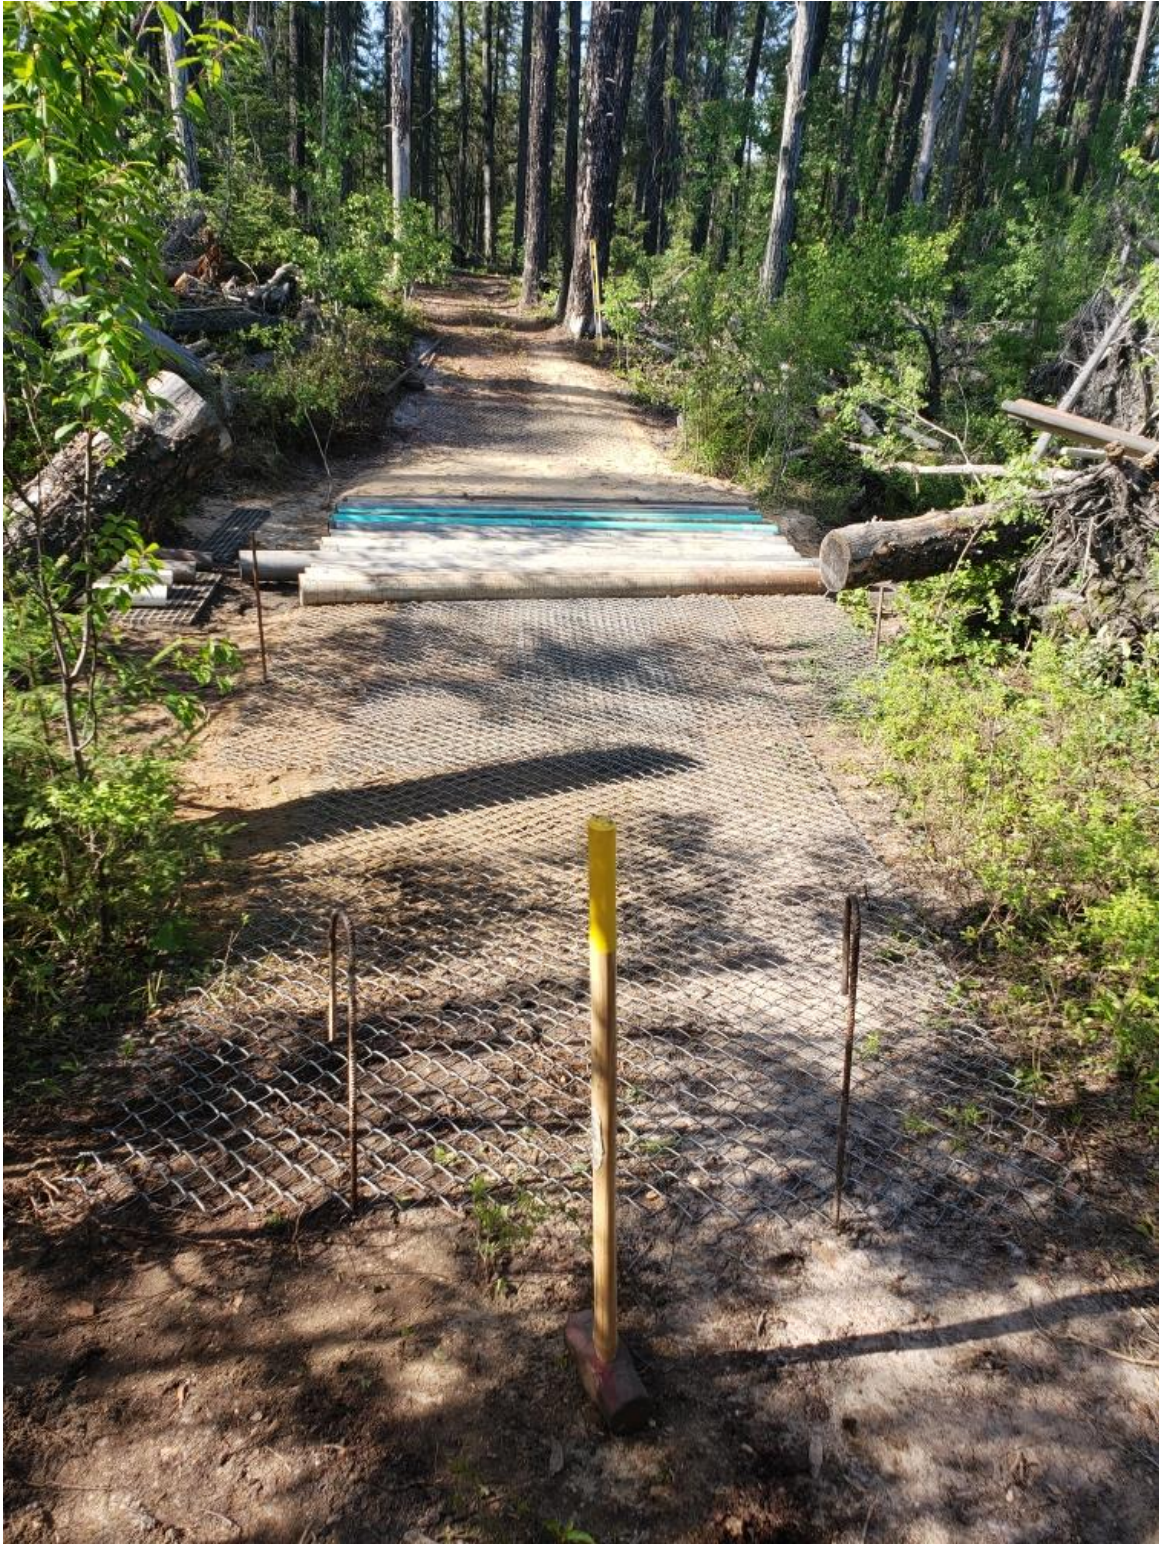
Figure 12. Shows the galvanized fence being secured down with 6' lengths of ½ inch rebar (already down 4' in picture).

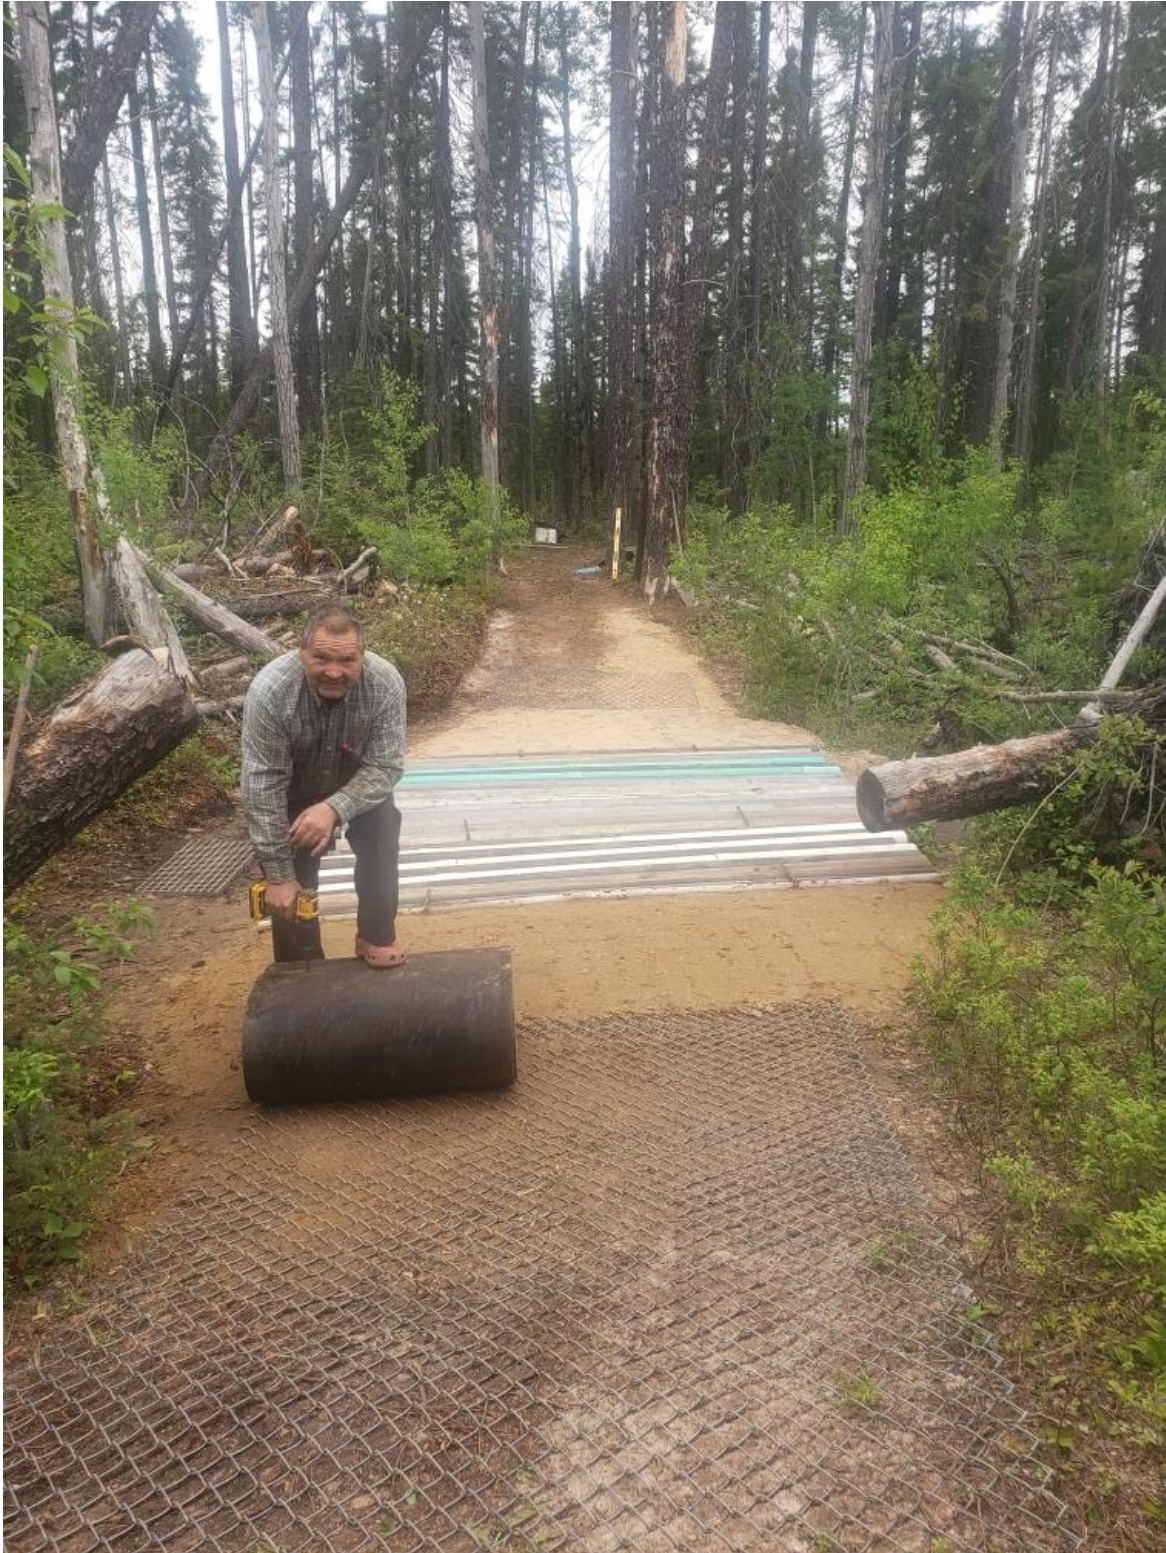
Figure 13. Shows the initial unrolling of the first conveyor belt.

- Two rolls of used heavy duty conveyor belting reinforced with steel wire meshing were laid down over top the pipes to further secure the pipes down (see figures 13, 14 and 15). A third roll of extra wide heavy-duty conveyor belting reinforced with steel wire meshing was laid over the initial two rolls and centered across the ATV path (pictures unavailable at time of report writing). This was all to allow a lightly to medium loaded ATV and wagon (or small drill rig) to be able to roll over the completed assembly without damaging the PVC pipes below. The heavy-duty conveyor belting will also act as an anchor to keep everything secured and in place during heavy creek flows such as springs thaws and during heavy precipitation.

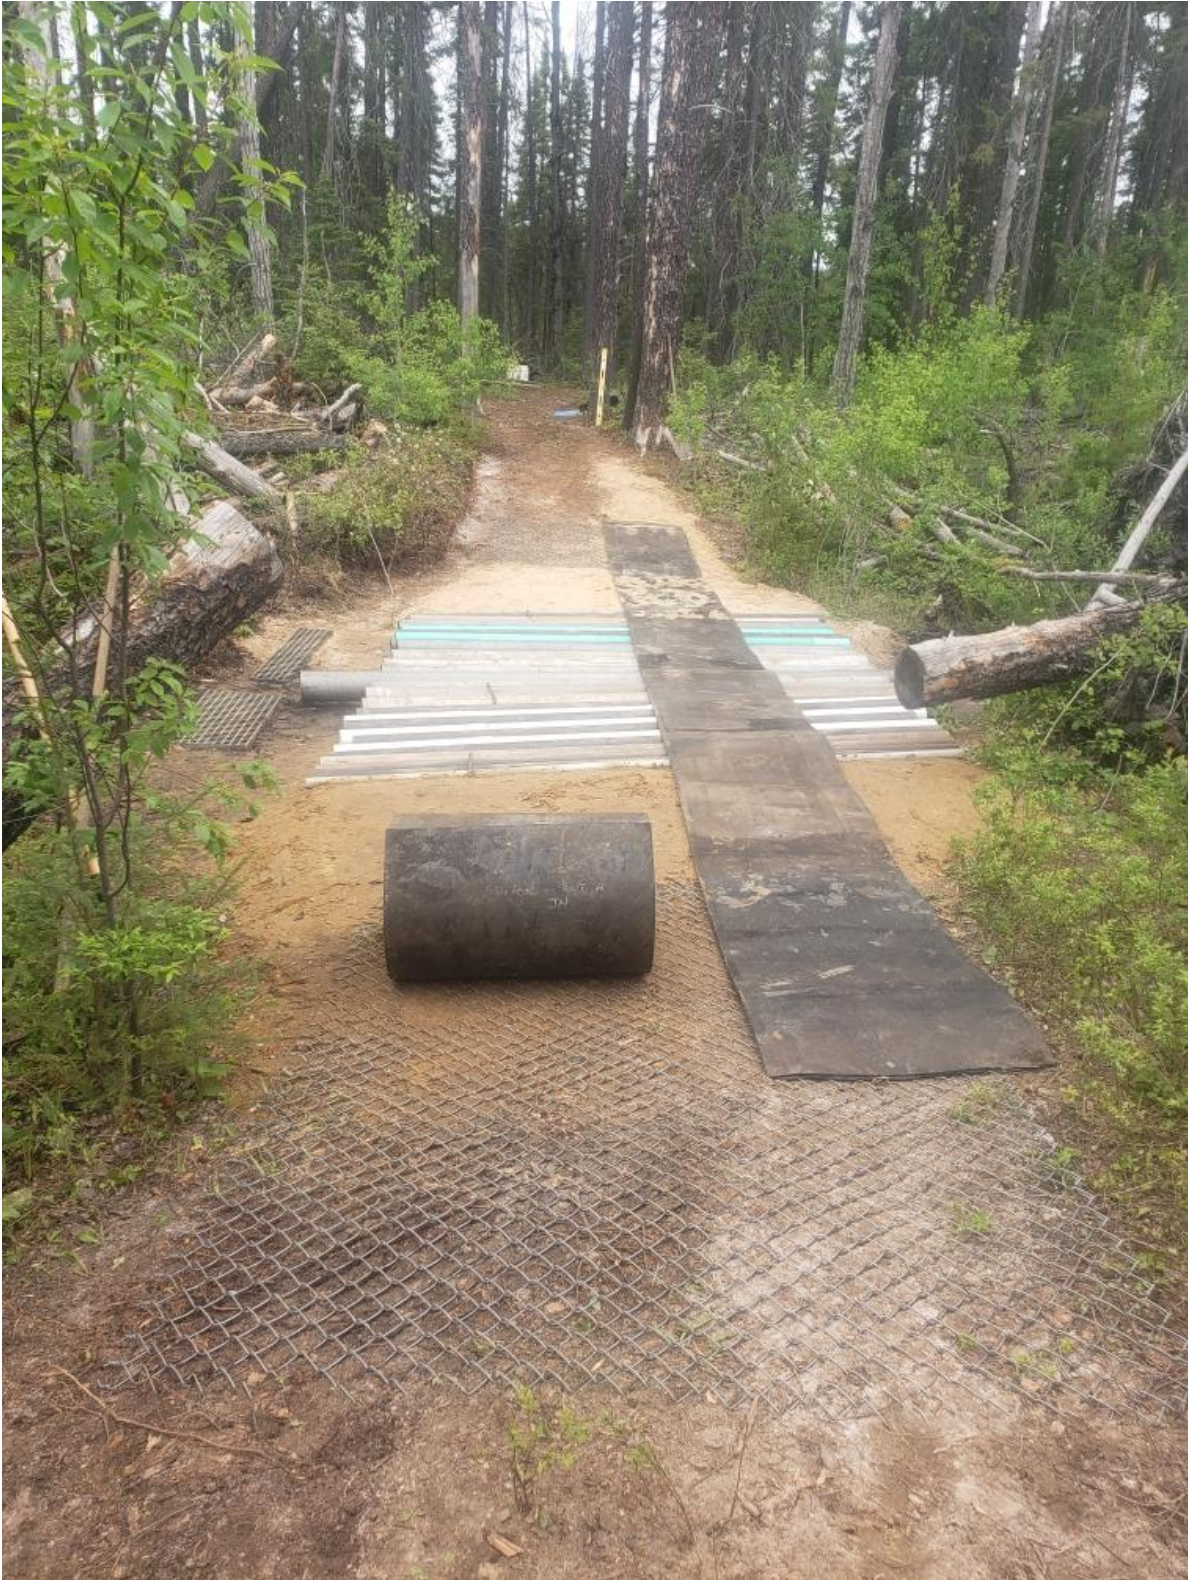
Figure 14. Shows the continued placement of the conveyor belts.

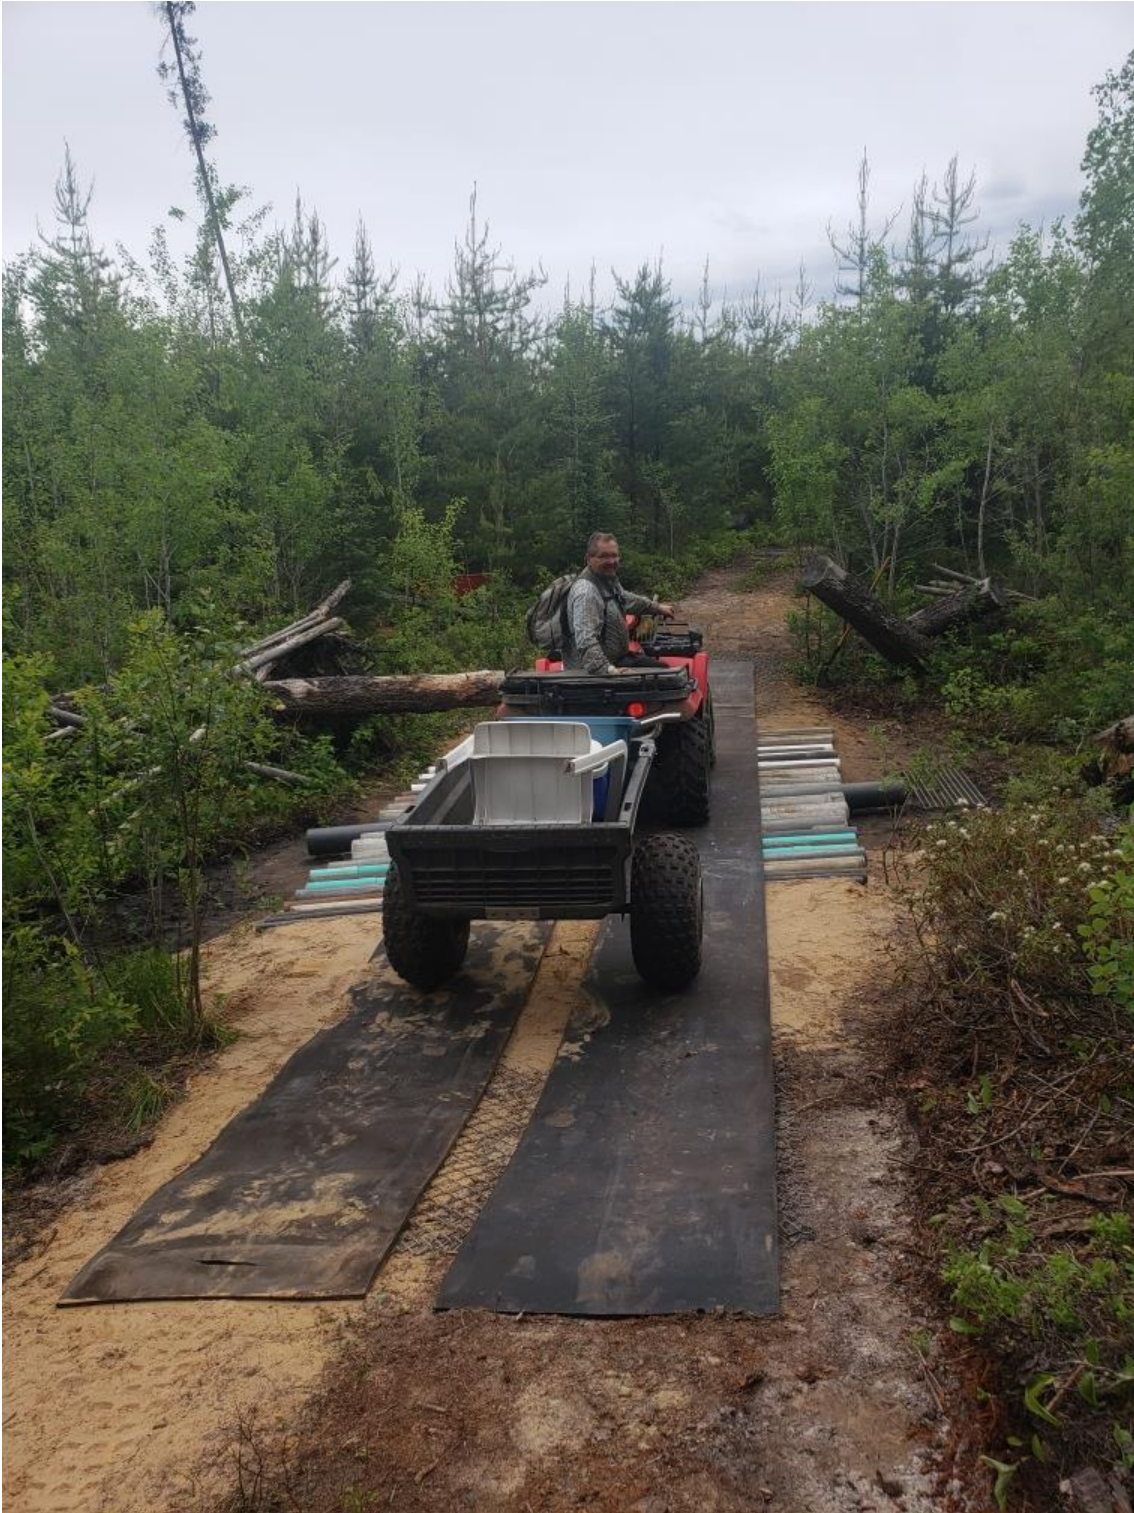
Figure 15. Testing the creek crossing. A third much wider conveyor belt was later added over top of the first two conveyor belts (picture unavailable during time of report writing)

Per the above expense summary, a total of \$11,402.74 was spent on this project. The bridge was inspected in the late fall of 2021, just before the onset of snow, and after the heavy fall rains. The bridge was found intact with no wash outs. This proves the fundamental and economical construction strategy and methodology of the designed temporary creek bridge.

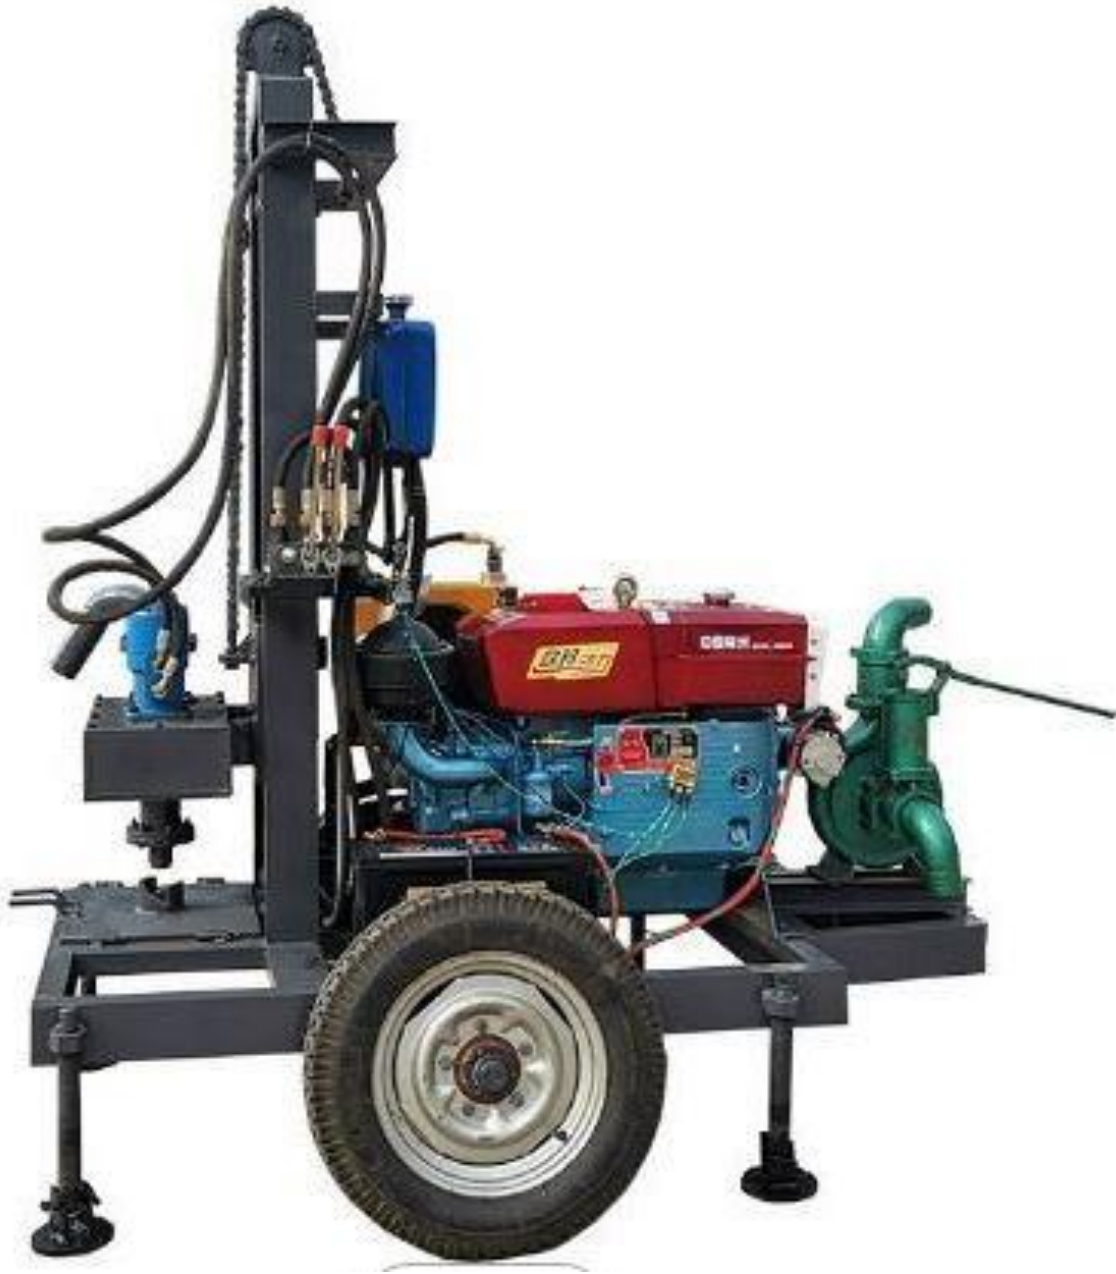
Figure 12. A portable drilling rig which can be towed behind an ATV which the owner plans on acquiring in the near future to commence a drilling program on the property.
