Nous tenons à améliorer <u>l'accessibilité des services à la clientèle</u>. Si vous avez besoin de formats accessibles ou d'aide à la communication, veuillez <u>nous contacter</u>. 2022 Prospecting Report
Skead Property
Maclennan Townships
Sudbury, Ontario

Prepared By:
Stephen Skjonsby
Mineral Process Solutions
September 09, 2022

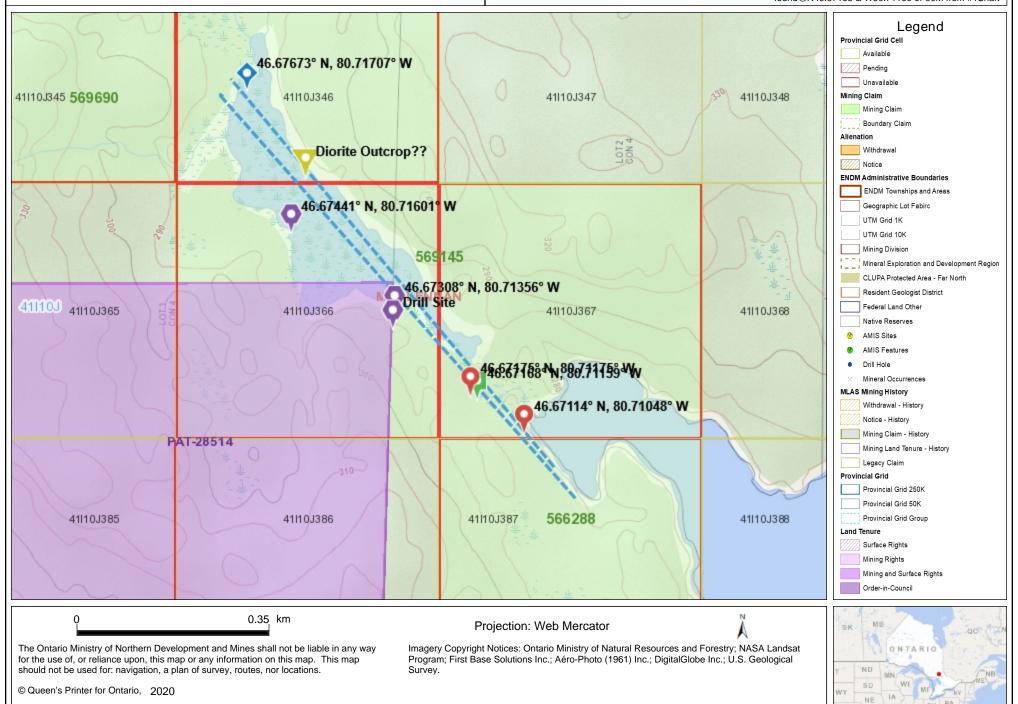
Bonanza Lake Map

Site Visit held on 22/05/2020 with S. Skjonsby&R. Hill#2Shaft @N46.67175 &W80.71175. Qtz vein found@N46.67168 & W80.71159 or 90M from #1Shaft

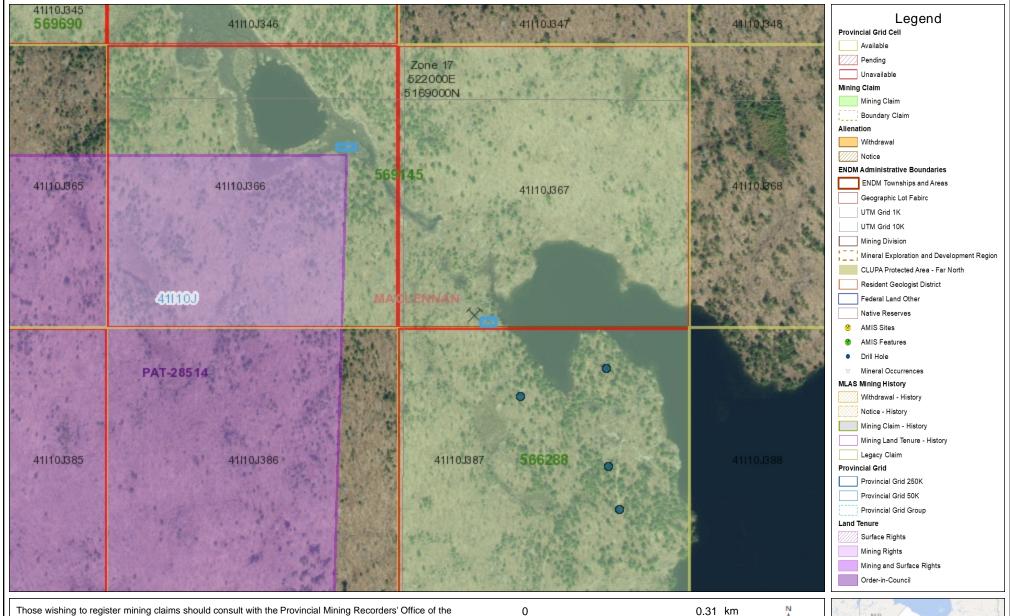
Bonanza Lake North Property

Property Examined and south showing was stripped and percusive driilled

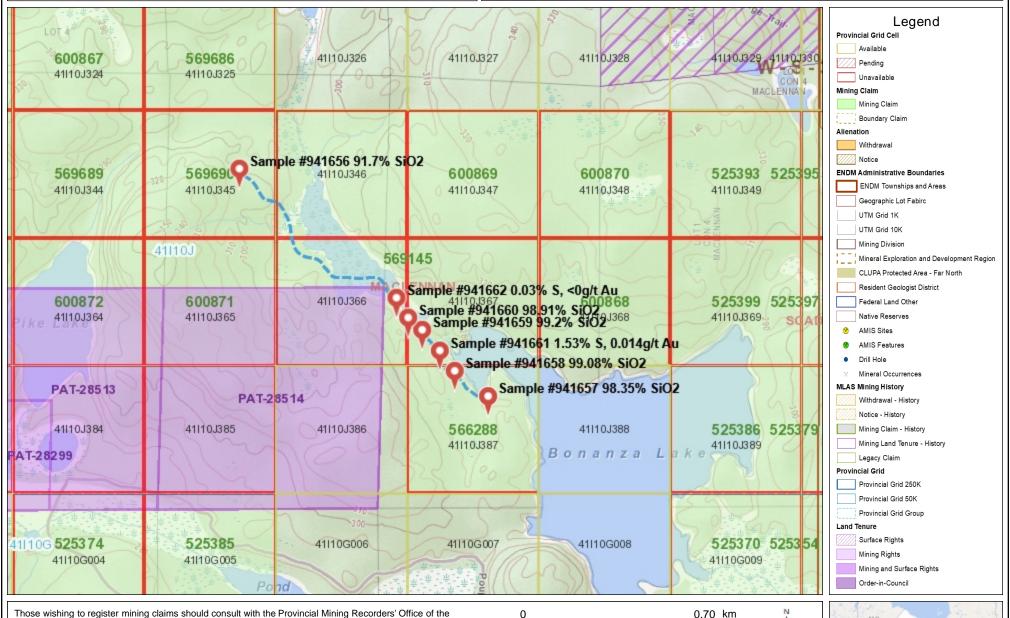
Bonanza Lake 08.17.2020 sampling results

Sampling completed to further assess north limits of structure and prospect for extension

Silica assays collected on August 17, 2020 ranged from 91.7% in Quartzite to 99.2% in the main vein.

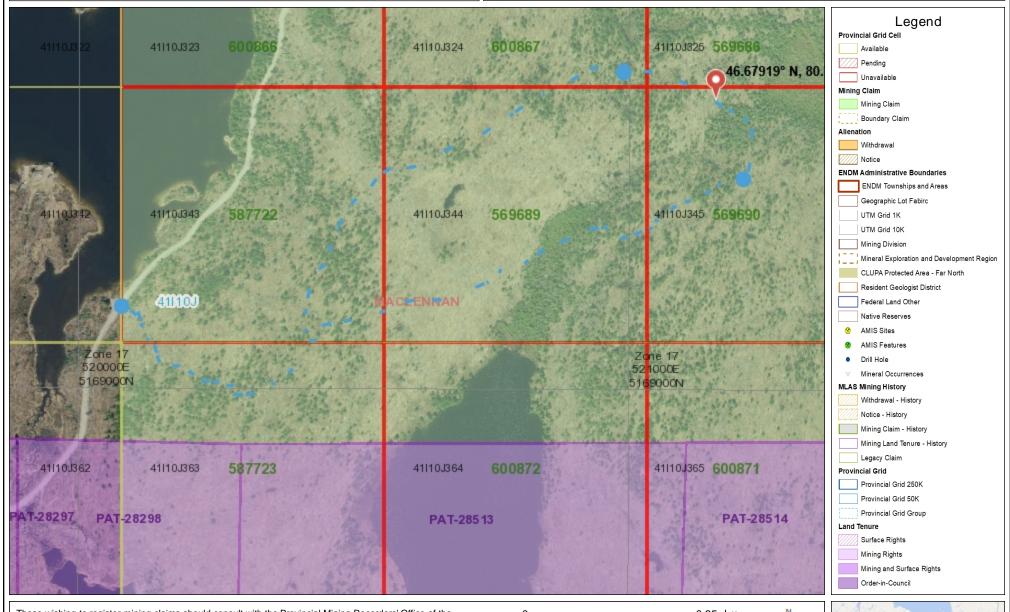
Oct 2 2020 Prospecting Traverse

Walked to 46.67759,-80.72267 & 46.67929,-80.72313 to look at silica outcrops

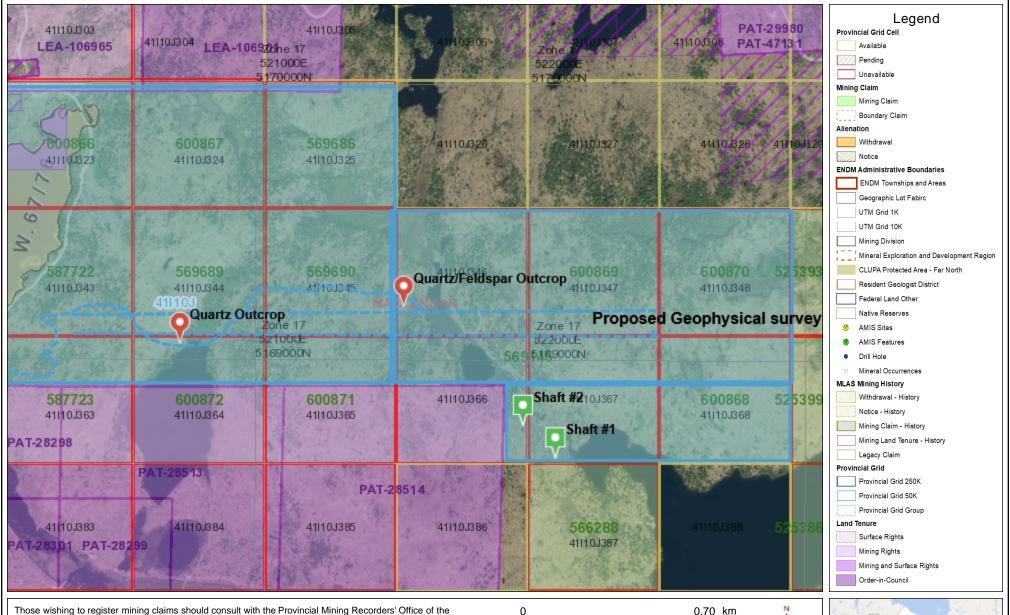
15 Claim Bonanza Lake Property

Claim Units acquired are highlighted in Blue. Lease #106901 & 106965 are leased to Wahna Gold Resources & Metanor Resources. Secondary Quartz

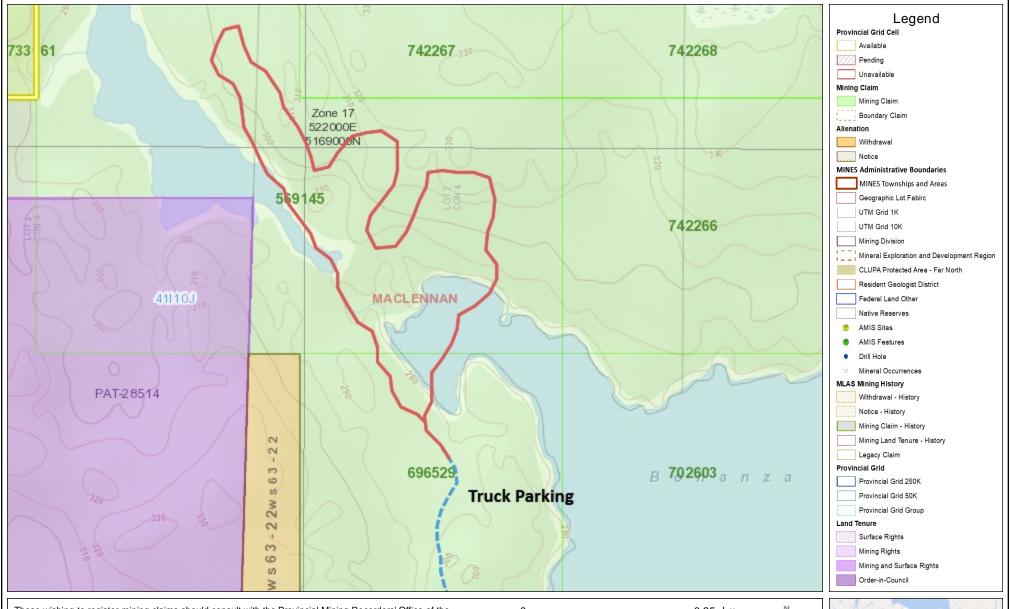
Dec 21 2020 Beep Mat Traverse Scale 1:10000

Completed traverse when ice depth +4" Traverse in red, no conductors found

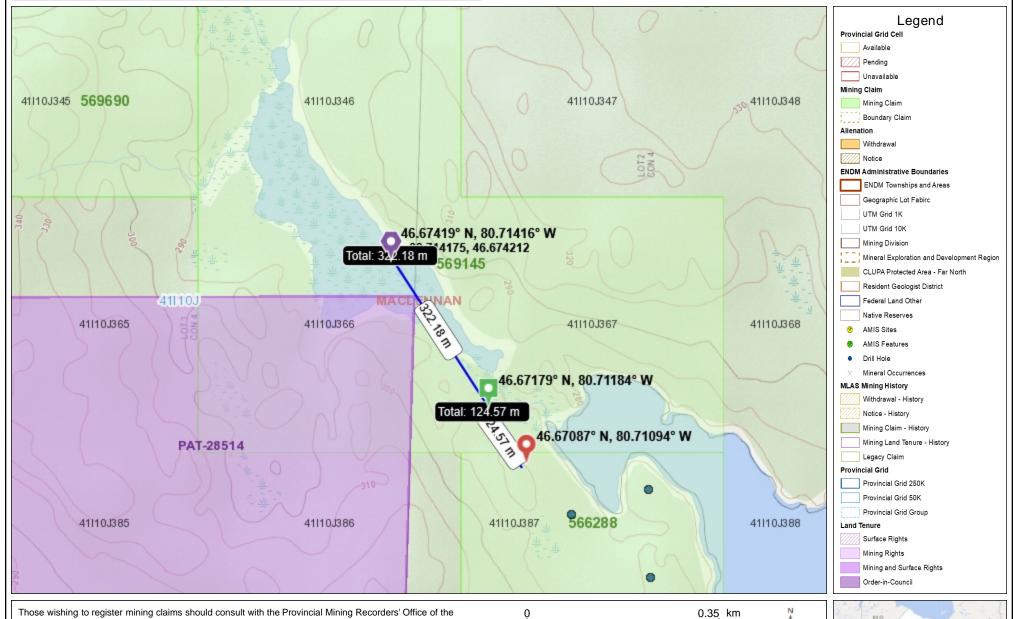
July 15 2020 traverse

Walked and looked at outcrop with Beepmat

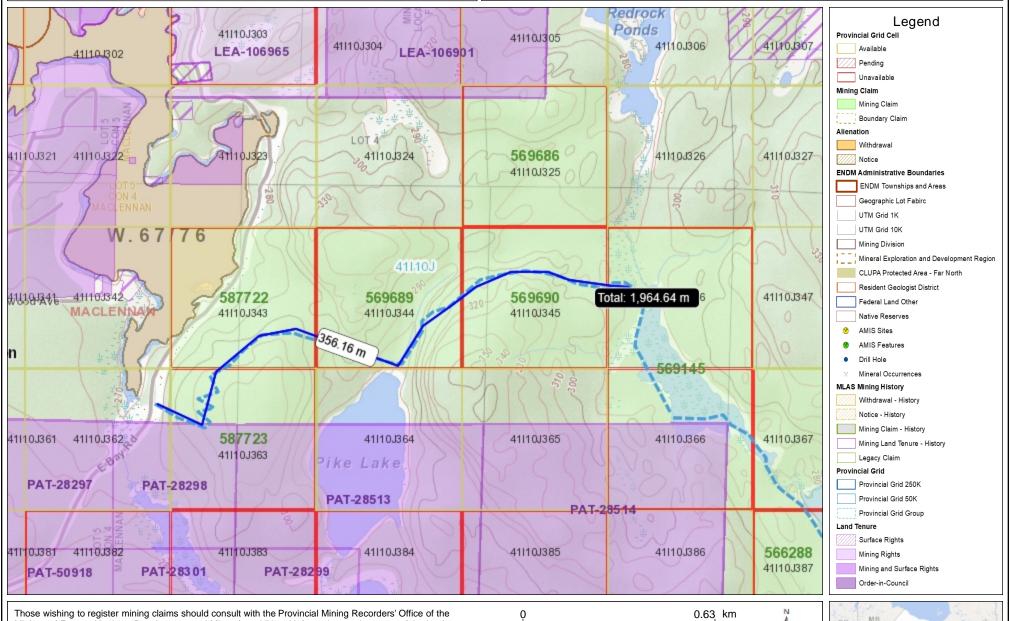
July 17 2020 traverse

We extended the trail across the swampy outlet of Pike Lake over to the swamp section and identified a large Silica boulder/Outcrop that will need further review -

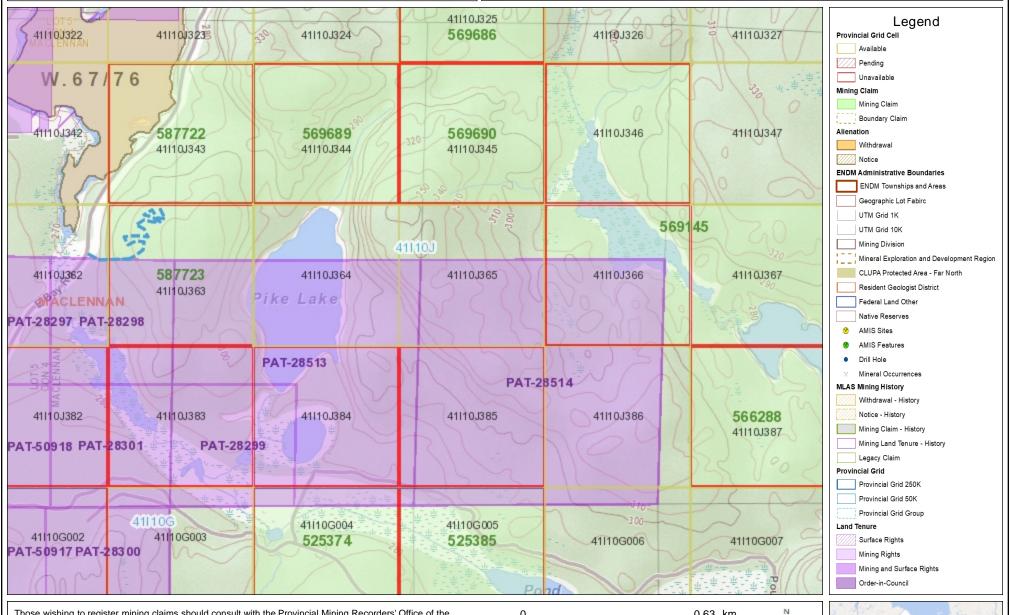
July 23 2020 Prospecting Traverse

Searching on hill slope for quartzite outcrop source from all the boulders.

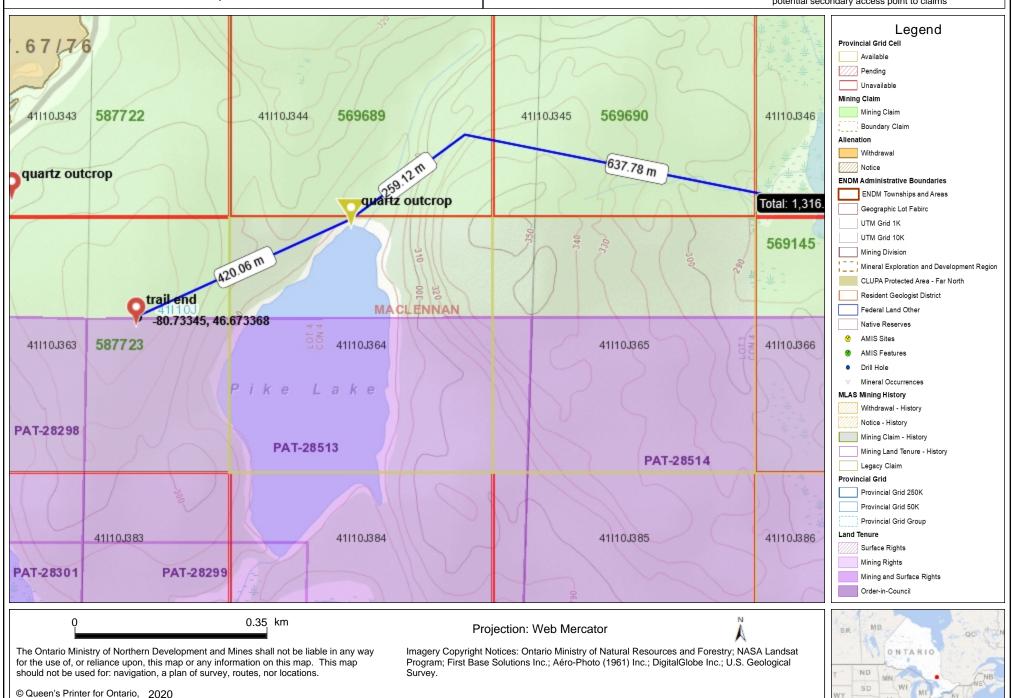
June 10 2020 Prospecting Traverse

Prospected the Western End of the claims on June 10 2020 locating two potential quartz outcrops and potential secondary access point to claims
