VISION LAKE MINING INC.

RE: VISION LAKE GOLD DISCOVERY, ROBB TOWNSHIP, ONTARIO

Re: Work in Tesluk pit July 2000 Submission Number 2.21398 Transaction Number WO160.30105

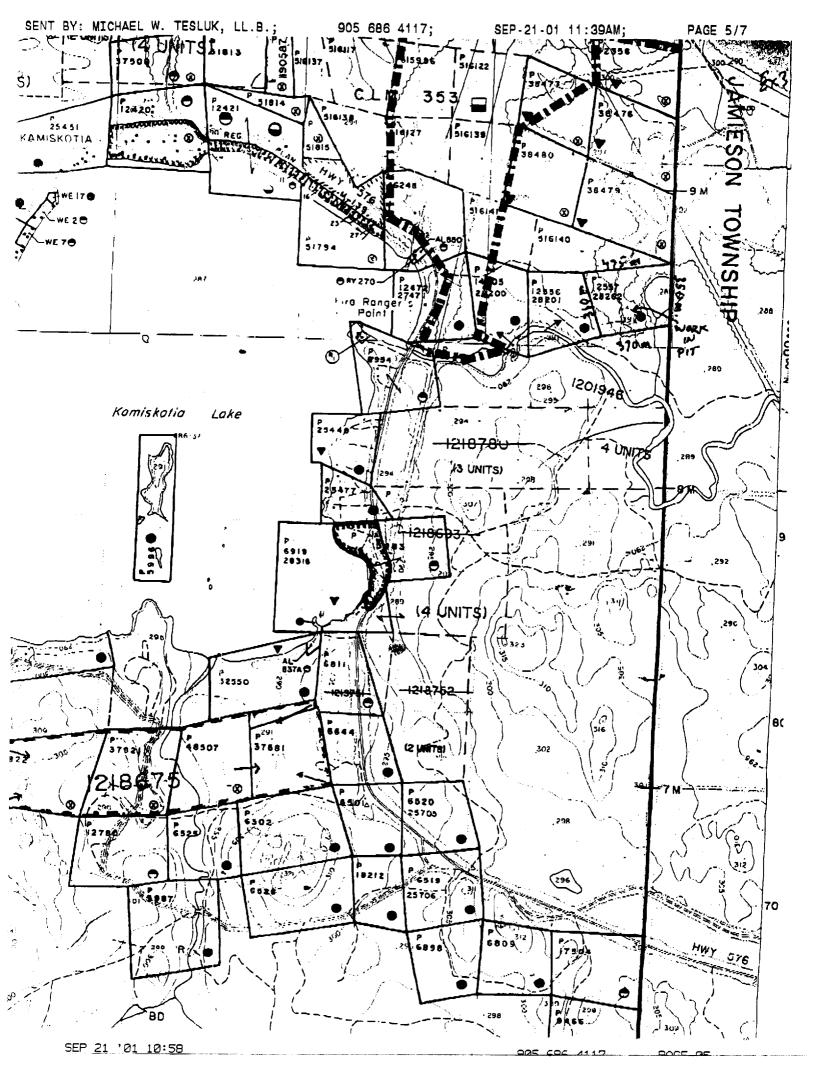
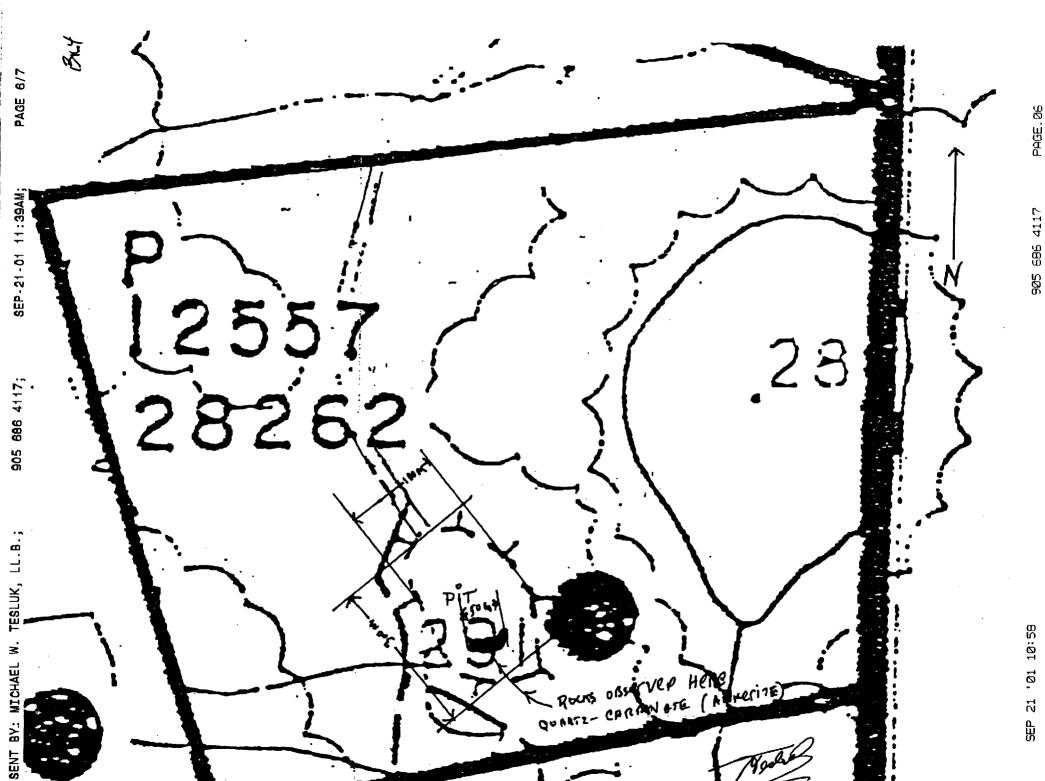
- (i) The location of the pit is clearly shown on Province of Ontario Map G-3968. There are no surveys, grids or coordinate lines, survey stations. The access road is shown on Map G-3968.
- D (ii) The pit area is 100 metres by 300 metres shown on Ex. 4 being map of claim P12557. Rocks were upturned over a length of 50 metres so Dr. Kirwan could observe the rocks.
- (iii) Dr. Kirwan describes the rocks in his report and shown on Ex 4 as quartz carbonate (ankerite)
 - (iv) No sampling was done
- (v) On exhibit 4, the east boundary of claim P12557 is the Robb/Jamieson township line. North is marked on exhibit 4

Map: I enclose copy of map of Ministry of Natural Resources Plan G-3968 Robb Township showing the pit on claim P12557. I also enclose photographs of pit in the Spring and Summer of 2000 showing the rocks exposed. The rocks observed by Dr. Kirwan were located at the east wall of the pit after these rocks were turned over by the Daewoo Shovel. You can see the pump referred to in the invoice. The pump is at the west end of the pit and the man is looking east.
