Progressive Rehabilitation Report

Concrete Cap

Fatima (Texmont, New Texmont) Mine Site Vent Raise Cap

April 8, 2013 Rev. 1

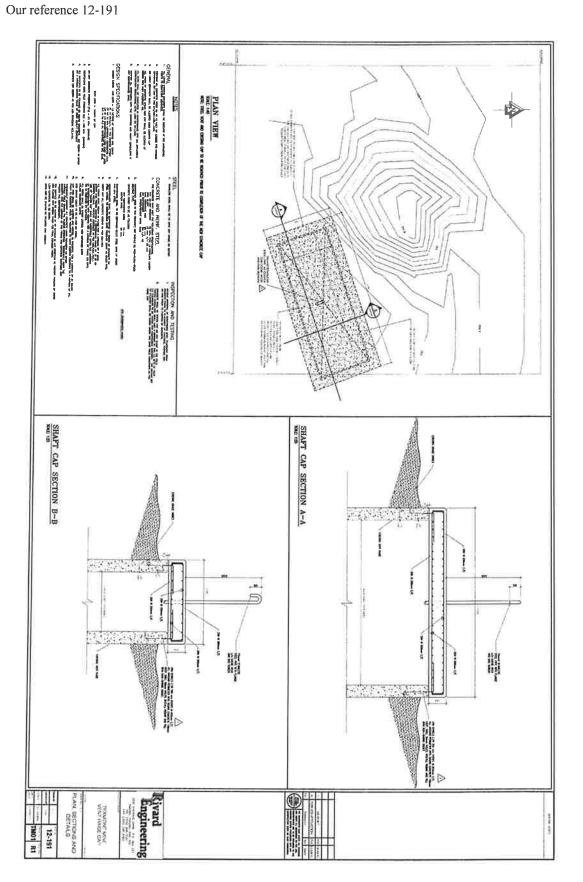
Rivard Engineering Drawings

A new reinforced concrete cap, constructed as prescribed by the Mining Act as outlined in Schedule 1, Part1, Section 3 of the Mine Rehabilitation Code of Ontario, was constructed above the existing concrete vent raise collar and tied into the perimeter of the collar. A copy of the as built drawing of the cap, complete with a 76 mm (3") diameter monitoring pipe is enclosed in Appendix B. Construction of the cap was completed on September 13, 2012.
