SUMMARY REPORT ON DIAMOND DRILLING

HEMLO GOLD - FREEWEST J.V.

HOLLOWAY AND TEDDY BEAR PROPERTIES

NORANDA EXPLORATION COMPANY, LIMITED
(no personal liability)

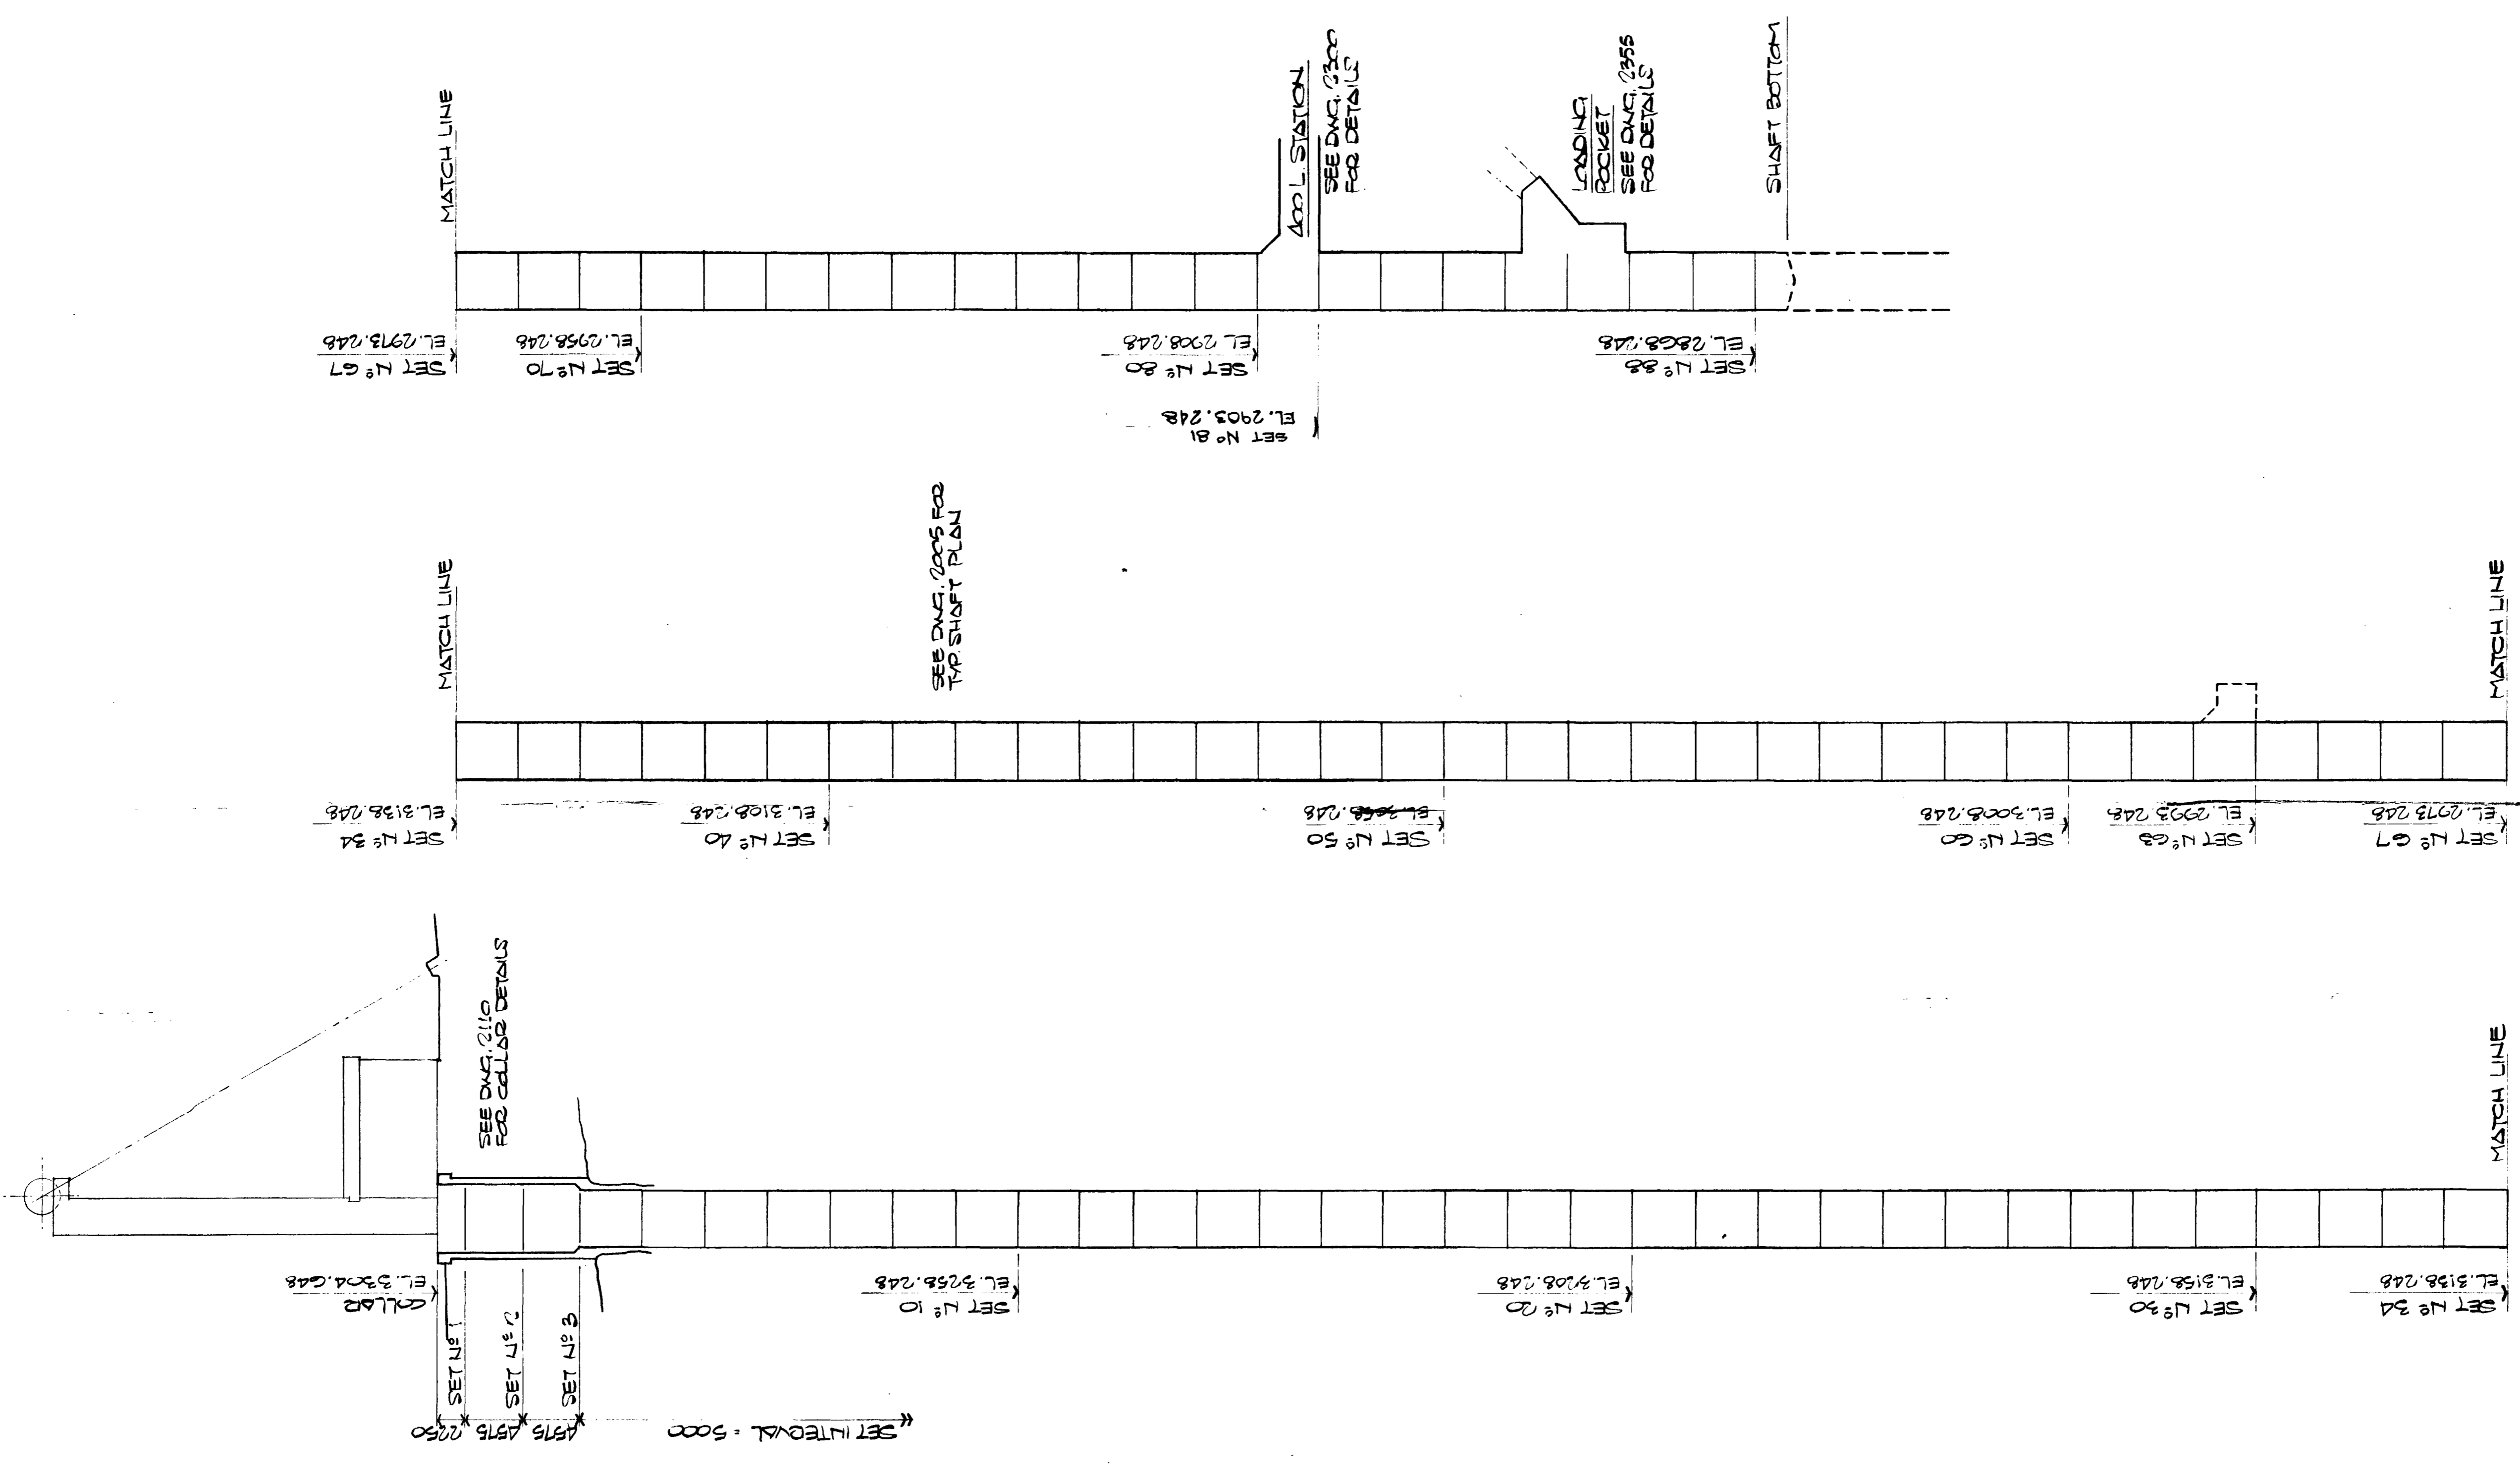
CLIENT: HEMLO GOLD MINES INC.
 TITLE: HOLLOWAY PROJECT CONCRETE SHAFT SHAFT LONG SECTION

CLIENT: HEMLO GOLD MINES INC. PROJECT: HOLLOWAY PROJECT - CONCRETE SHAFT - SHAFT LONG SECTION. DATE: 22-01. DWG NO: 4895-2000. REV: 2

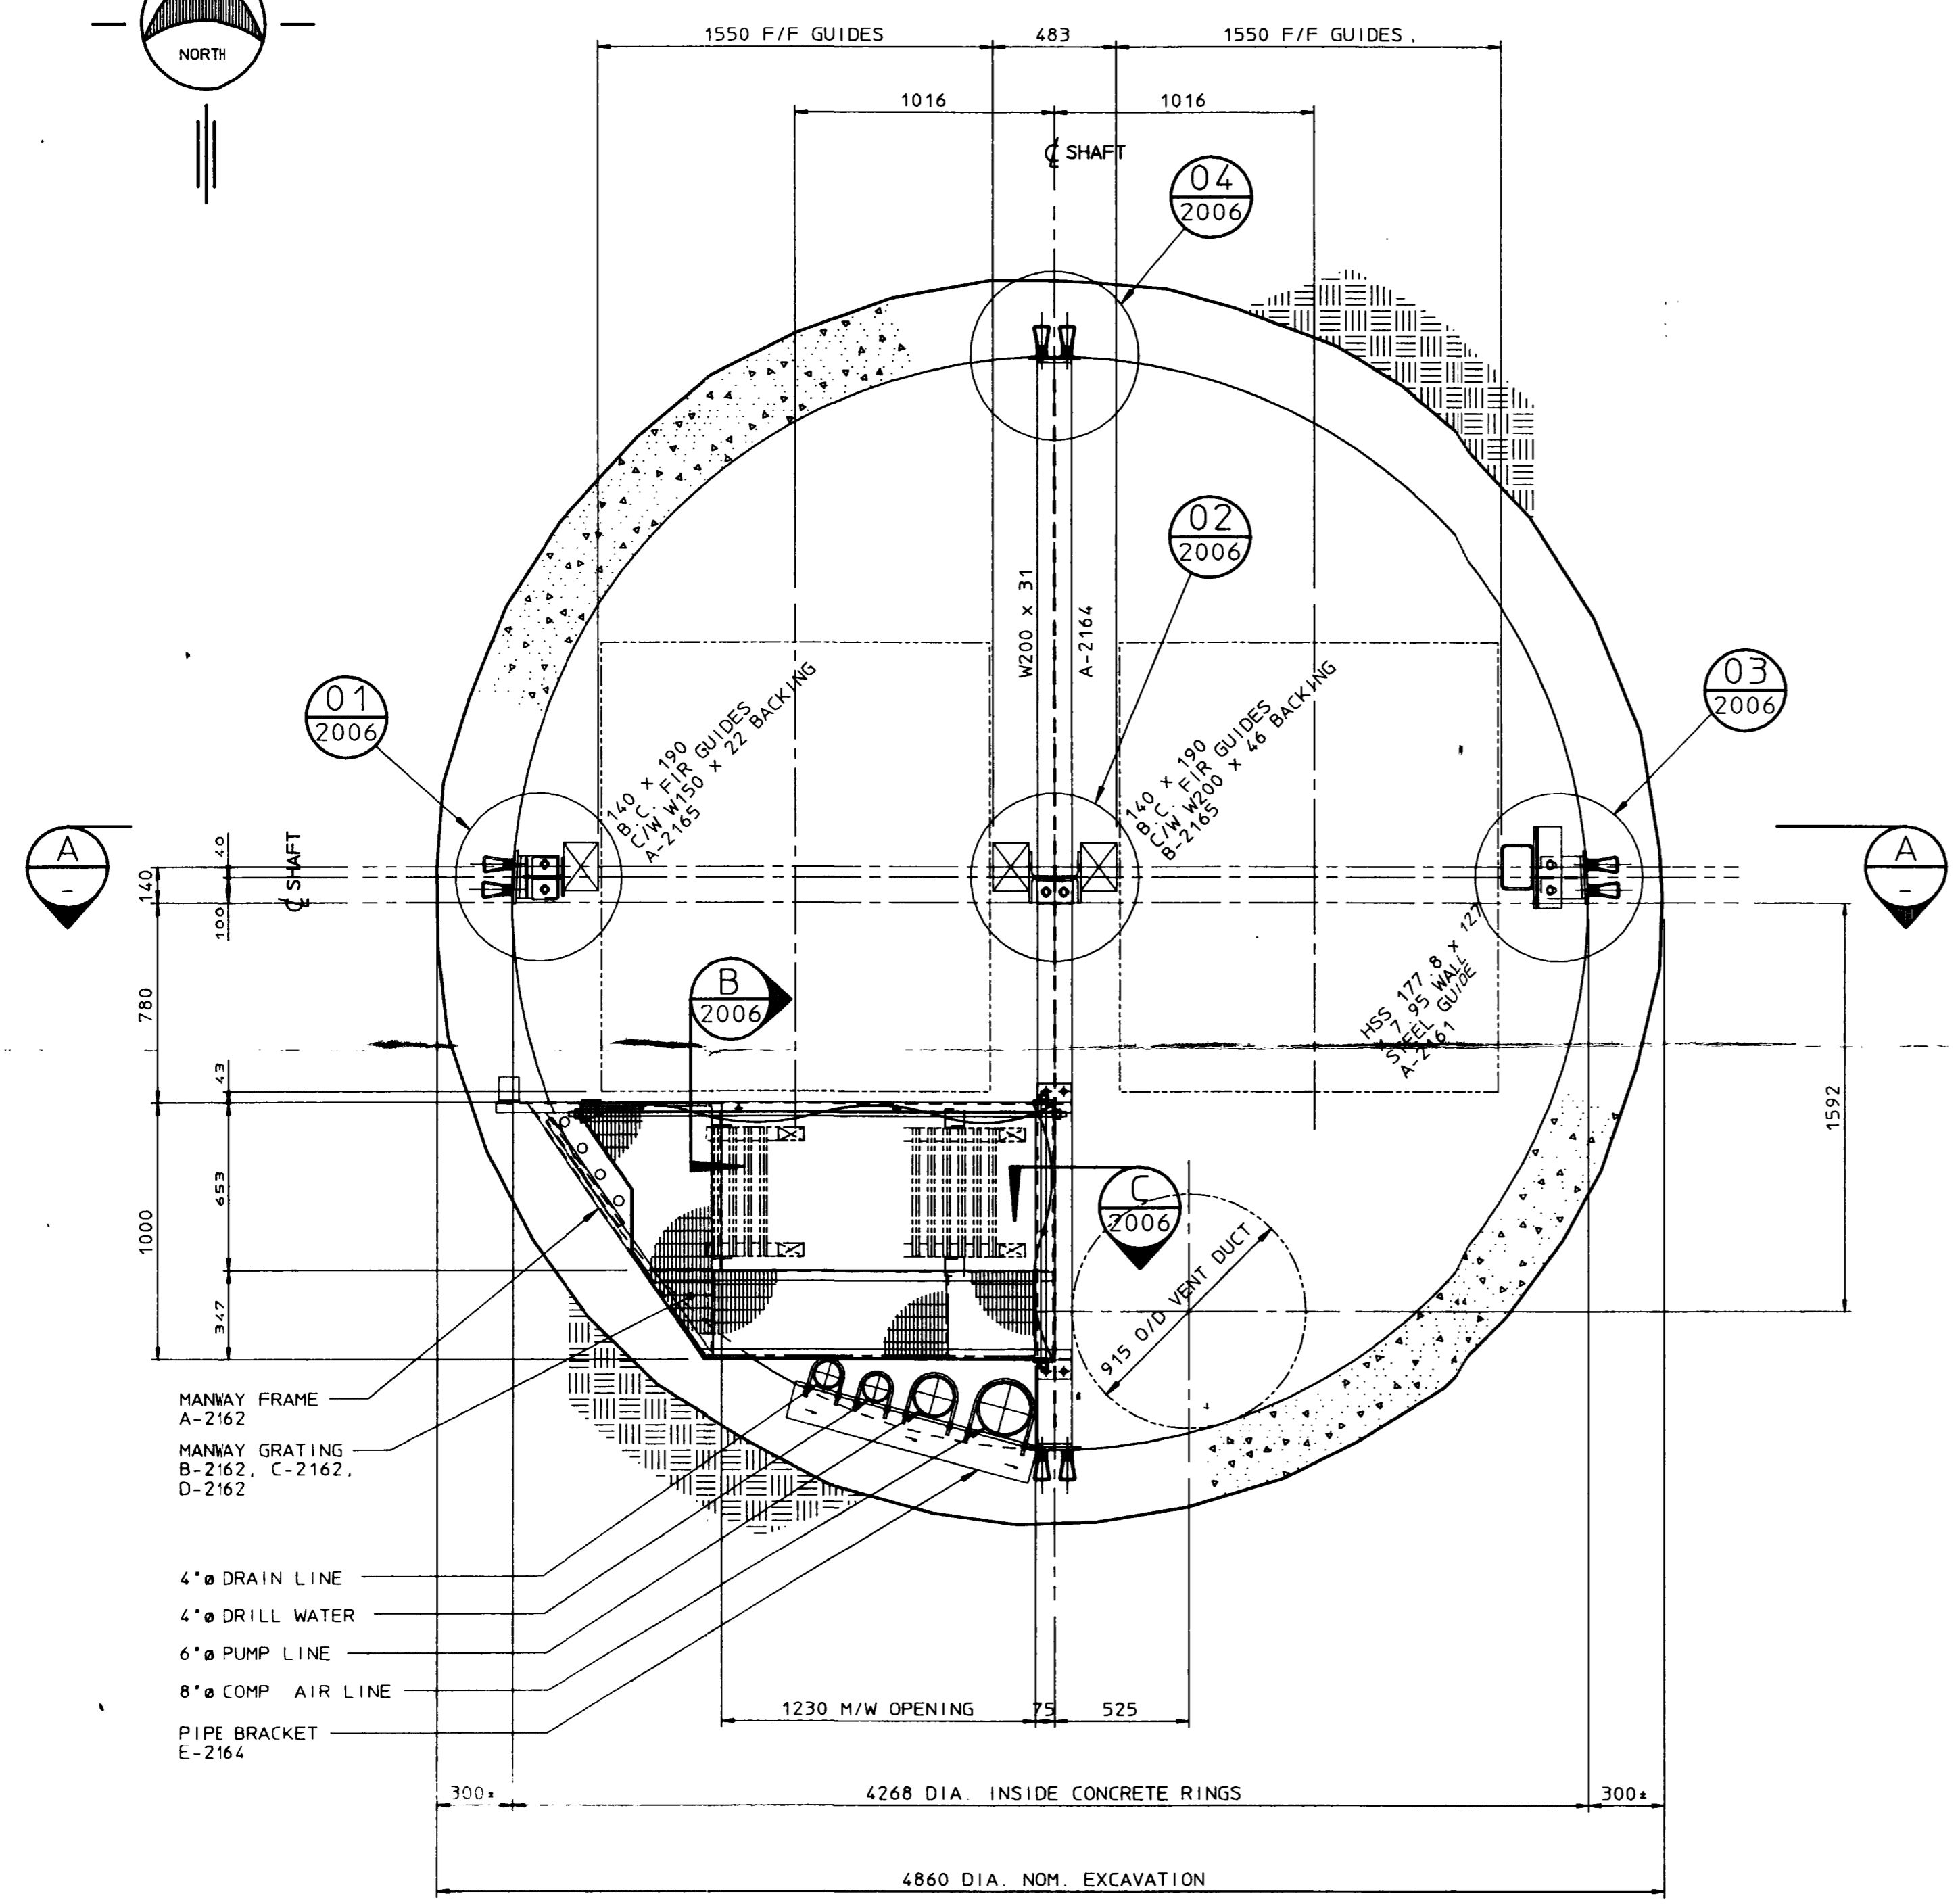
SHAFT PLAN

- MANWAY FRAME A-2'62
- MANWAY GRATING B-2'62, C-2'162, D-2'62
- 4" DRAIN LINE
- 4" DRILL WATER
- 6" PUMP LINE
- 8" COMP. AIR LINE
- PIPE BRACKET E-2'64

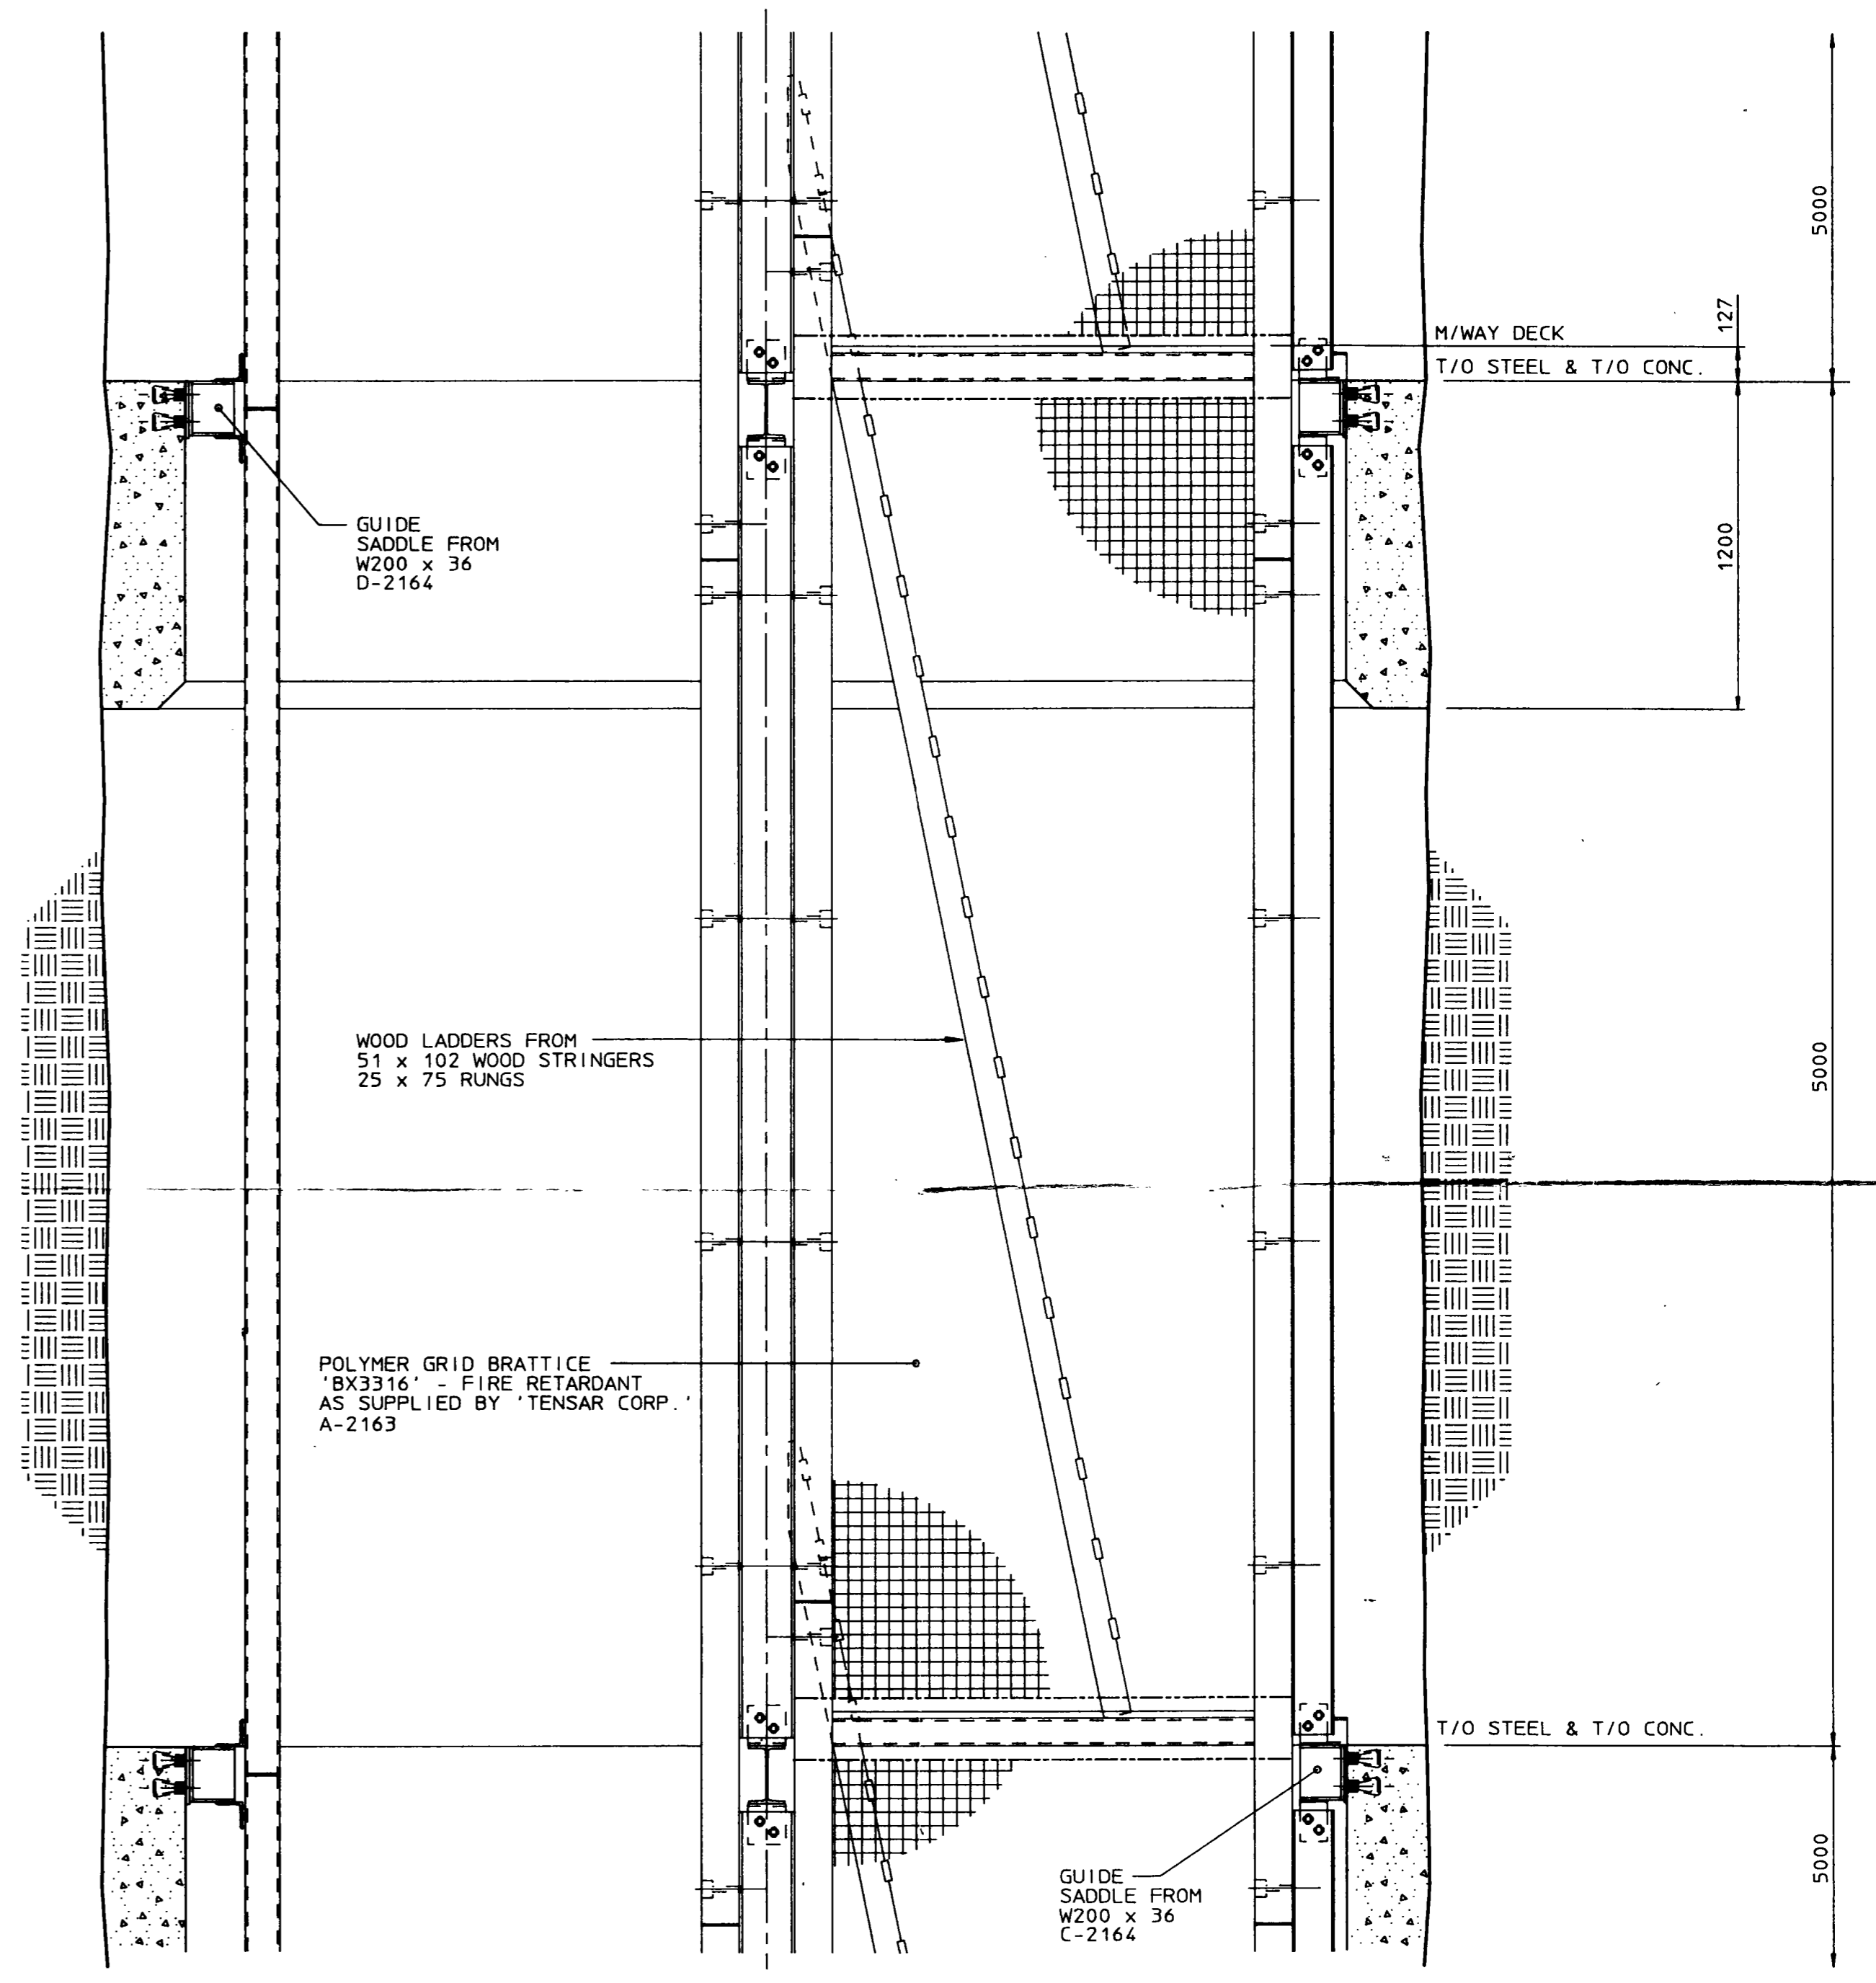
AA SHAFT SECTION
 SCALE: NOTED

CLIENT	HEMLO GOLD INC.
TITLE	HOLLOWAY PROJECT CONCRETE SHAFT SHAFT GENERAL ARRANGEMENT
