Technical Report For Mechanical Stripping And Excavation. For What Is Known As The Gunnard East Project In Mctavish Township District Of Thunder Bay. Exploration Permit # PR-19-000247. Claim#214383 Legacy claim # 4265638.October 18th To November 27th 2020.

Submitted By Mitchell Noyes,

- 2020 Mining claim assessment work report completed by Mitchell Noyes. Mctavish Township, Claim number 214383, 252295, 216027.legacy claim number 4265638.Exploration permit #PR-19-000247.

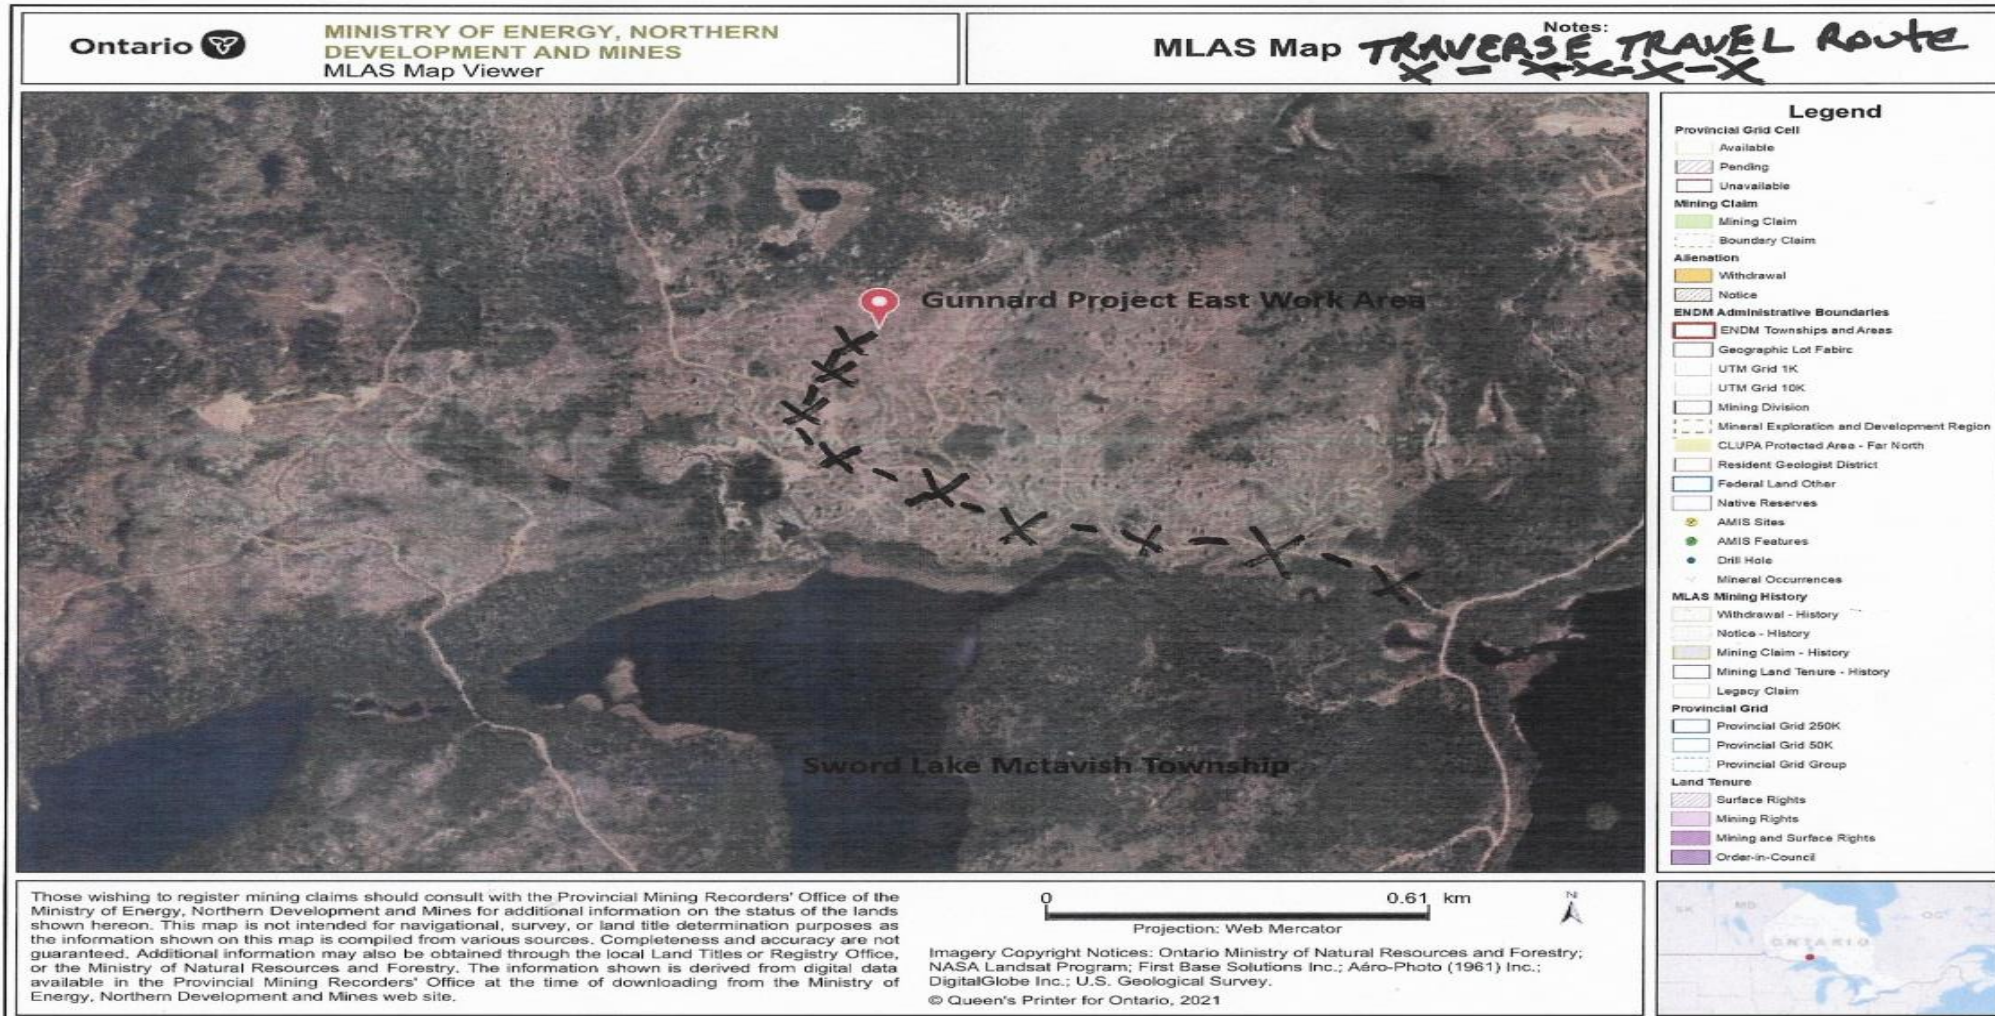
Work area October 18th. Granite out crop center of picture. Stripped hauled away large rocks/overburden to right of out crop. I had also come back to this area on dates of November 24,25 to strip this area down more approximately 10x20 meters wide and 2 meters deep This photo is looking to the east.

- November 24th 2020, I moved excavator back to lower part of work area below granite outcrop to strip and excavate more of the vein I had originally worked. I spent a total of 8 hours working with excavator digging it deeper to see how far down the vein was. Daily total for excavator $\$150 \times 8 = \1200.00

- November 25th, 2020 again on this day I spent a total of 8 hours stripping, removing overburden and digging deeper while following the vein. Daily total for excavator $\$150.00 \times 8 = \1200.00 . As I was excavating, I was finding Amethyst purple blue in colour mixed with quartz and granite. proximate size of area excavated 10x20 meters wide and 2 meters deep.

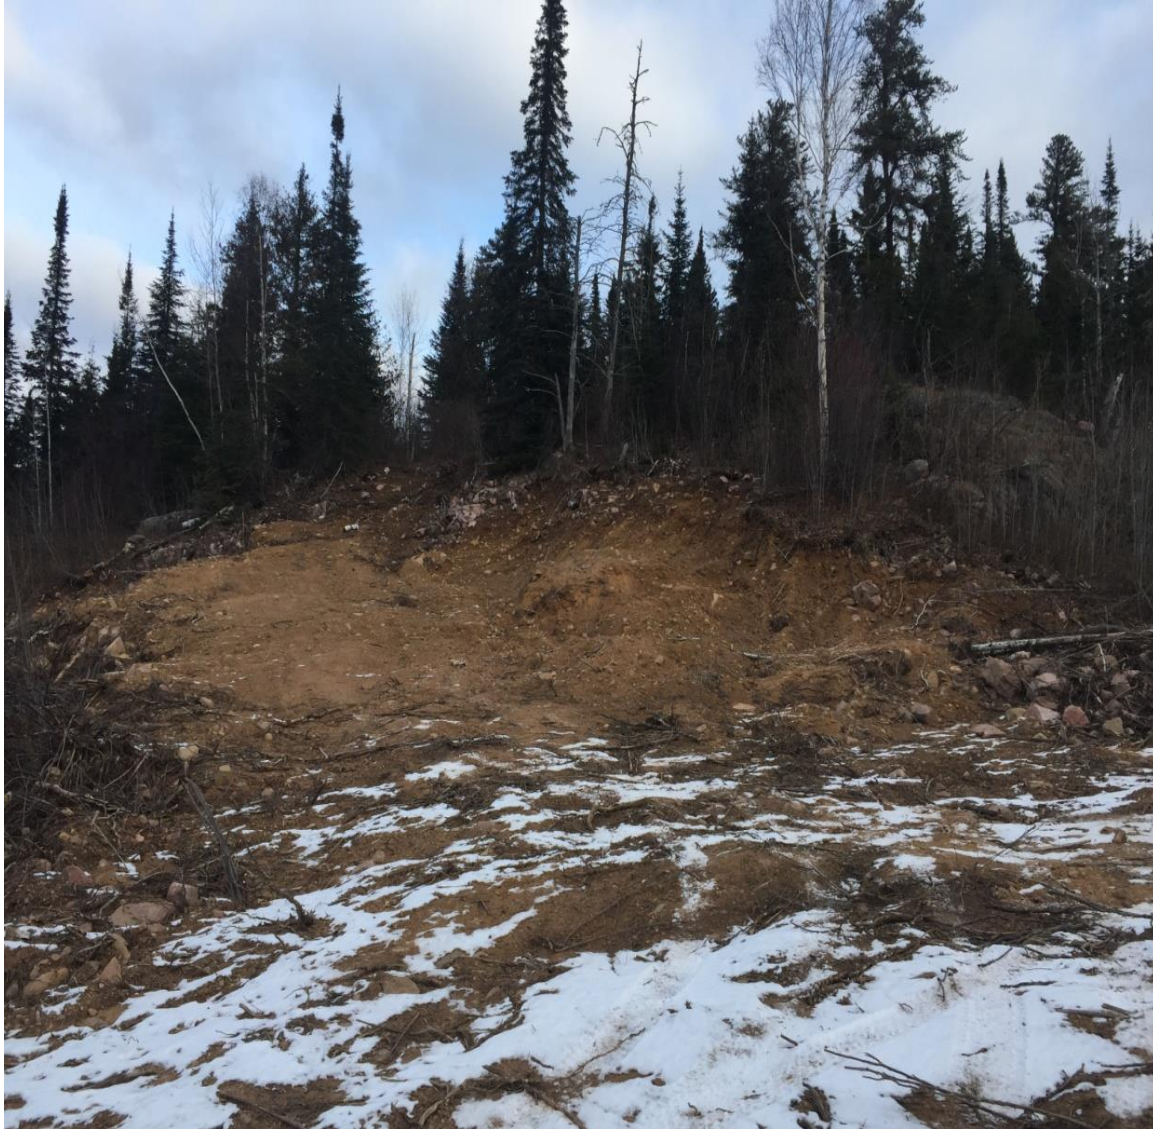
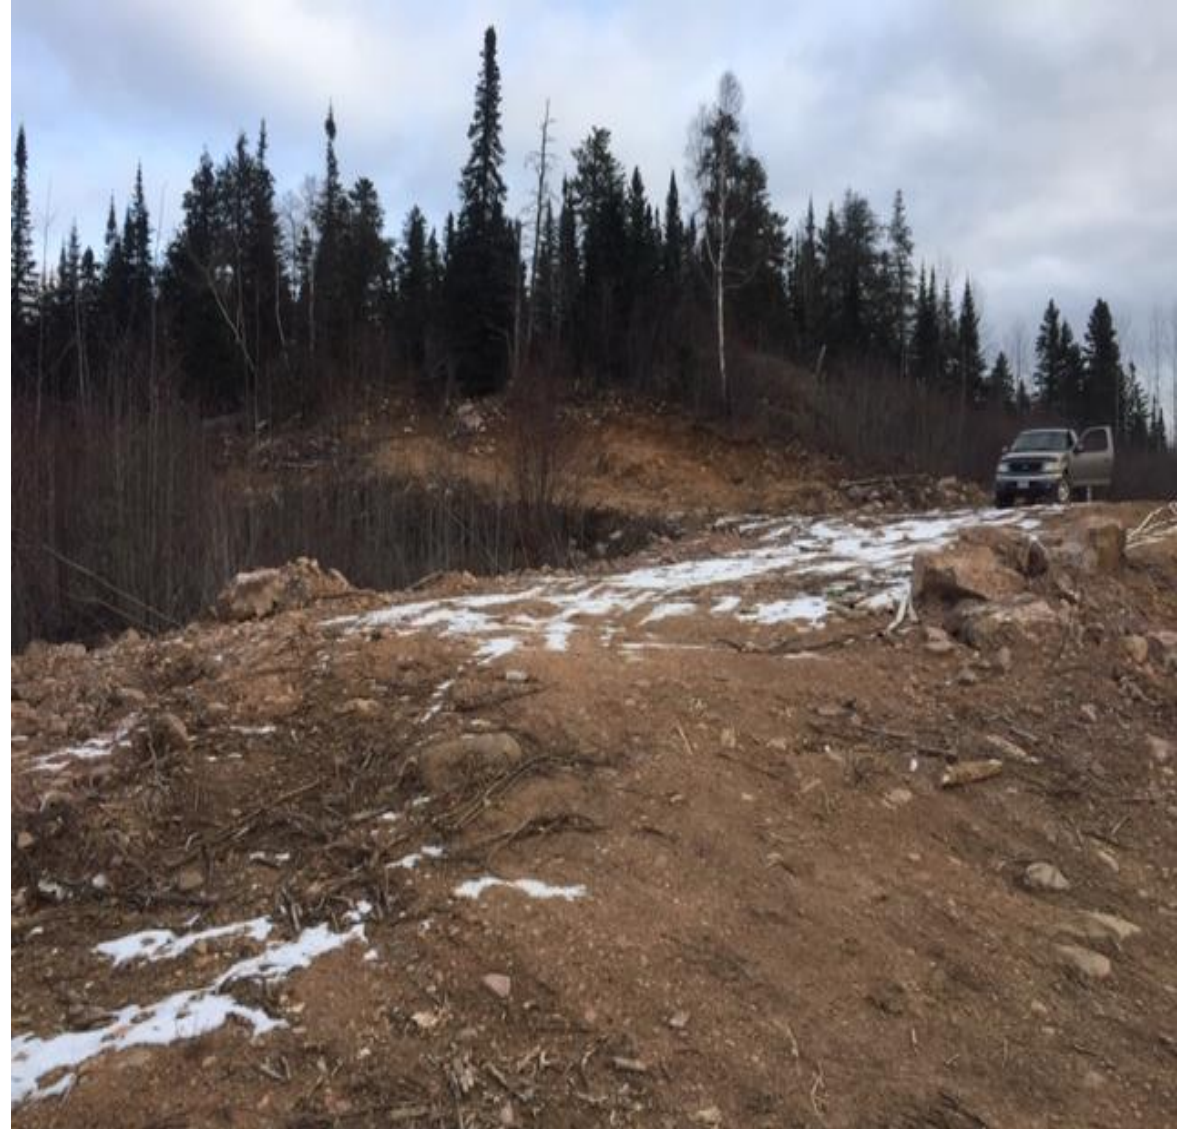
Work area dates of November 17,18,19.Left photo access trail to higher ground, Area stripped to bedrock. Photo 2 area sloped and prepped for better access for future exploration.

- November 17th, 2020, I moved excavator to higher ground to excavate and strip down an area to look for veins of Amethyst. I spent 8 hours pulling back overburden and stripping down to bedrock. Daily total for excavator $\$150.00 \times 8 = \1200.00

- November 18th, 2020, I continued in the same area stripping and excavating down to bedrock hoping to find veins of Amethyst I expected to be here. I did not find any signs of Amethyst or any veins running through the area. I spent a total of 8 hours on this day working with excavator. At this point the area stripped was approximately 20 meters by 20 meters in size. Daily total for excavator $\$150.00 \times 8 = \1200.00

- November 19th, 2020, I spent a total of 8 hours cleaning up with excavator trenching/slopping, removing overburden large rocks and smoothing it off using previously moved overburden to build and make a work area to have it more accessible for equipment for future work I plan to do. I also started to build an access trail to higher ground for future exploration in 2021. Daily total for excavator $\$150.00 \times 8 = \1200.00

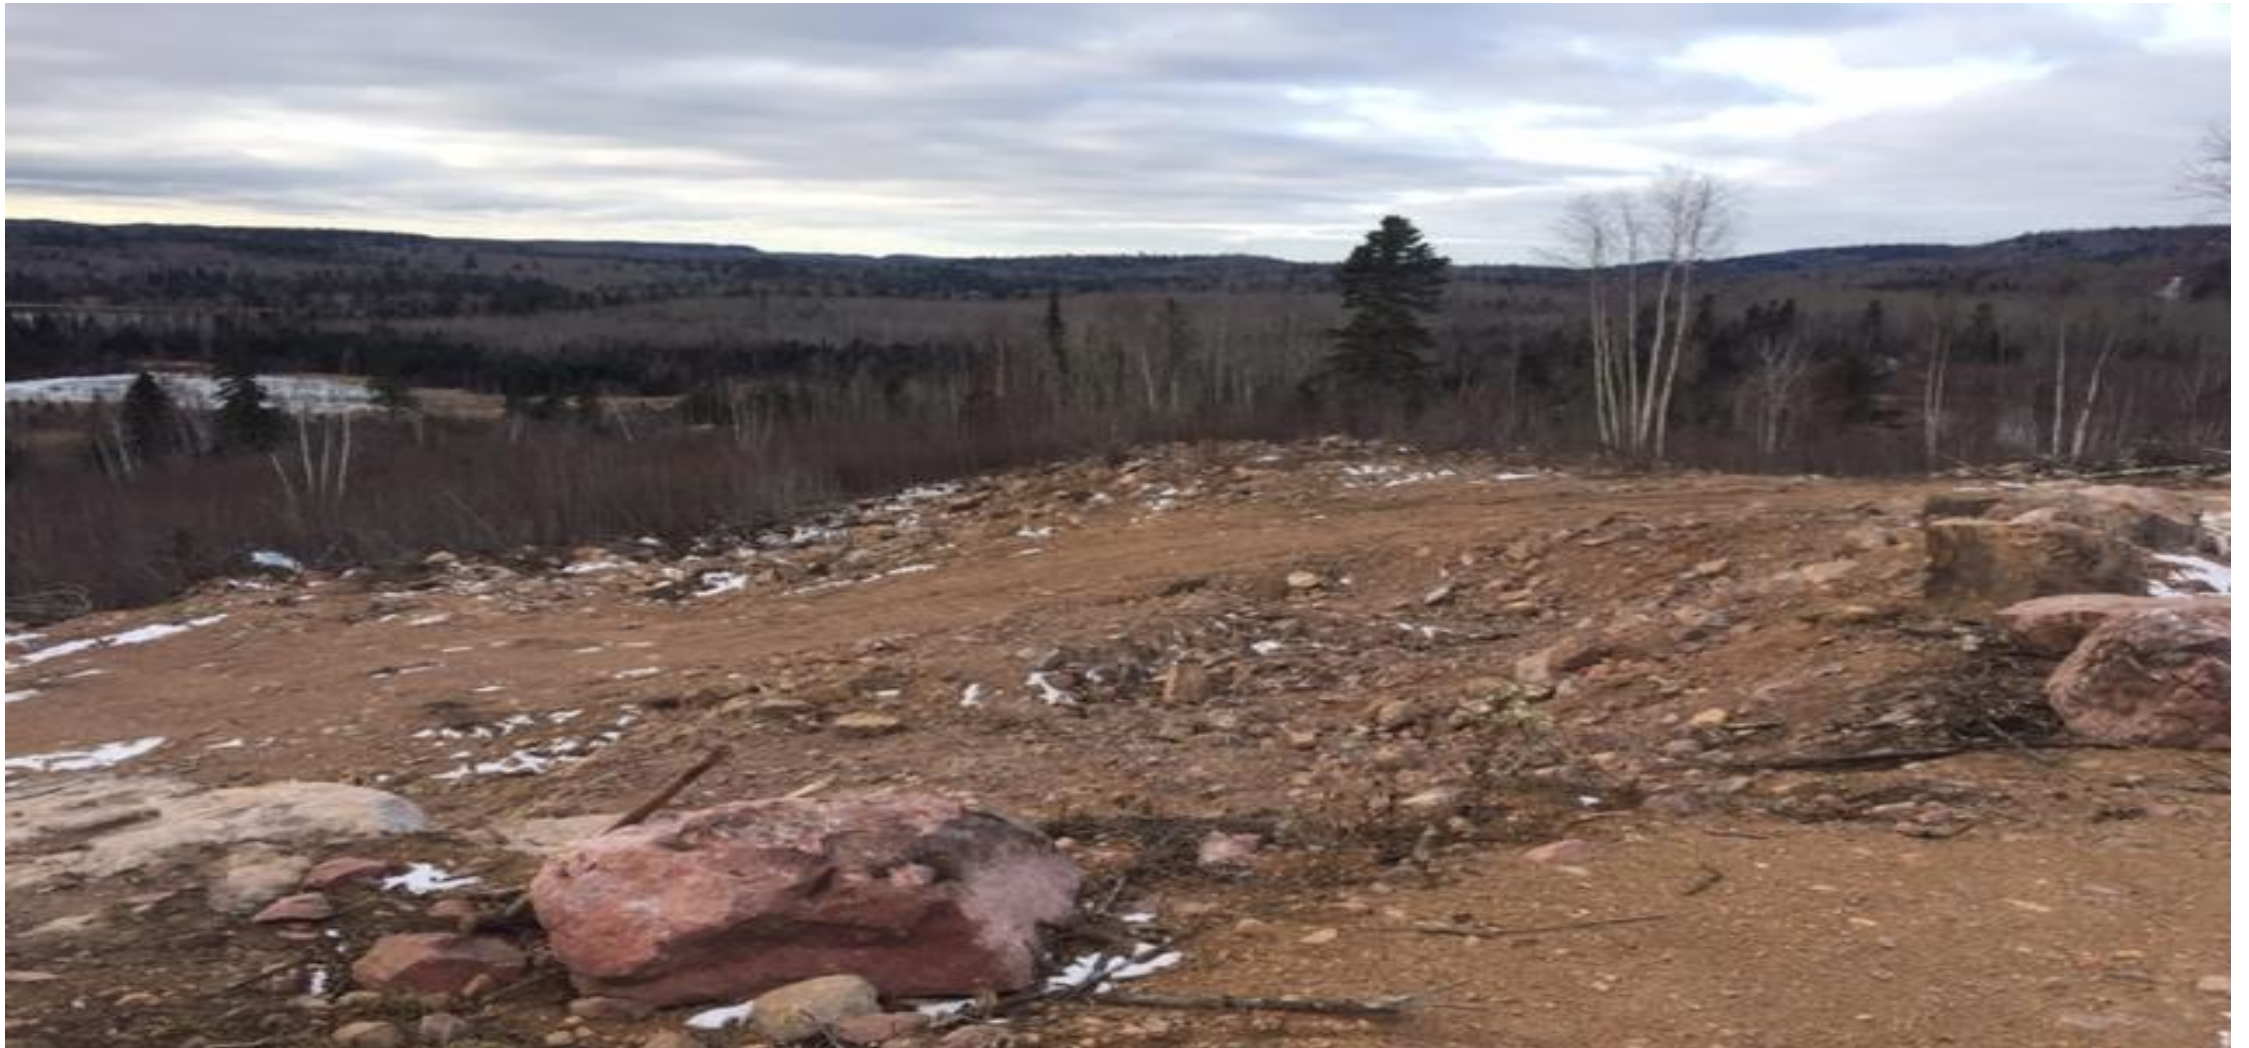
October 19th area stripped ,removed overburden large rocks. Looking west from granite out crop. Large rocks used as buffer wall to right of photo. Far back of photo area excavated and stripped dates of November 26,27th.

- October 19th again I sorted and hauled out more overburden and rocks to improve the work area prospecting/exploring for amethyst while exposing vein.8 hours loading with excavator and using dump truck to haul it away. I also used some of the larger rocks to use as a buffer wall for safety along upper part of granite outcrop. Daily total costs for each piece of equipment. Excavator \$150.00x8=\$1200.00 Dump Truck \$150.00x8=\$1200.00 Totalling \$2400.00 for this day.

- November 26th, 2020, I moved excavator to the west of granite outcrop and began excavating/stripping overburden brush and loose granite rock trying to find the vein and to see where it was heading. I found that the vein headed west. Daily total for excavator $\$150.00 \times 8 = \1200.00 .

- November 27th, 2020, I continued stripping/excavating where I had left off the previous day. Continued digging deeper and following the vein in a west direction. I found I had to dig deeper approximately 3 to 4 meters to uncover the vein. I was only able to find more Amethyst purple blue in colour mixed with granite quartz and mud stone. proximate size of area excavated was 30x10 meters and 3 metres deep over this 2-day period. I had also began stripping access trail to follow the vein in a west direction. My plan is to return to this area in spring of 2021 to carry on exploring for amethyst. Daily total for excavator $\$150.00 \times 8 = \1200.00 .

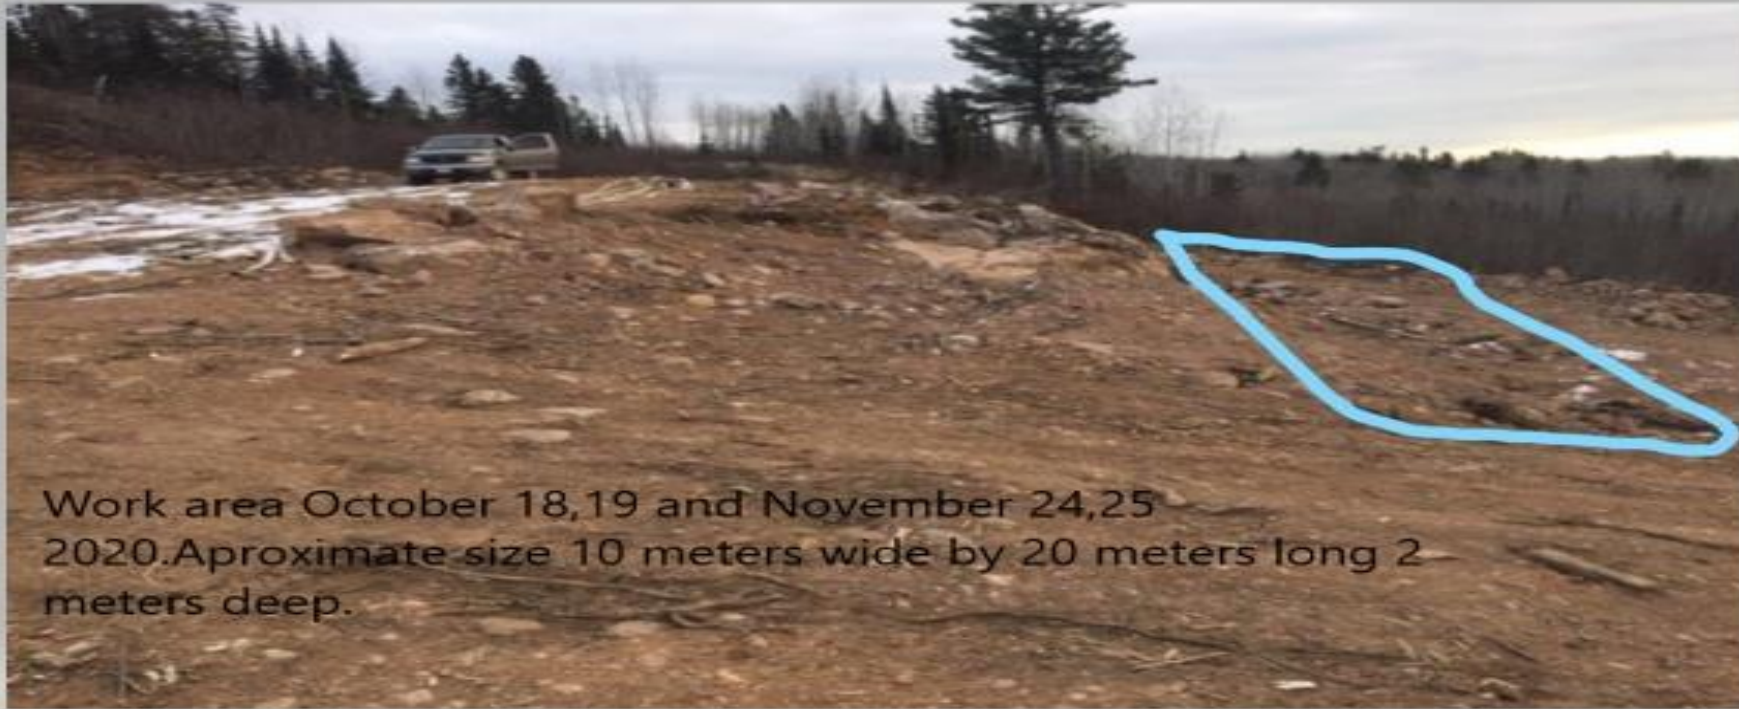
Work area October 18,19 and Noyember 24,25
2020.Aproximate size 10 meters wide by 20 meters long 2
meters deep.

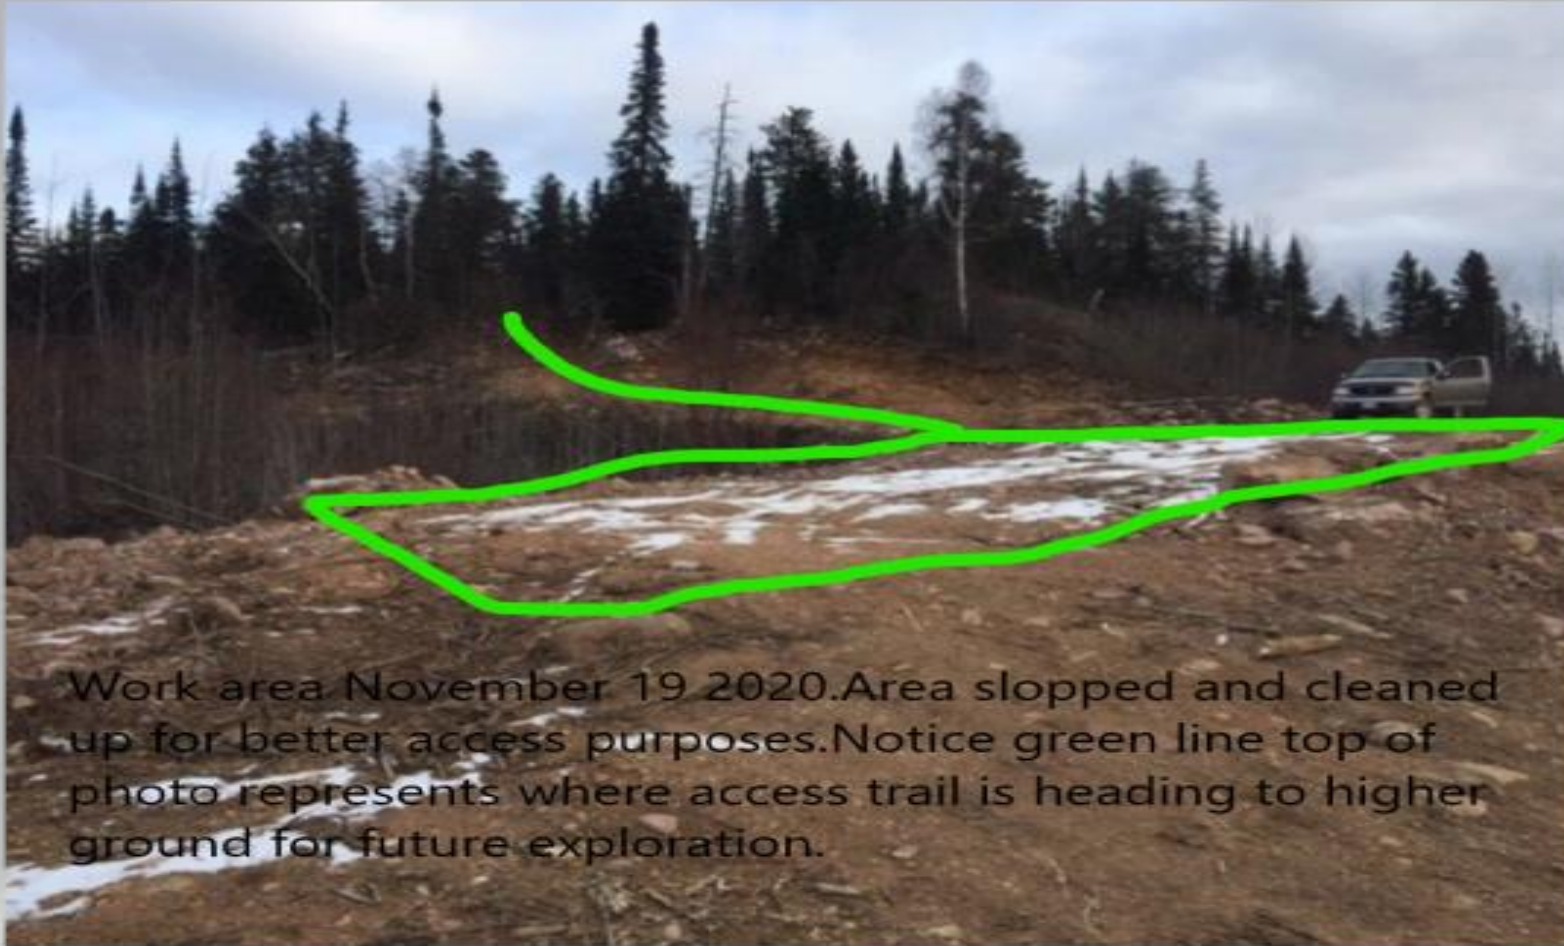
work area November 17, 18 2020. Aproximate size 20 meters long 20 meters wide. Notice access trail to higher ground for future exploration to left of red outline.

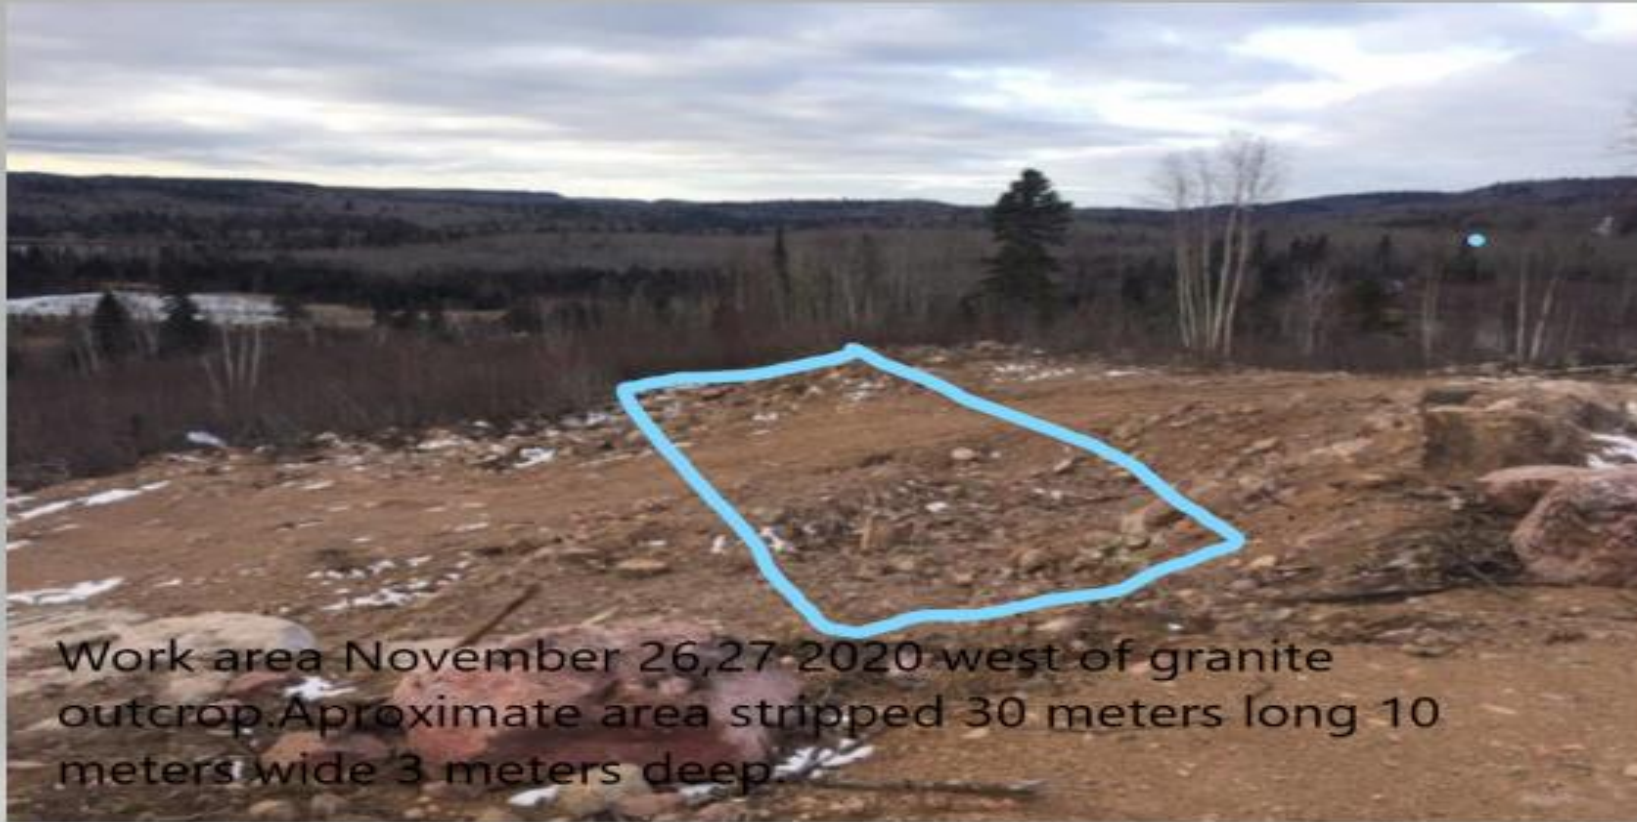
Work area November 19 2020. Area sloped and cleaned up for better access purposes. Notice green line top of photo represents where access trail is heading to higher ground for future exploration.

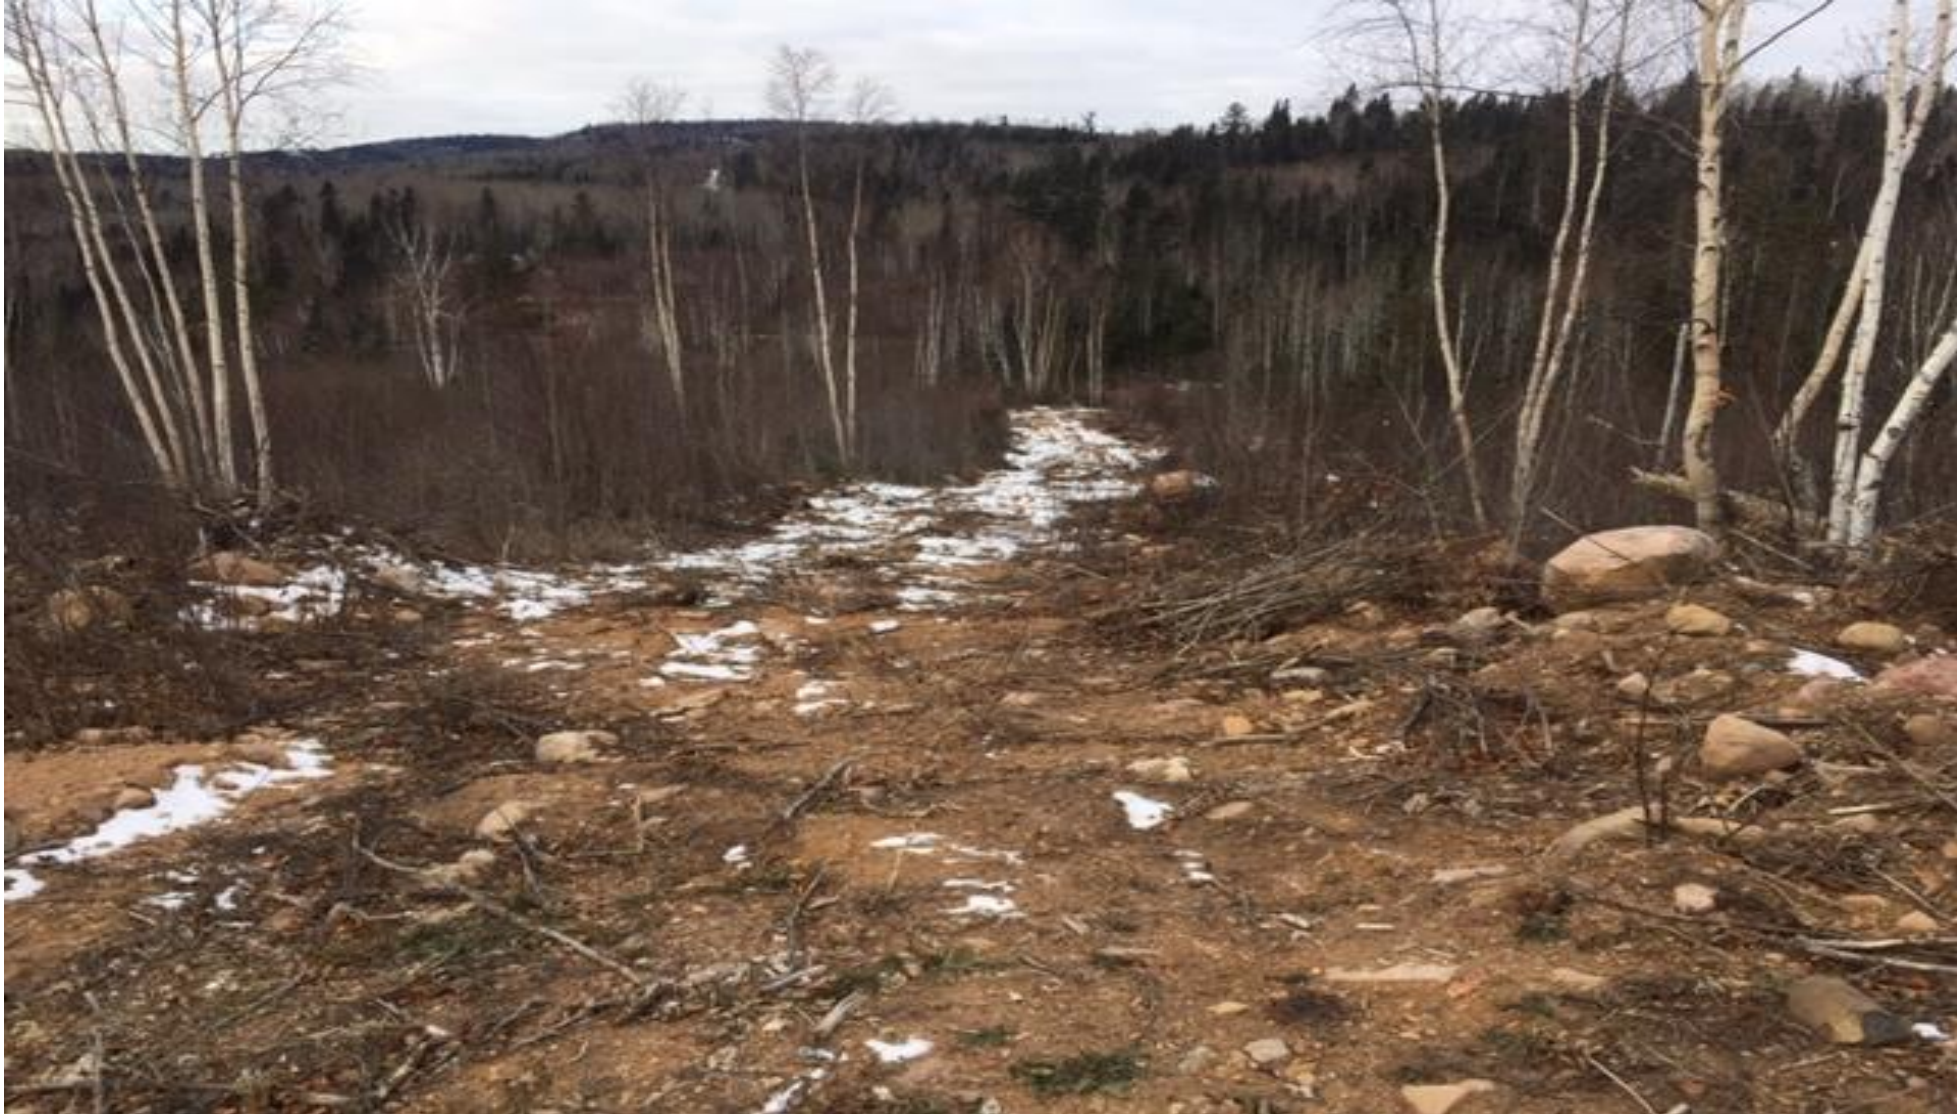
Work area November 26,27 2020 west of granite outcrop. Approximate area stripped 30 meters long 10 meters wide 3 meters deep

Following vein building access trail for future exploration. Work dates November 26,27,2020.Looking west of granite outcrop.

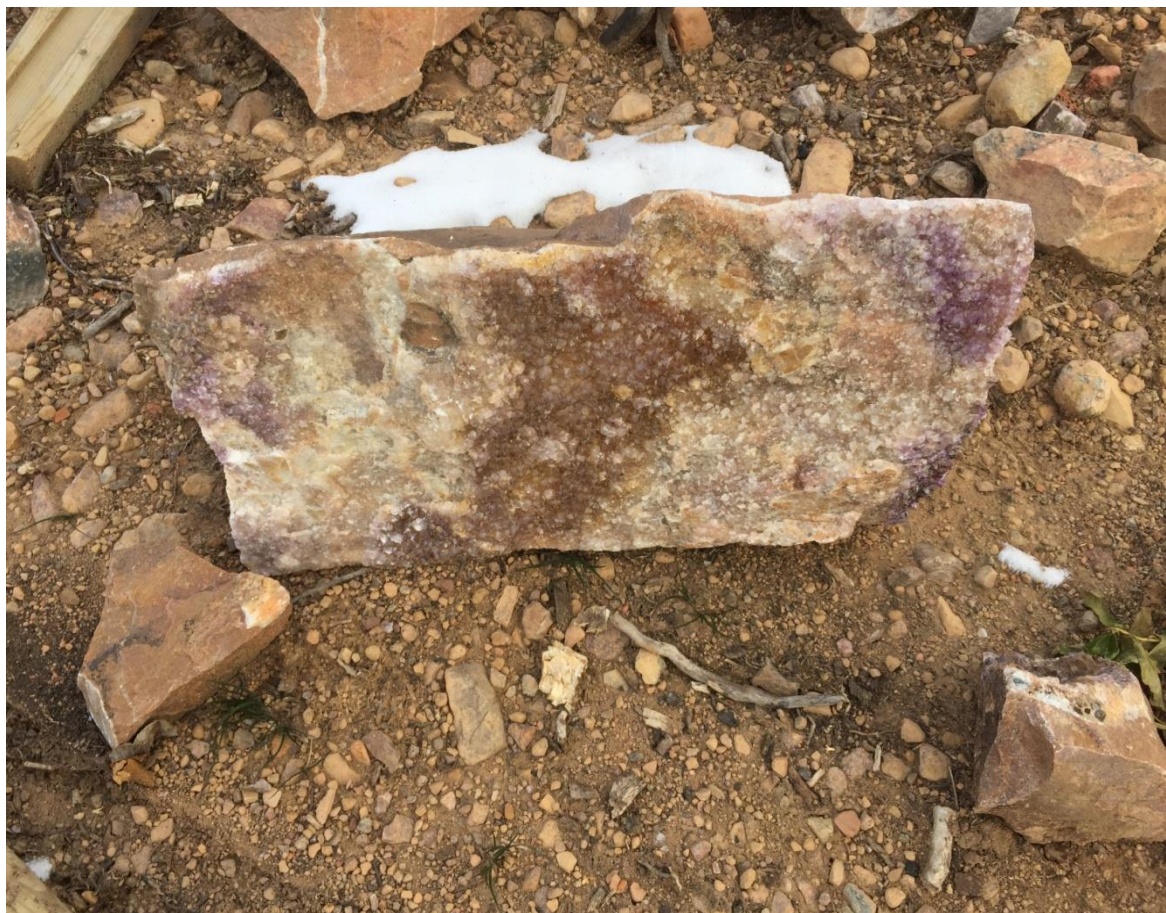
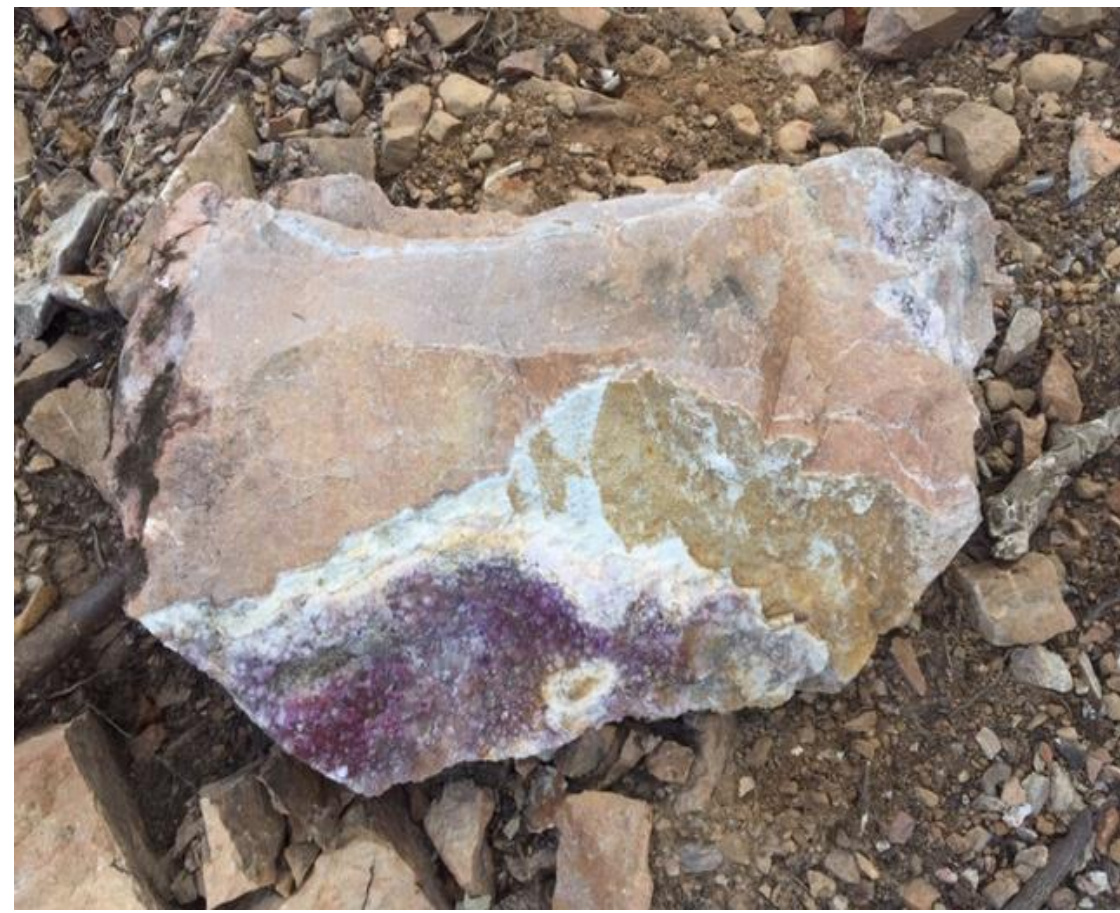
Amethyst found in work area while excavating vein below granite outcrop dates November 24,25 2020.

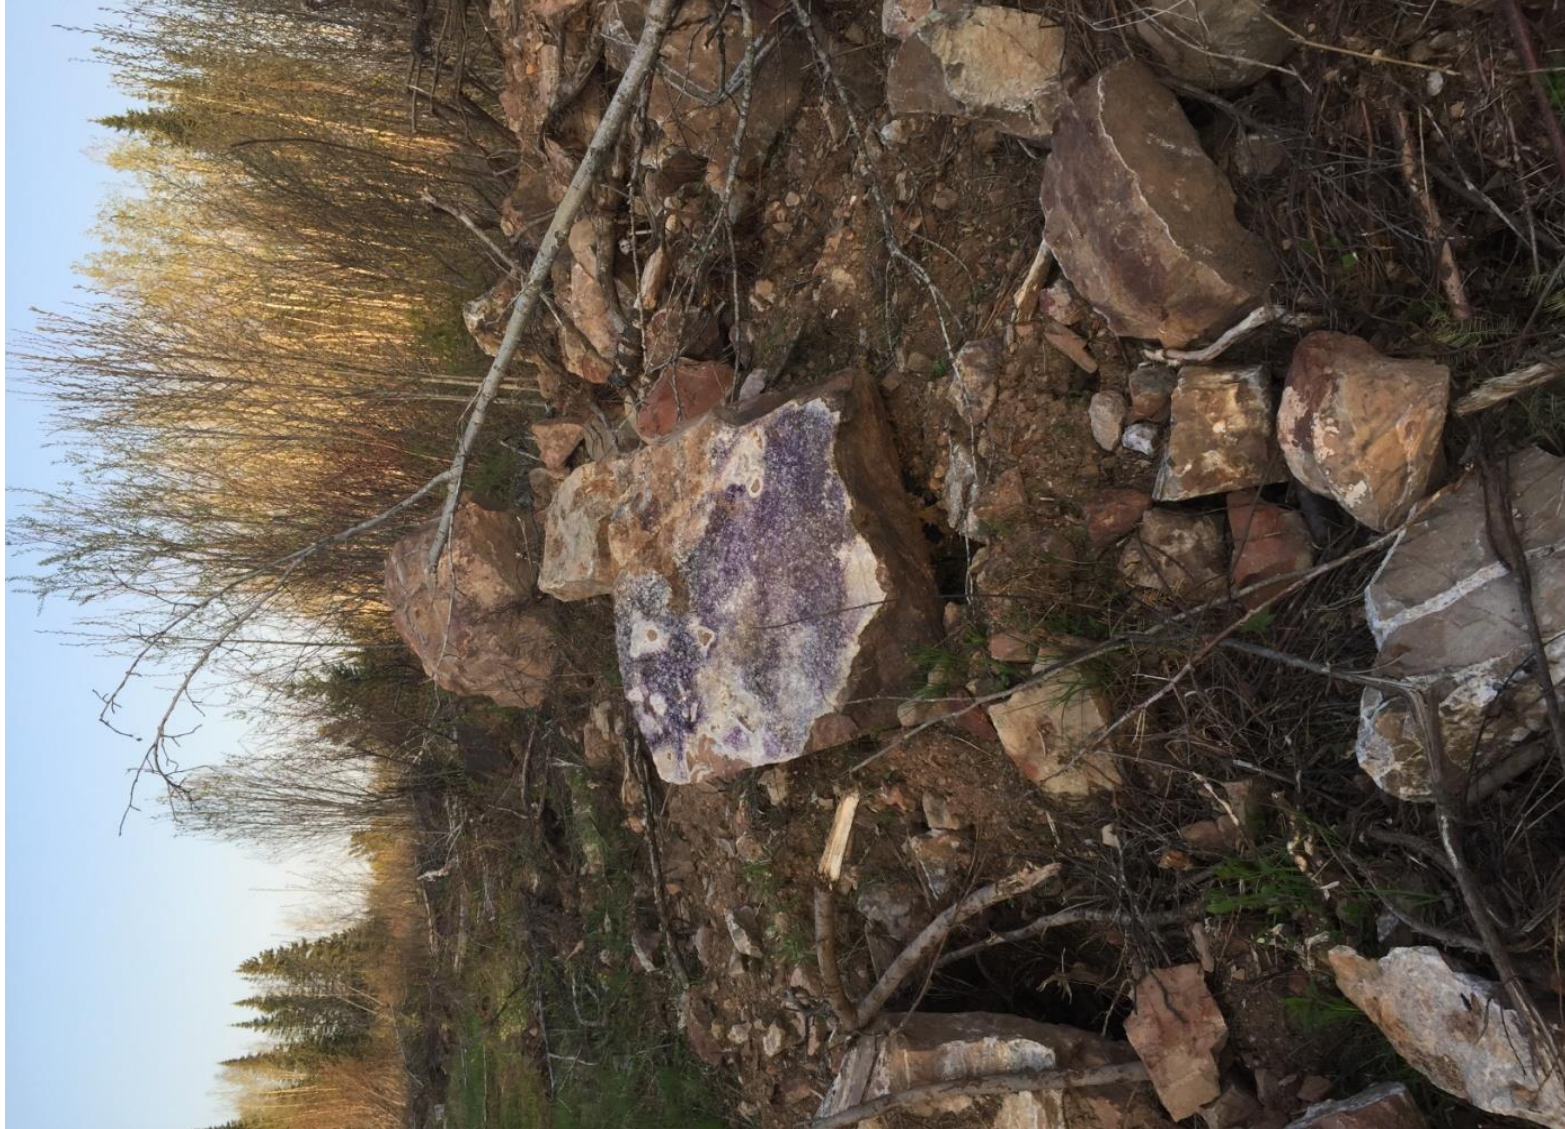
Amethyst found in work area on November 27th 2020 west of granite outcrop.
