# **PROSPECTING REPORT**

**THE EAGLE LAKE SOAPSTONE PROPERTY**

**Mining Claim 638409**

**MAGABRA RESOURCES CORP.**

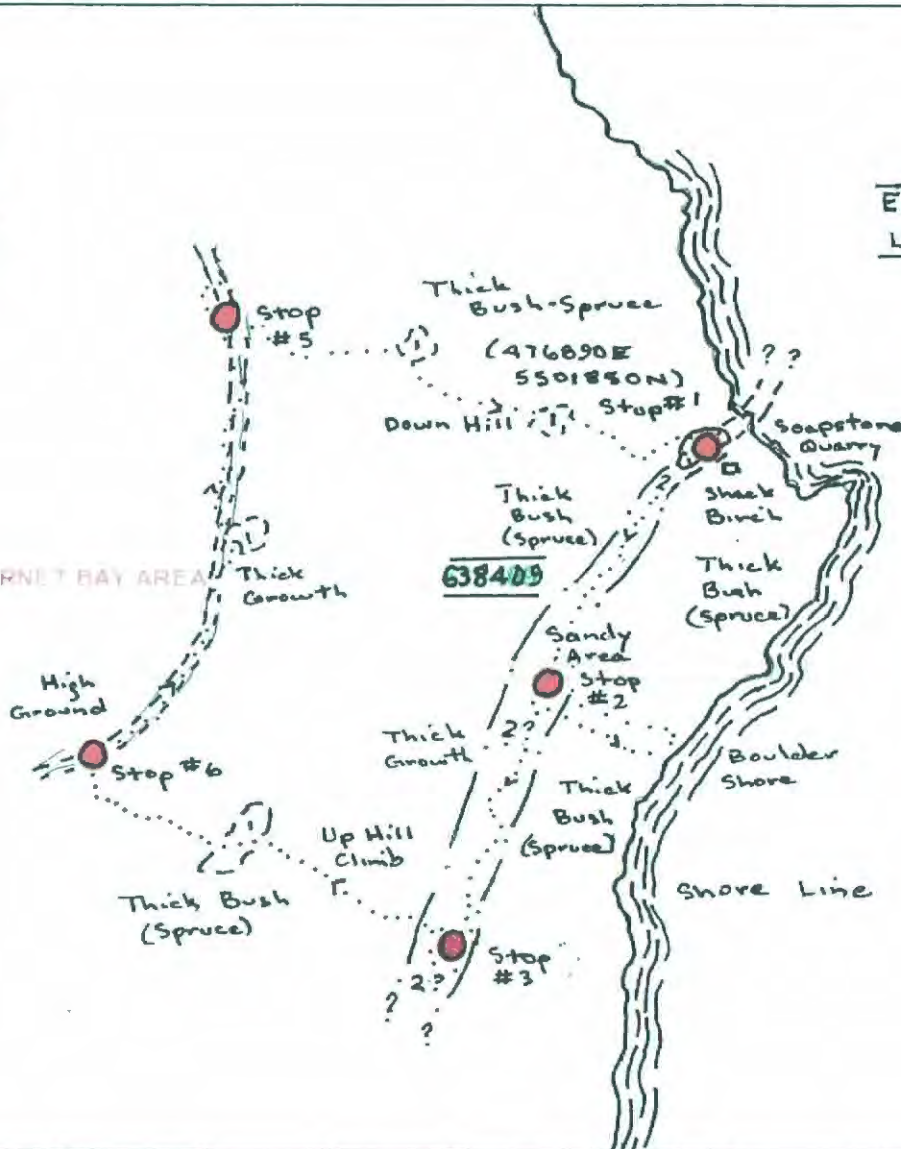
-The talc-chlorite schist serpentine soapstone unit exposure is about 40 m in length and approximately 30 m in width striking at an azimuth of 063 degrees. The depth of the unit is unknown; however, the western face of the pit (+/- 20 by 15 m) is vertical and quarried in the same strike co-ordinate.

-The pit within the topography slopes moderately to the lake. The west wall to the top of the water filled basin is about 3.5 m in vertical height. The water lies above lake level indicating the water is naturally occurring – rock unit competent. A man made sump pit was noted at the end of the pit.

-Debris – The remains of fencing and signage was down, heavily overgrown around the north end of the pit, remnants of concrete pillars and pits noted including shack on the south side of the pit. Within the pit is floating vegetation debris. As for mining develop casting – waste pile – the material was dumped on the shore and into the lake. The material does “not” impose any health hazard. Based on historical photographs, little remains of the large cut blocks and what remains are small fragments in matrix of sandy loam.

Third, with site cleanup to quarry standards, the remaining waste material can be utilities for carving and fishing weights and lures. Further, I believe the soapstone body is greater in size proven by an exploration drill program which includes a ground magnetometer survey.
